THE LANDSLIDE OF CALAIZA IN THE COAST OF GRANADA (ANDALUSIA, SPAIN).

ABSTRACT

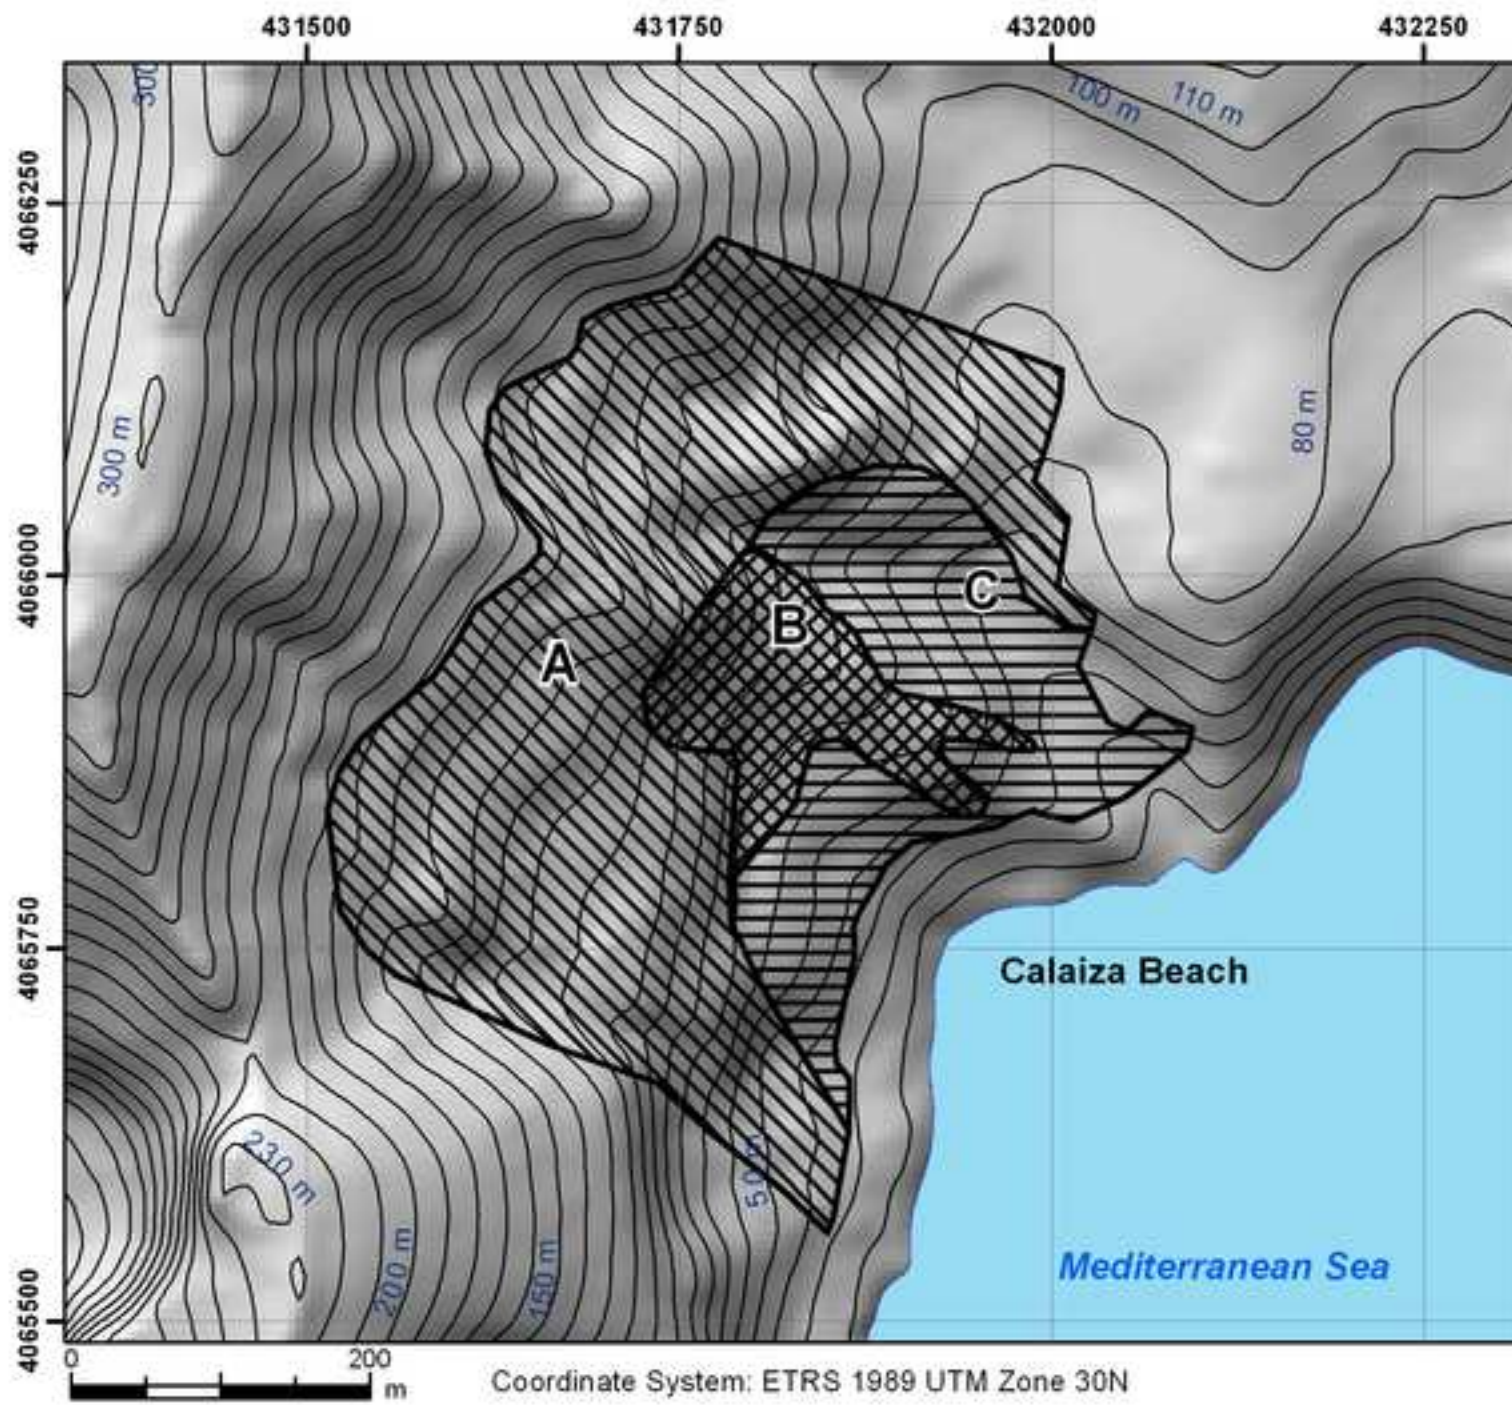
Figure 5

19
20
21
22 *Fig.5. Projection into the current urban area of the preliminary zonation proposed by private*
23 *geotechnical firm to the builders for the further development of the Eastern margin of Cerro Gordo (La*
24 *Herradura, Granada, Spain). The zonation indicates: A) area suitable for building; B) area suitable with*
25 *restrictions; C) area not recommendable for building. Only areas in the upper parts were considered*
26 *suitable for building, and the rest either needs some restrictions or is not recommendable.*
27

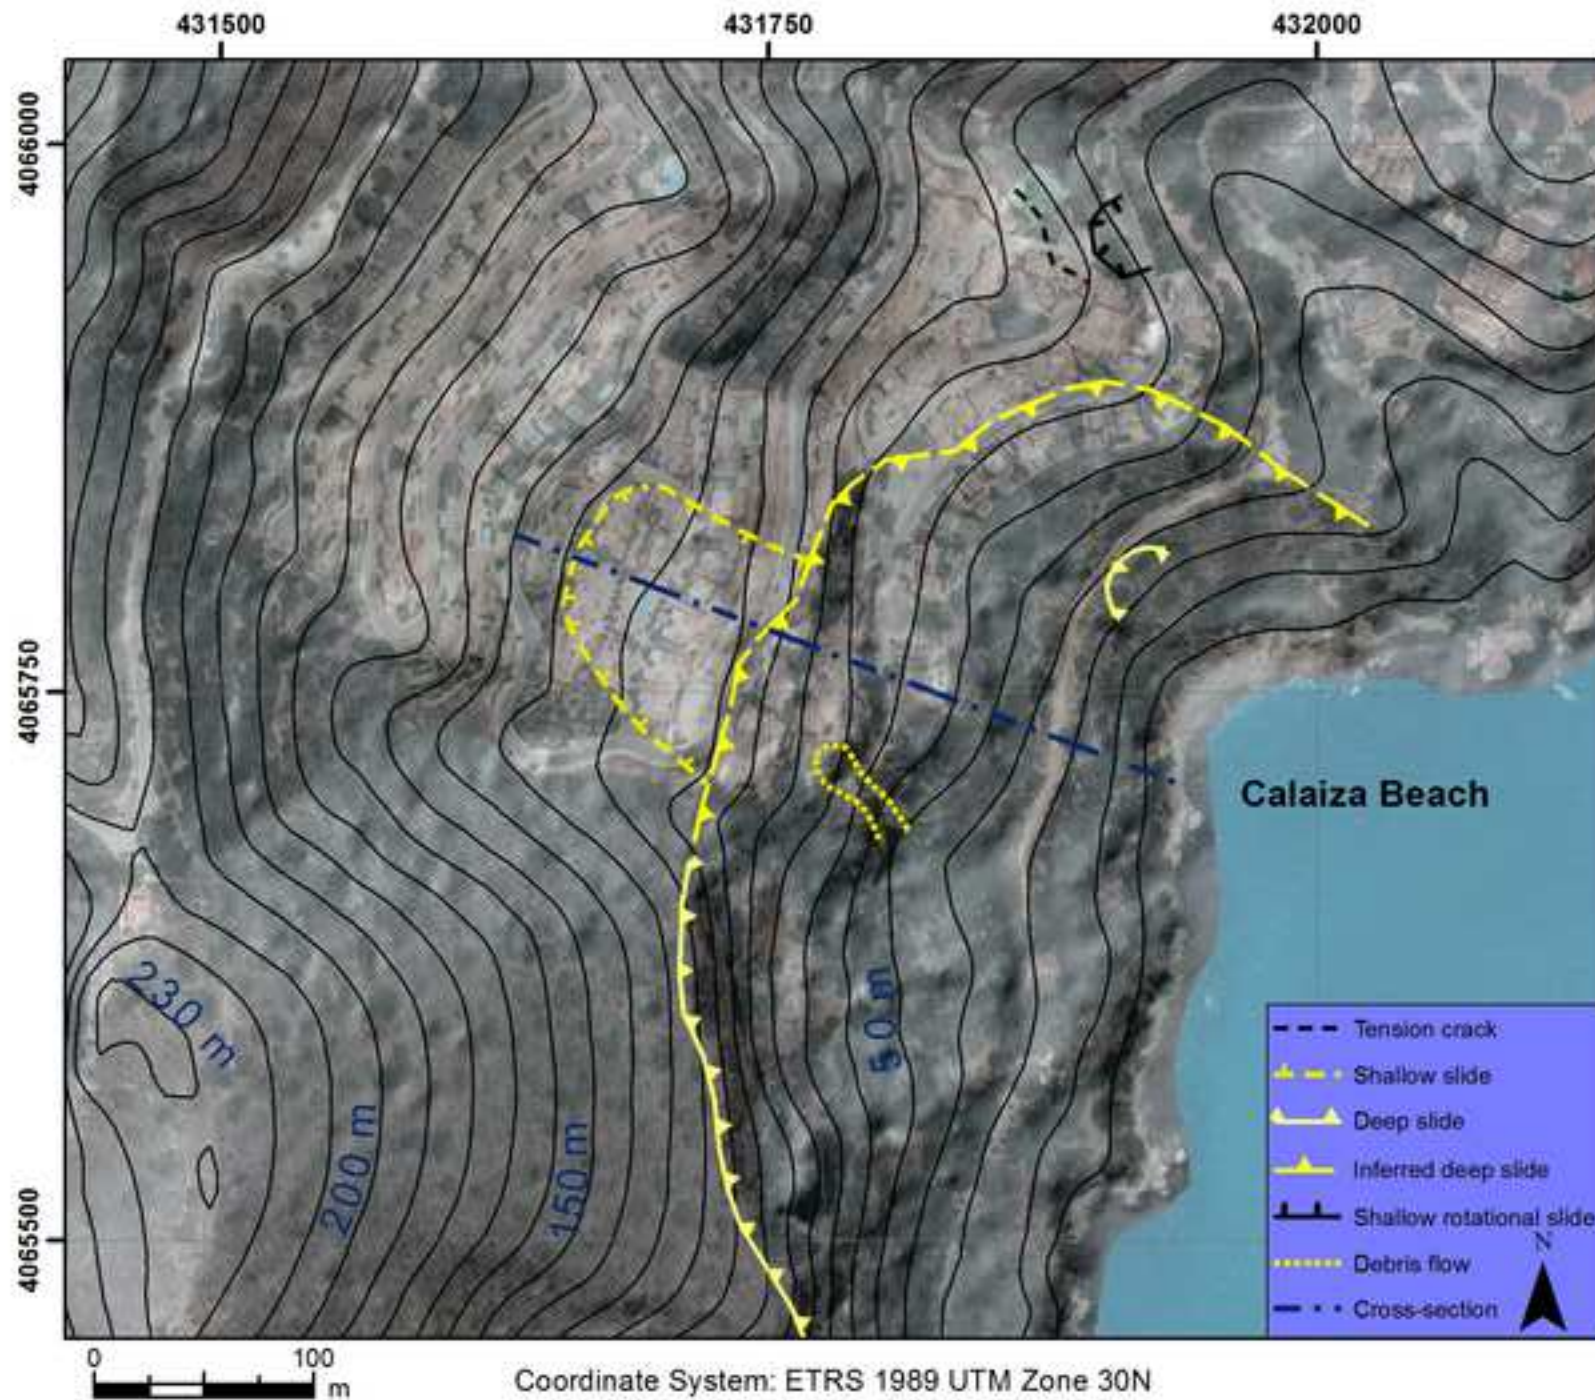
Figure 9

1 resulting from the sliding of a mass of marble on its schistose basement, to be buried under the sea. In the
2 Eastern slope of Cerro Gordo, the map and cross section (Figures 9, 10) show the distribution of
3 landsliding areas related either to Calaiza landslide, including more recent local flowing of infills in
4 different sites of the urban complex, where new scarps and rupture breaks appear since the construction of
5 the urban complex. Also may be distinguished the upper or lateral sections of the urban complex outside
6 the landsliding area in which little or no pathologies are found.

7 *Figure 9 Map of distribution of damaged areas in the urban complex according to data recorded in 2016*

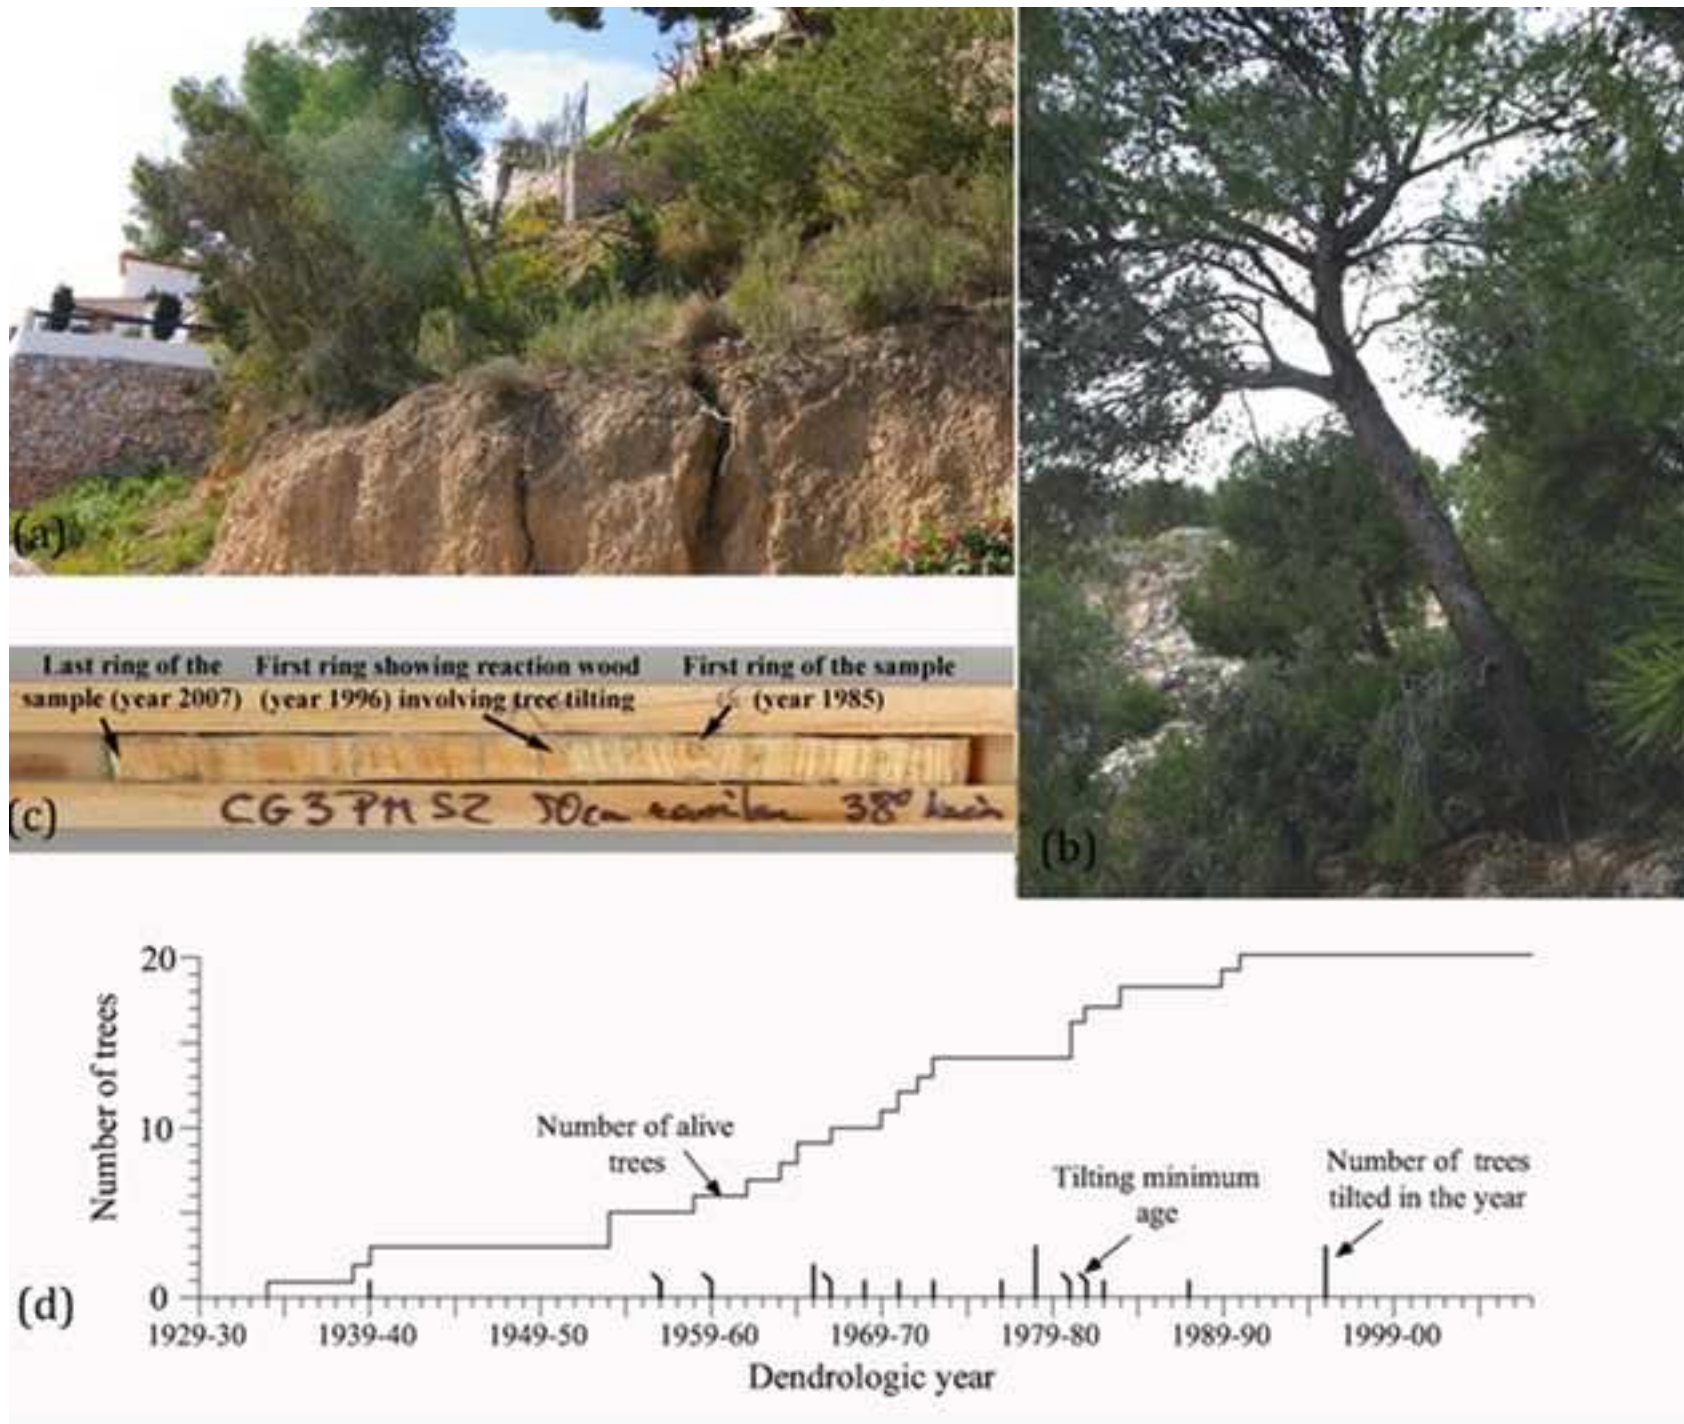
39
40
41 Figure 13. Dendrochronological analysis of the activity of the Calaiza landslide: a) Tilted pines located near the head scarp of
42 the active part of the landslide in the northern limit of the lower section; both presence of fresh open cracks and leaning tough right
43 tree trunks indicate very recent activity (photo taken in February, 2008) ; b) Mature tilted pine with a curved trunk; recovery of the
44 vertical position of the upper part of the trunk suggests that some years or a few decades have elapsed since tilting event occurred;
45 c) Core sample of a young tilted pine; change in wood colour by the presence of reaction wood (due to tilting) is apparent in the
46 ring formed in year 1996; d) Chronology of tilting events of trees living on the landslide; e) Monthly rainfall from 1960 to 2010 in
47 the coast of Granada.

53
54 The main landslide reactivation events occurred in 1965-66, 1978-79 and 1995-96, periods in which
55 tilting of two or three trees each one took place. Other tree tilting events involved a single tree; they could
56 be caused by small movements of the landslide or by local instabilities of the slope. It is worth noting that
57 other minor reactivations events could have been not recorded by tree rings if they produced small
58 displacement (i.e. not significant ground surface deformation) or if affected only trees tilted in previous
59 events.

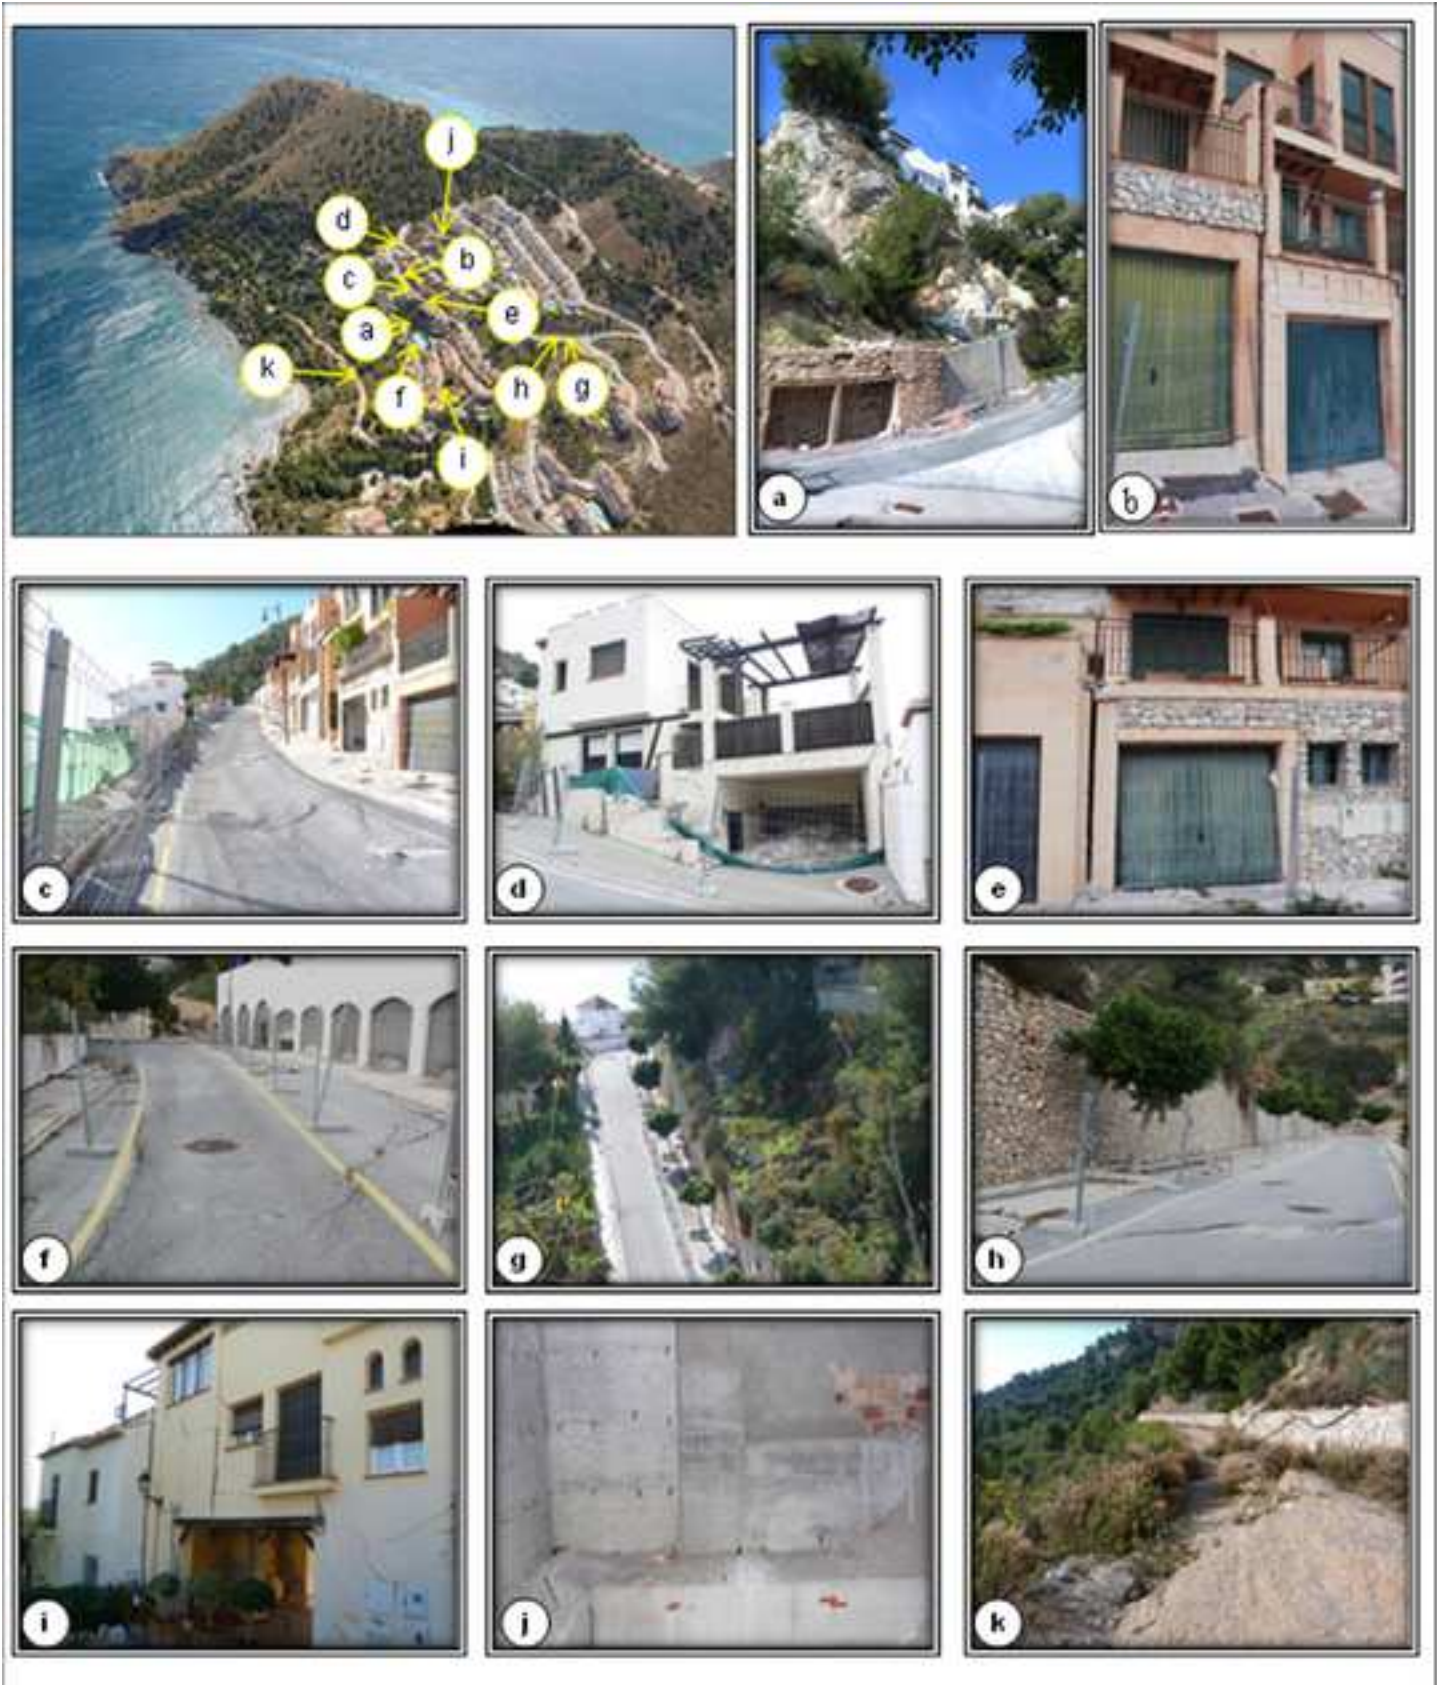
15
16
17 *Figure 14. Some examples of damages: a) structural damages in a house in the upper affected section; b) failure of way along its*
18 *front; c and d) lateral displacement of two houses in the upper affected sections; e) deformation and wall cracks of a passage*
19 *house in the lower side of the middle section; f) Deformations and partial rupture of a wall of stone attached to another one of*
20 *reinforced concrete also inclined; Deformations of one of the main access road to lower part of the middle section; g) Overall view*
21 *of slope failure affecting a wall and the way accessing to the lower side of this section; h) Detail of the deformation and overturning*
22 *of the sidewalk under the leaning wall forward by the thrust of the ground composed of fillings; i) Closer view of upward*
23 *displacement by a local rotational slide of the way accessing to the lower side of the section; j) Open cracks and circular breaking*

24 *of the way in between houses of the lower section affecting some parking rooms; k) Open cracks in footings and foundation walls*
25 *of a house in the upper affected section ;l) slope failure by a local slide flow affecting a section of the lower way accessing to*
26 *Calaiza beach; the former retaining wall is also broken.*

53
54 The rigid ceramic walls show stress lines through fissures and cracks. In some areas of the different
55 urbanisations, pressure on the soil has affected whole houses, damaging structural concrete walls and
56 even tie-bars that link the superficial footings, producing complete structural affection that has led to
57 collapse, and in some cases forced the complete demolition of the affected buildings. The same detriment
58 has happened to landscaped areas throughout the different urbanisations, causing damages in fences, brick
59 walls, slabs and staircases unable to withstand beyond the slightest land movements. As a consequence,
60 the land deformations have altered retaining and garden walls –both masonry-made and plastered, as well
61
62
63
64
65

1 as slabs, pavements, and pools, in both private and common areas. Given the magnitude of the issues,
2 local repair of damages does not seem suitable unless a large-scale intervention is put in place. This
3 would limit and contain the general deep landslides shown on the geotechnical studies already conducted,
4 and would need to be further studied on those still pending, taking into account the technical advice of
5 qualified experts. In 2015, due to the fear of immediate collapse, 24 houses were sealed by the City of
6 Almuñécar while by September of 2016 they were 42; furthermore, many other were progressively
7 increasing its damages (Figure 14).

9
10 For an overall slope stabilization the technical assessments (CG 2007, 2011) suggested remedial works
11 along the Calaiza beach slope front and the foot of eastern slope of the lower side of the middle section,
12 with a large basal stabilizing wall at the foot and widespread treatment of local containing walls and
13 foundation reinforcement in different sections of the urban complex, with treatment of rock slopes against
14 block falls and to avoid further effect of up warding erosive down cutting in the lower section and finally
15 the repair of the widespread damages in houses, ways and communal areas of the middle and lower
16 sections of the urban complex. In the meantime, before the availability of financial support for this really
17 expensive geotechnical overall program which may attain a large amount of money ($>10^9$ €), some
18 preliminary urgent treatments has been resolved by the Tribunal proposing an urgent treatment of the

19 most damaged houses and ways and a widespread repair of drainage network with extension to infilled
20 sections, local soil compaction and reinforcing of infilled sections, and implementation of a monitoring
21 and surveying program until the evidence of a new slope equilibrium in the urban complex. The increase
22 of damages during recent rainfall periods (2002-2016) expressed a very urgent need of this geotechnical
23 treatment in order to avoid major slope failures in the near future.
