Contents lists available at [ScienceDirect](https://www.sciencedirect.com)

Case Studies in Construction Materials

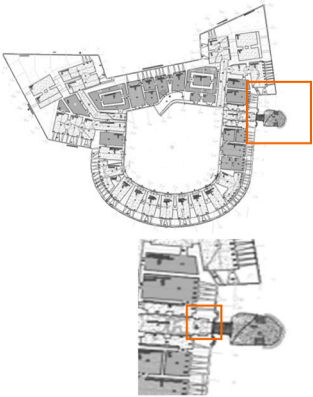
SAN FERNANDO DE BOCACHICA FORT			Date:	23/08/2020
Tipology:		Vault		
Location		Code:	Record N°

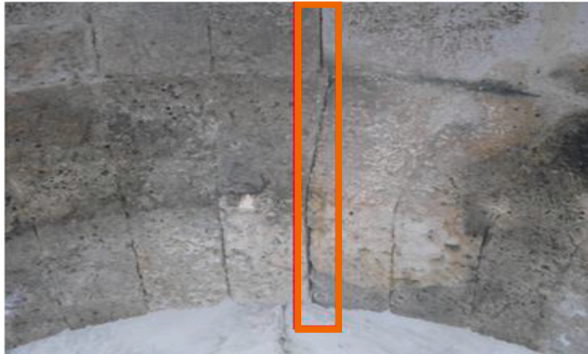
Damages:				
Damage group	Type of Damage	Damage Subtype		
Features induced by Material loss	Features induced by Material loss	Loss of Mortar		
Condition:				
Condition	Clasification	Color condition		
Fair	1			
Risk:				
Grade	Clasification	Sorting by color		
Moderate	1			
Affection:				
<input type="checkbox"/>	Safety	<input checked="" type="checkbox"/>	Aesthetics	
OBSERVATIONS: Loss of mortar in the joints (Top photo). Alveolization with cavities greater than 2 cm, disjunction of films, disintegration of the stone structure (Central photo). Fracturing and detachment of stone material from the structure is observed (Bottom photo).		POSSIBLE CAUSES: Runoff water and chemical factors that have disintegrated the mortar. Limestone corrosion, mechanical aggression, wind erosion and rainwater. Impact aggression and weathering.

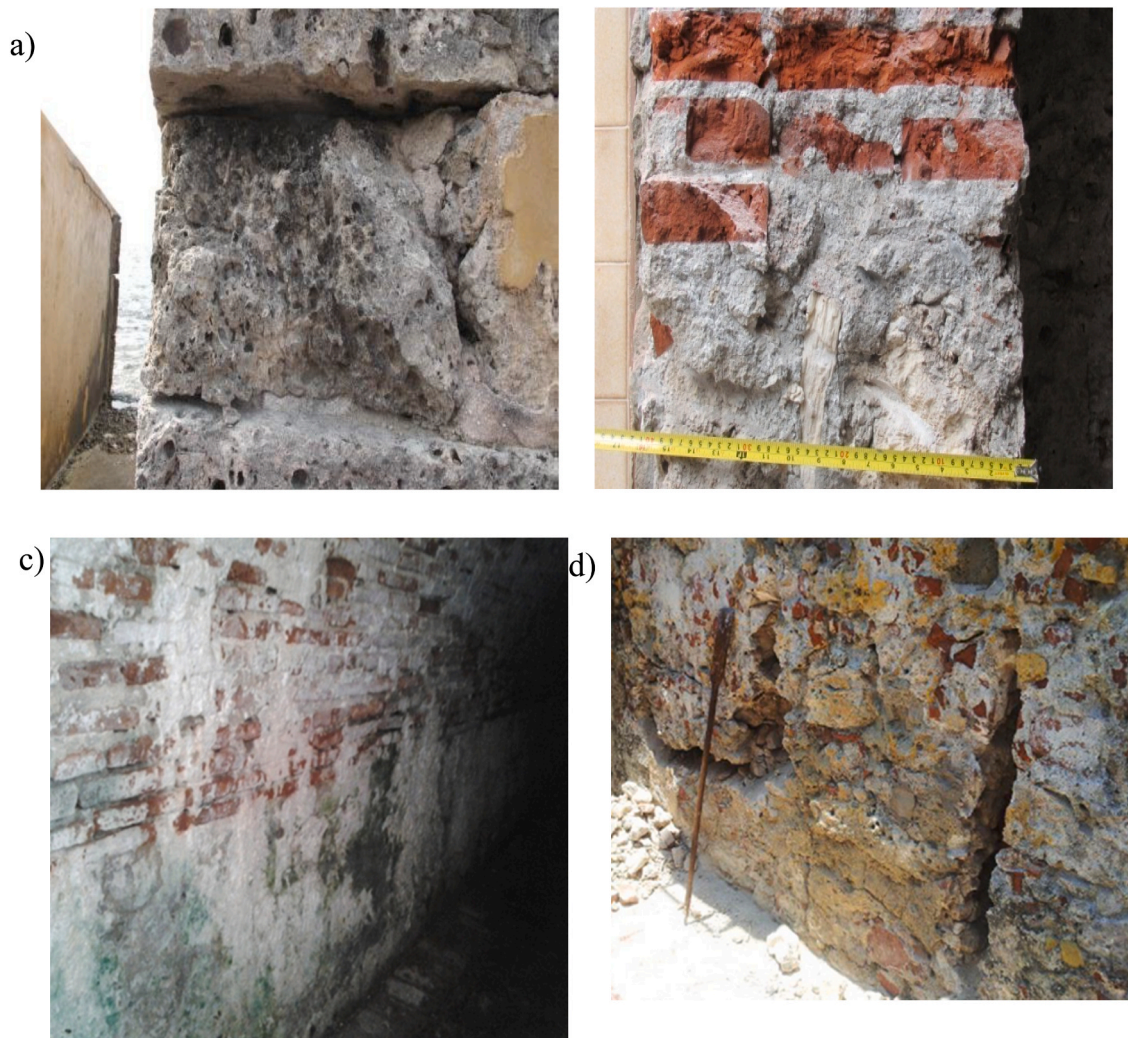
Fig. 4. Materials of San Fernando de Bocachica Fort. a) Limestone; b) brick; c) plastered limestone; d) mixed concrete.b).

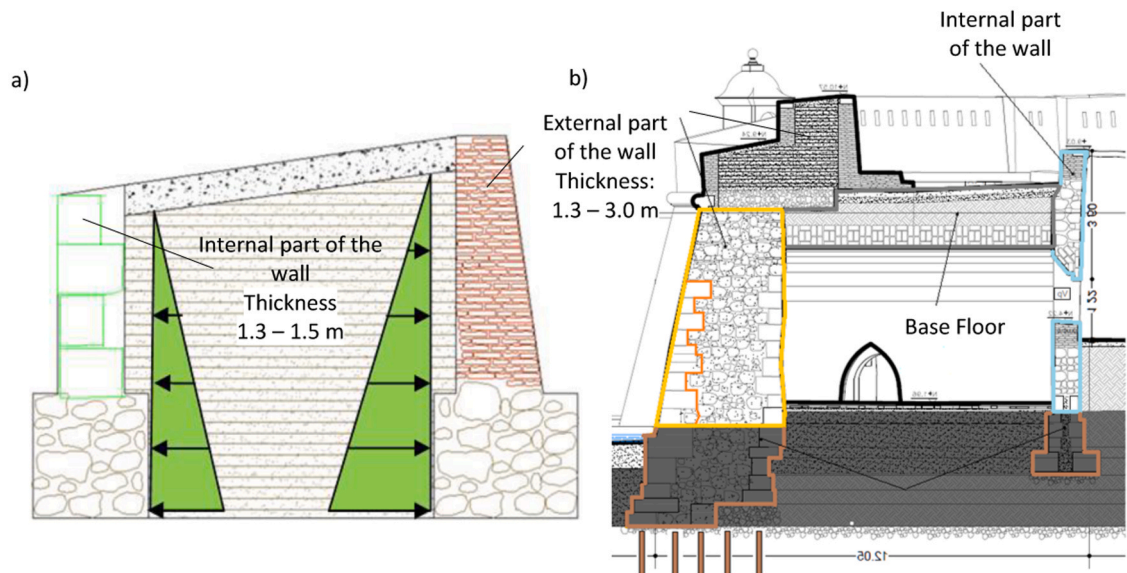
Fig. 5. a) Generic section of the Fort; b) Curtain and bastion construction system near to water bodies.

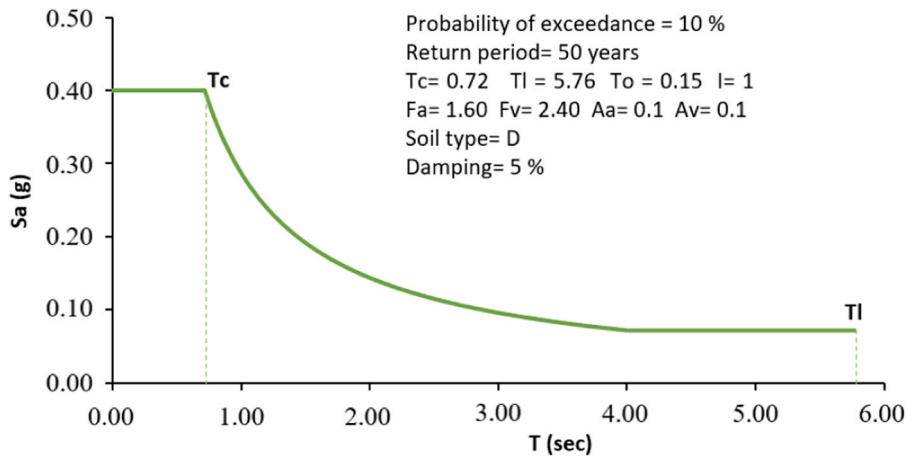
Fig. 6. Design spectrum for the NS according to NSR-10. I: coefficient of importance; Fa: amplification coefficient that affects the acceleration in the area of short periods; Fv: amplification coefficient that affects the acceleration in the area of intermediate periods.

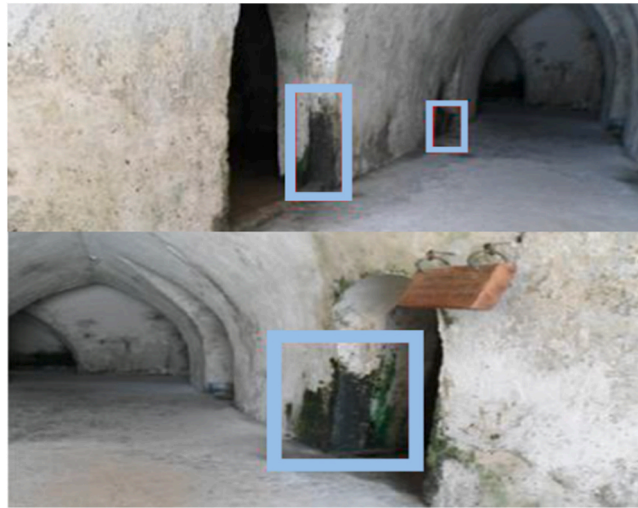
Fig. 7. Deterioration of the plaster, green spots on the wall of the vault, and rising damp on the floor.

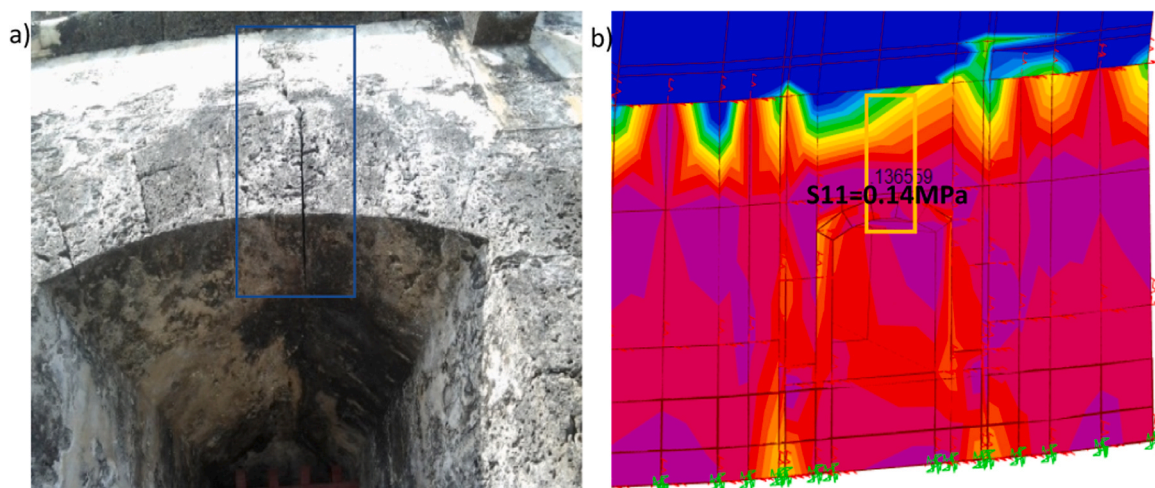
Fig. 8. a) Crack in the stone material in the upper part of a window, up to 2 cm thick in the real structure; b) state of stress resulting from numerical modeling with SAP2000.

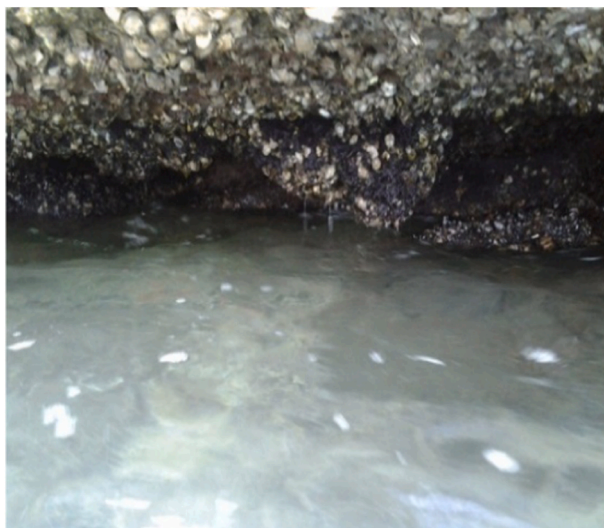
Fig. 9. Scour and deterioration of the stone material in the external part of the bathroom.

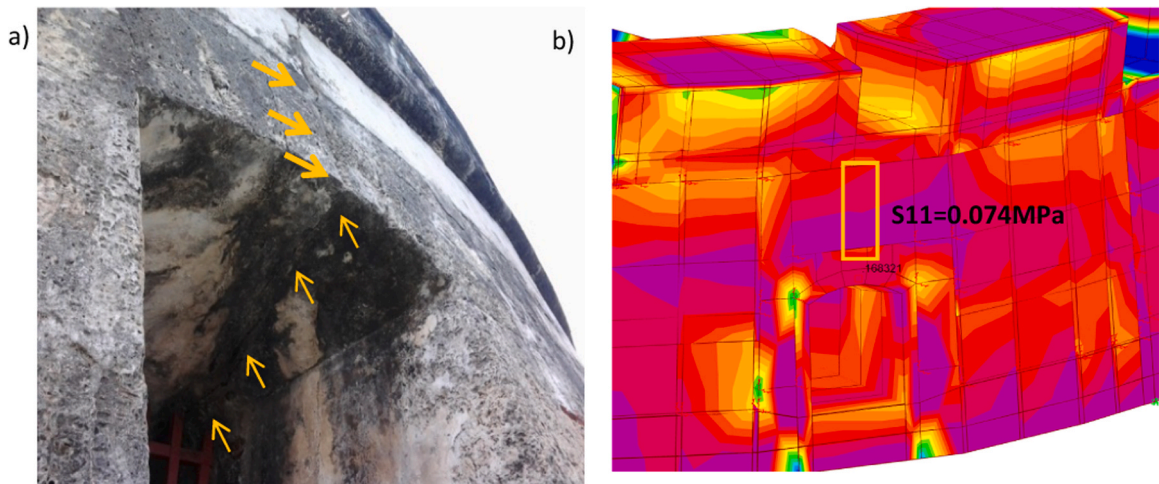
Fig. 10. a) Cracks in the key stone of the bathroom window; b) distribution of stresses according to the numerical simulation with SAP2000 in the same area.

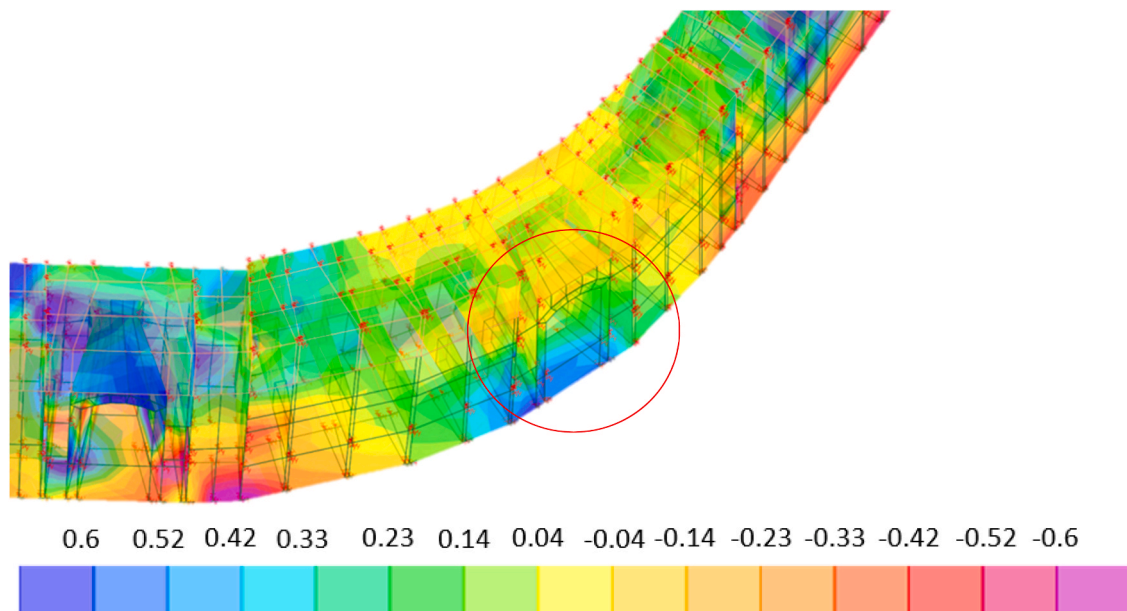
Fig. 11. Overstress diagrams showing the concentration of shear stresses in the lower part of the wall (MPa) [3]. Positive values: traction; negative values: compression.

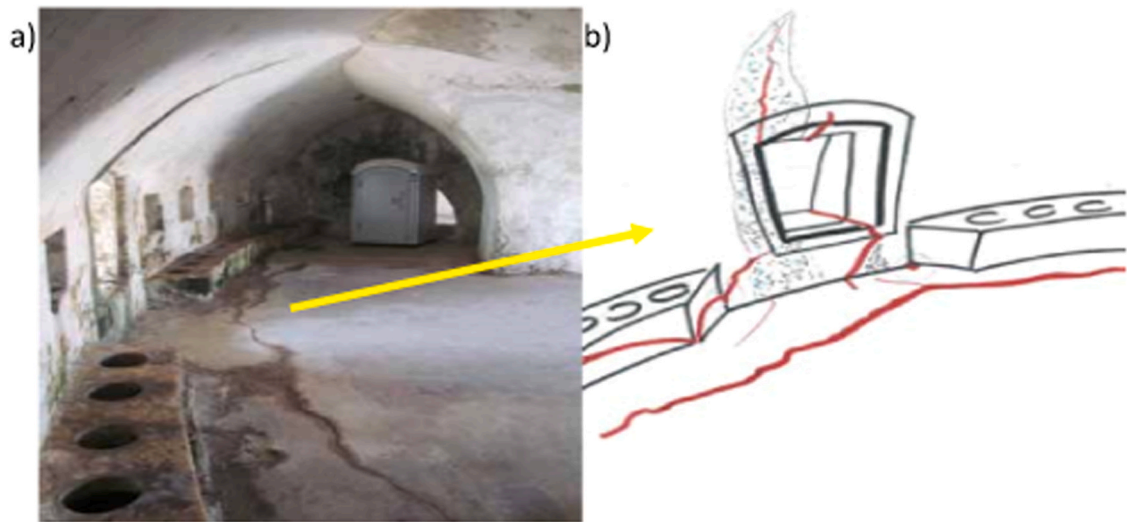
Fig. 12. a) Cracking pattern of the bathroom; b) side view of Fig. 11 a). Cracking chart sketch was recovered from Michele Paradiso et al. [26].

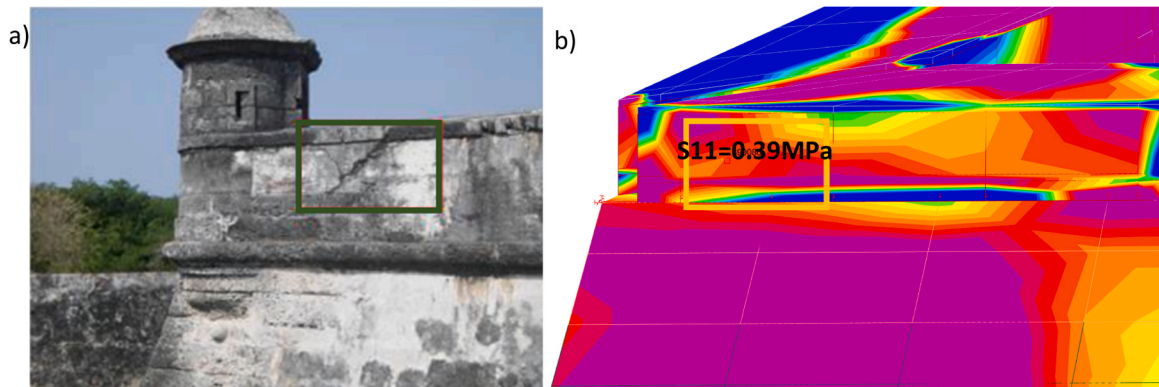
Fig. 13. a) Crack in the scarp with an incline of approximately 45 degrees; b) stresses found in the model in the same area.
