Article

Experimental Study of the Mechanical Behaviour of Bricks from 19th and 20th Century Buildings in the Province of Zamora (Spain)

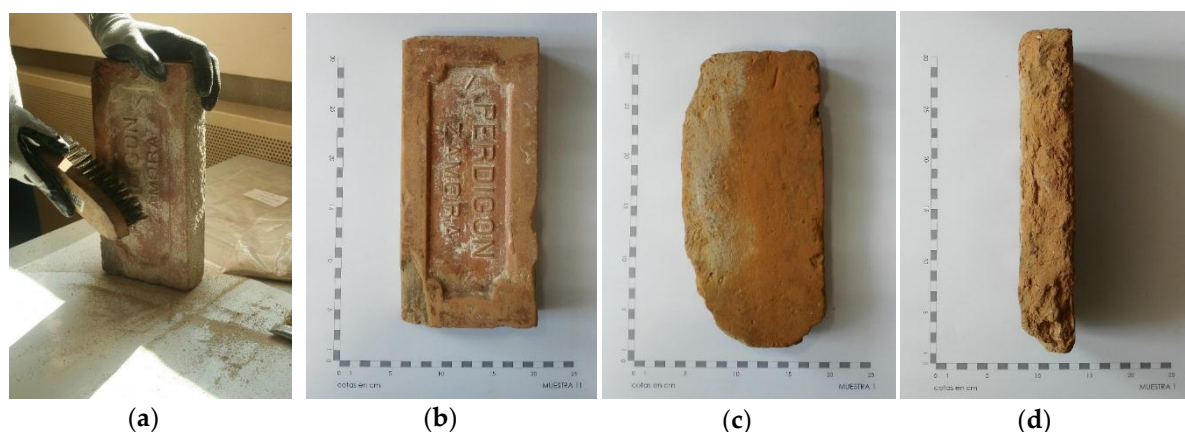
Figure 2. Brick cleaning treatment (a) and cataloguing (b–d).

Dirt and remains of mortar were removed from clay bricks by sandpaper and metal brushes, as shown in Figure 2, to avoid contamination of the material. After that, bricks were numbered and catalogued recording their origin, characteristics and geometry. The elaborated register includes photographs to know the original shape of the specimens.

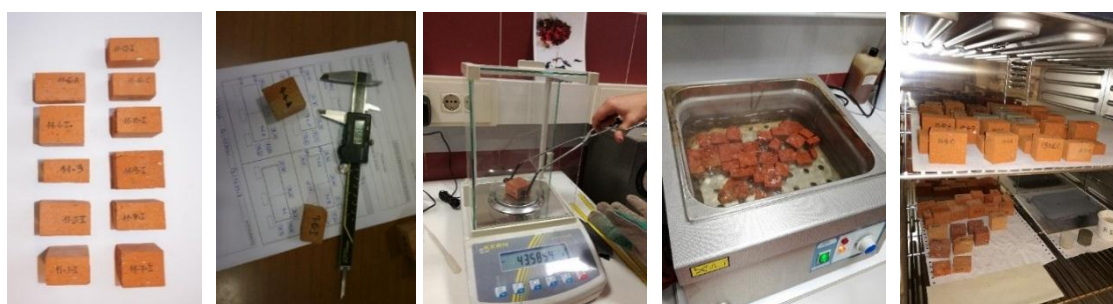
Figure 3. Measurement of the brick samples.

The samples are measured to obtain their apparent dry density (ρ_b), absorption (w_m), open porosity (π_a) and compressive strength (f_c), following the procedures outlined in Standards EN 772-13: 2001 [33], EN 771-1: 2003 [34] and EN 772-1: 2000 [32], as shown in Figure 3.

The lengths of the edges of the test specimens were obtained through a MITUTOYO CD 6" digital callipers of ± 0.01 mm resolution. These measurements allow for the obtaining of the apparent volume (V_g), and the length and cross-sectional area (A_b) for compressive testing. Due to the difficulties of cutting, specimens do not satisfy the geometrical tolerances of European Standard EN 772-1: 2000 [32], so the study considers the average length of the four axial edges and the average cross-sectional area of the load faces.

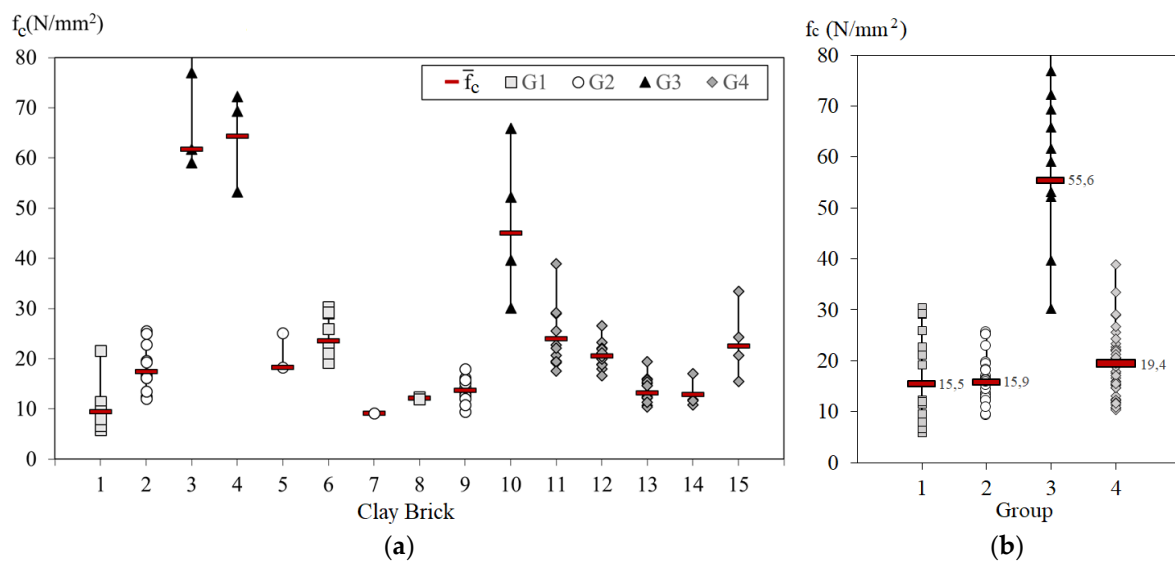
Figure 6. Compressive strength of (a) clay bricks and (b) groups.

Figure 6 shows the compressive strength results of all tests. These results vary between clay bricks and between samples taken from the same brick. This is particularly the case in those that reach higher values of resistance. In addition, Figure 6 points out the average values of resistance of each brick, listed in Table 2. The average values are determined from the compressive strength results of the pieces whose slenderness is greater than 0.5, since below this value unpredictable resistance results are expected [38,39].
