1 **A multi-method approach for characterizing landslides in an intramontane basin**
2 **of Andes (Loja, Ecuador)**

14 **Abstract**

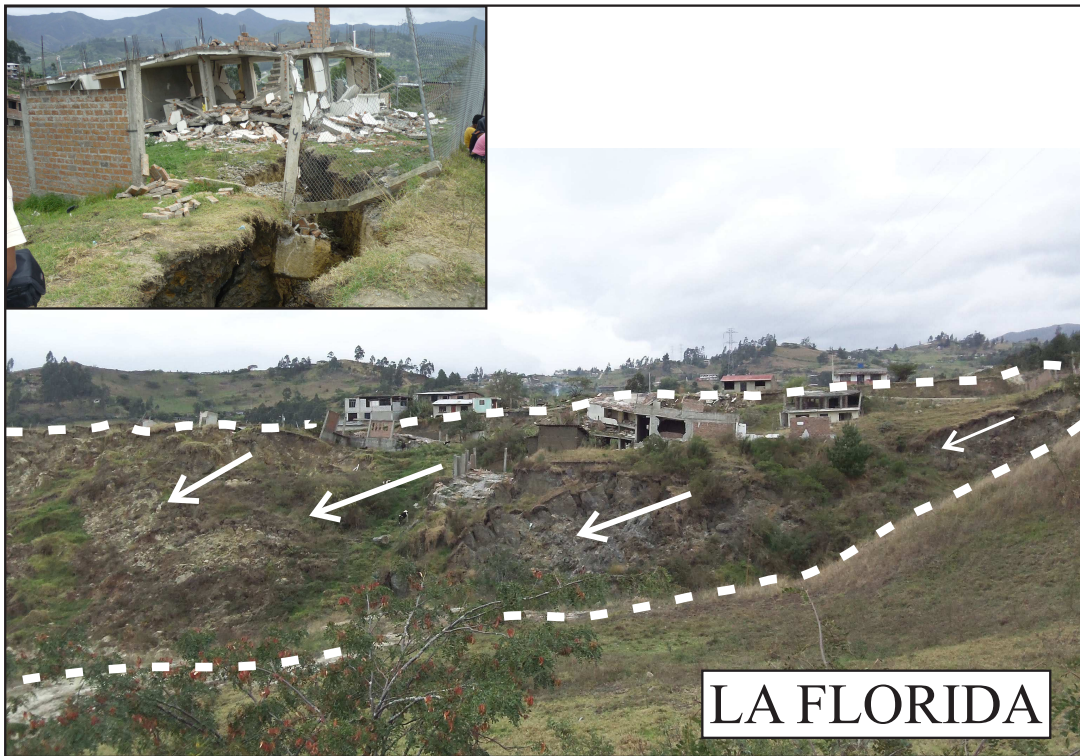
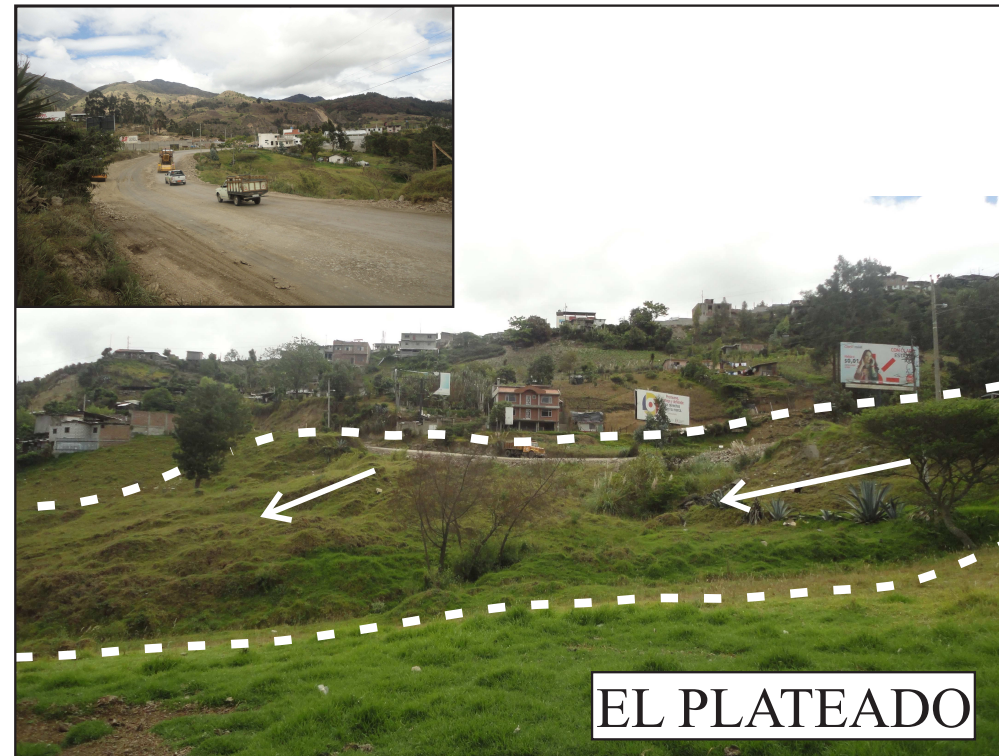
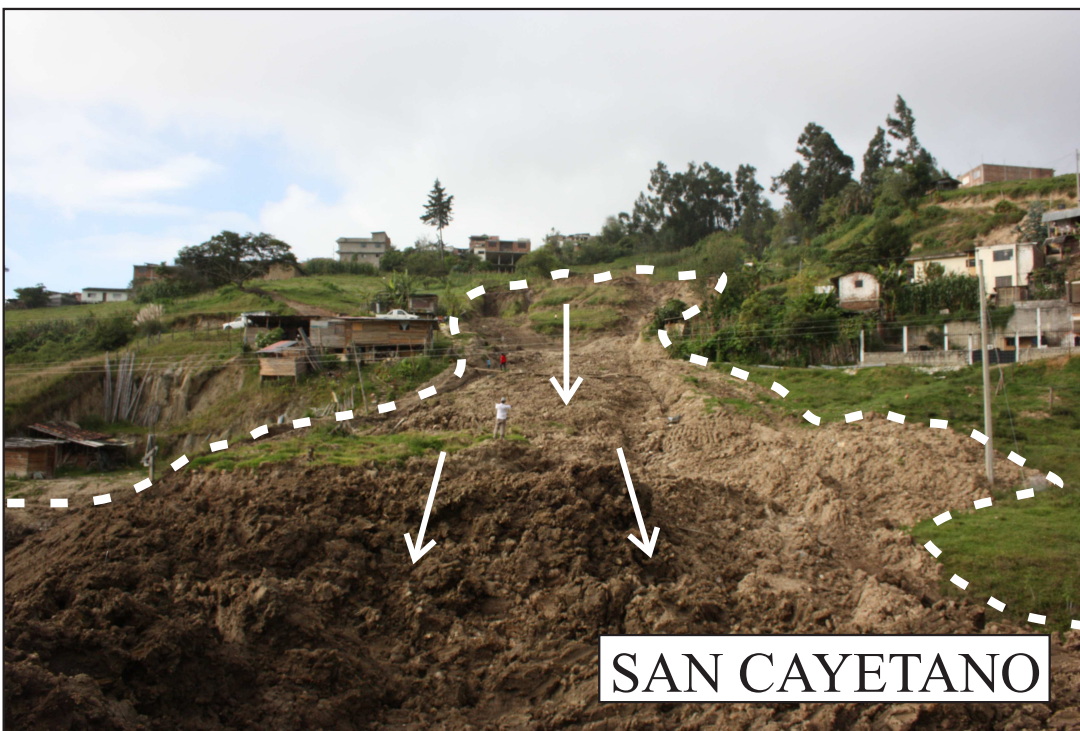
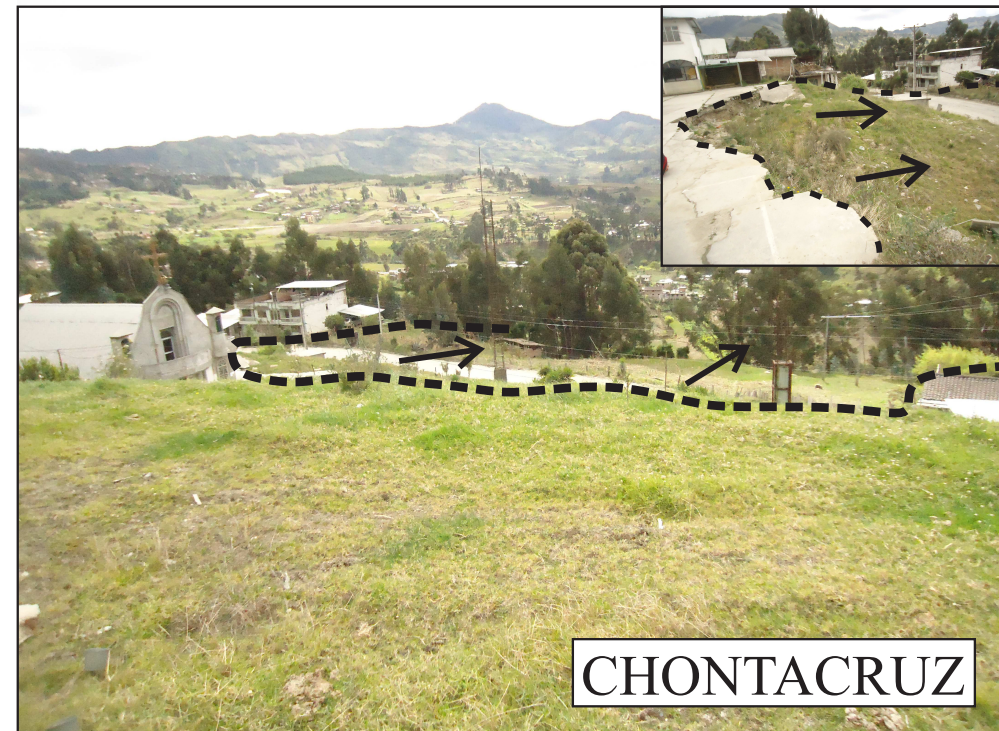
777 **Figure 4.** Photographs of the damage caused by the studied landslides.

194 We identified and mapped 287 landslides in the valley of Loja. Four of these landslides
195 were selected to be characterized in detail. The description of their geological setting,
196 typology, material involved and kinematics should illustrate the most common mass
197 movements in the valley of Loja. The four examples are the landslides of “La Florida”,
198 “El Plateado”, “San Cayetano” y “Chontacruz” (Fig. 4). Tables 3 and 4 show their main
199 characteristics.

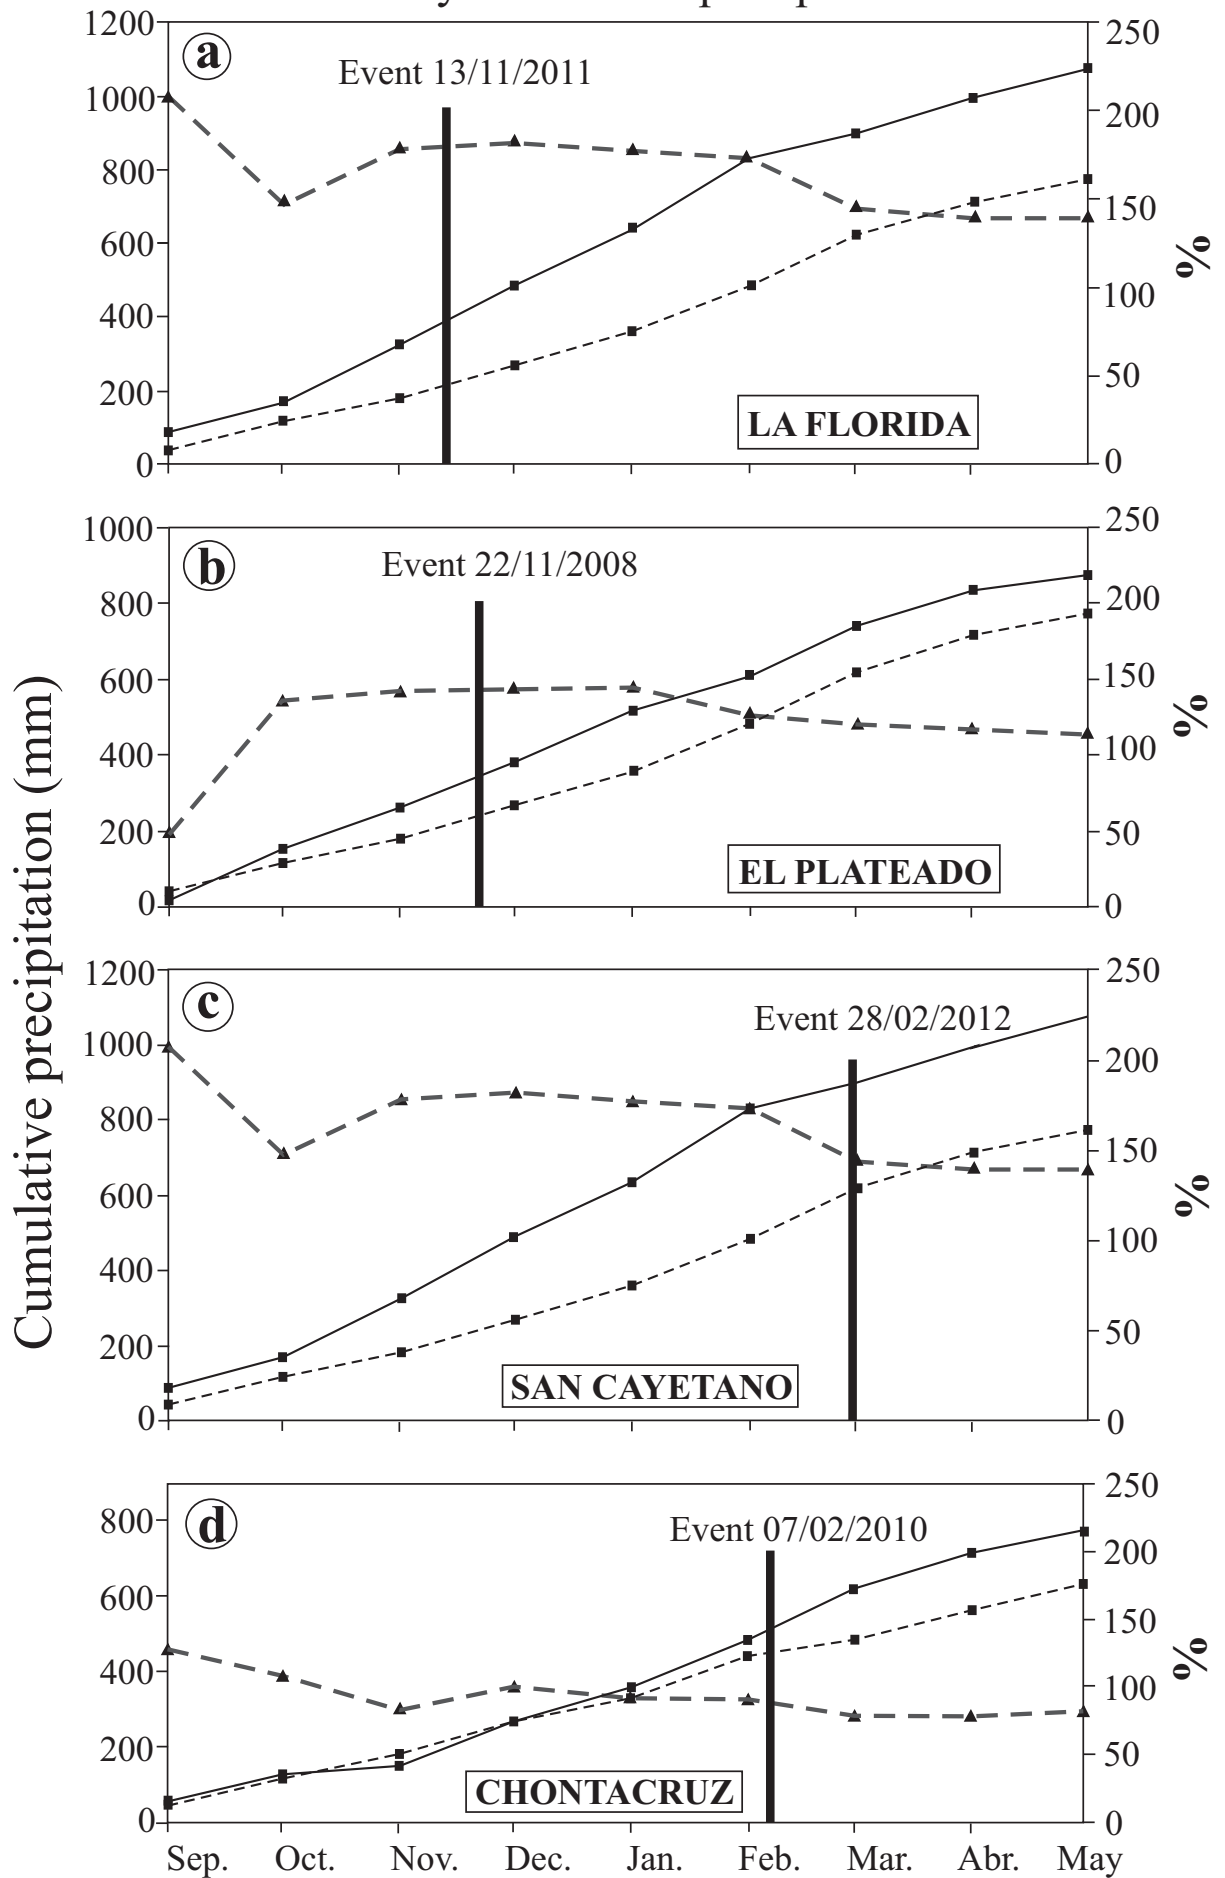
Figure 7

325 Second, for every landslide dated, the monthly rainfall trend was showed graphically.
326 This consists of plotting the cumulative monthly rainfall for every inter-annual (black
327 continuous line in Figure 7) period together with the mean values expected (black
328 dashed line in Figure 7) (column “Mean rainfall (mm) (1964-2014)” in Table 6). By
329 comparing both curves the rainfall divergence can be easily visualized on the charts. In
330 addition, the percentage of accumulated rainfall with respect to the mean values (red
331 dashed line in Figure 7) was also displayed showing the curve for that divergence.

418 Considering the total precipitation of the rainiest period (Sep. – May.) for every study-
419 case, it can be observed that the lower rainfall triggering one of the landslides
420 (“Chontacruz” landslide) reached about 82% of the mean value when considering the
421 whole record 1964-2014 (Table 6). In addition, in two of them (“La Florida & San
422 Cayetano” landslides) the accumulated rainfall reached almost 140% with respect to the
423 mean value, while the cumulative rainfall for “El Plateado” landslide was of about 14%
424 higher than the mean value (Table 6). Within this period, it can be observed several
425 months where the gauged rainfall exceeding 150% with respect to the average value,
426 even one of them overcome the 200% (Sep. - 2011). The curve for the percentage of
427 cumulative rainfall with respect to the mean values for every landslide shows about
428 180% for the first case (The Florida) (Fig. 7a), about 143% for the second case (San

429 Cayetano) (Fig. 7b), 145% for the third case (The Plateado) (Fig. 7c) and 90% for the
430 last case (Chontacruz) (Fig. 7d).

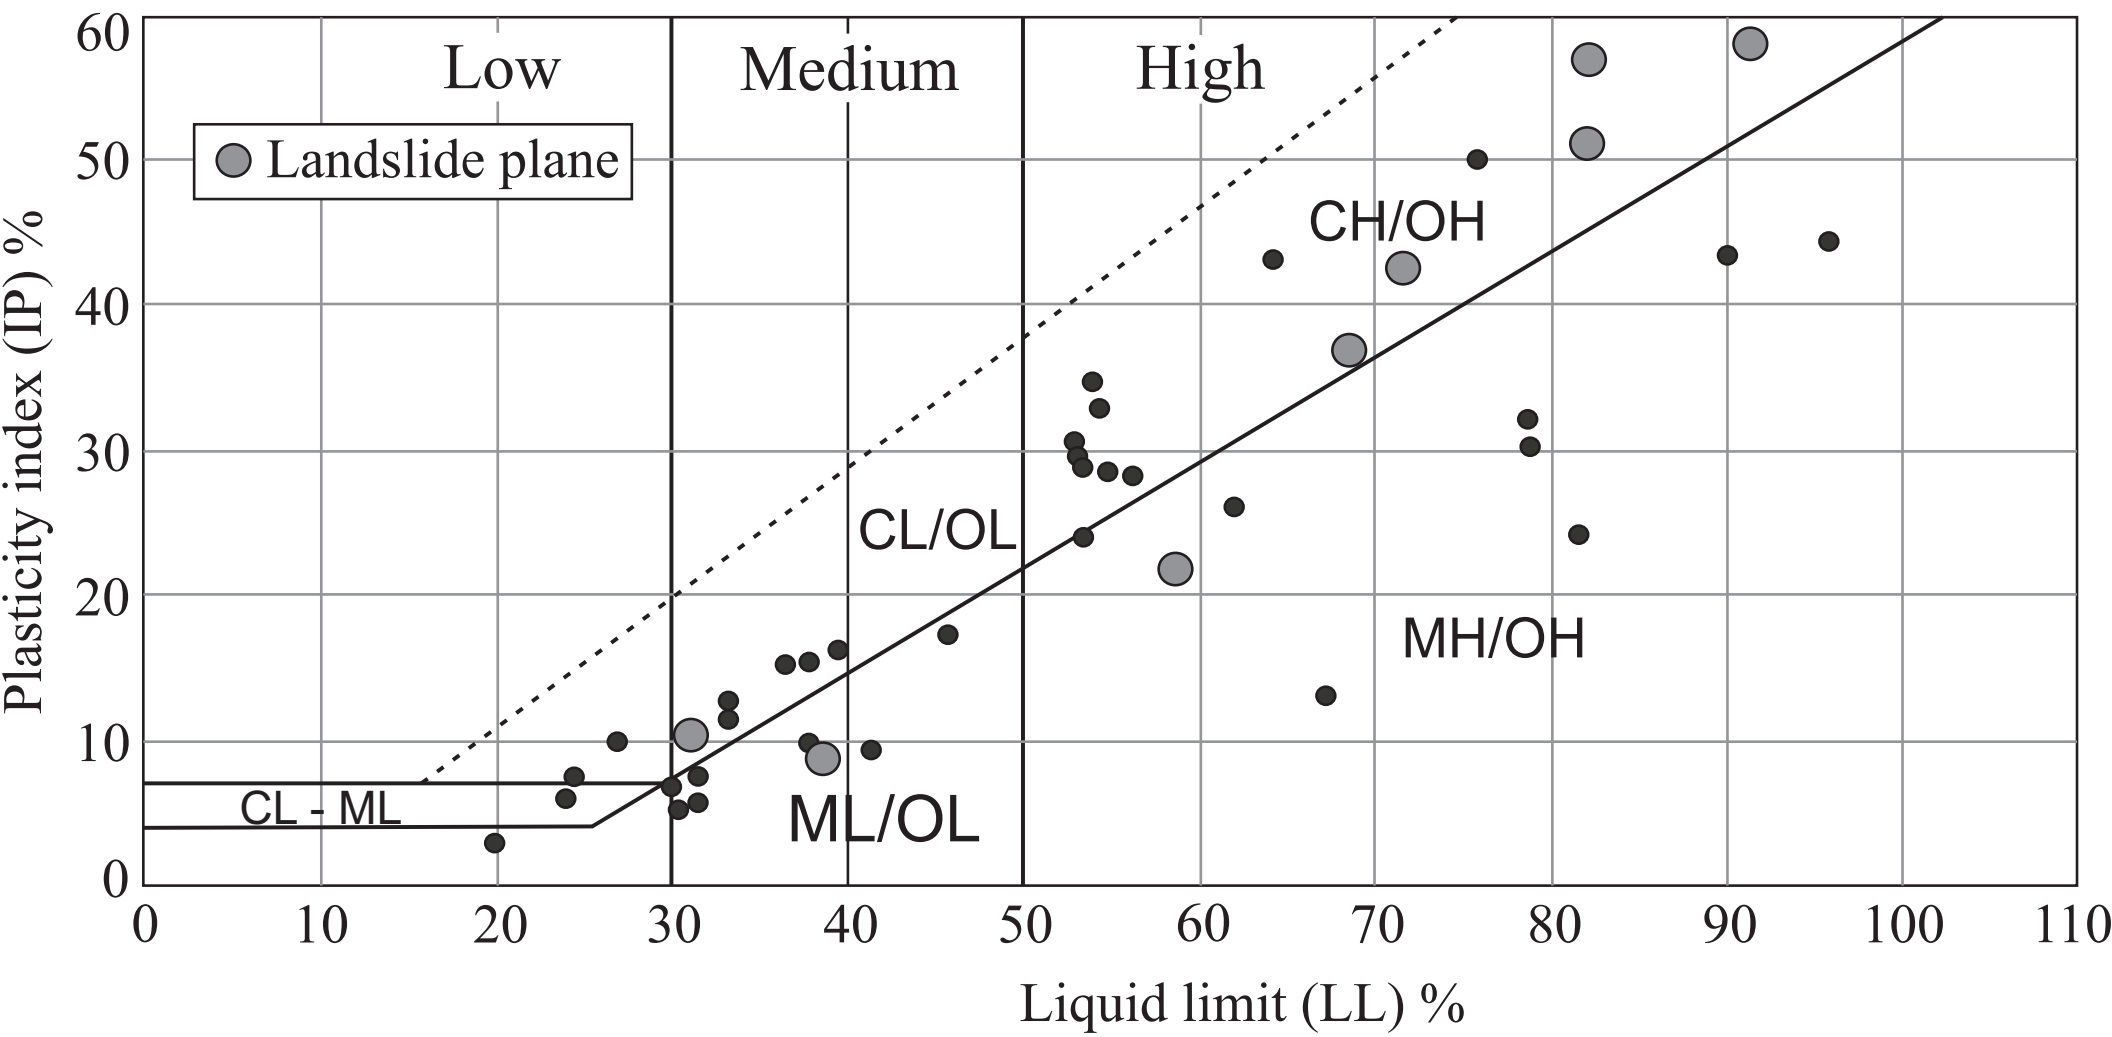
807 **Figure 12.** Location of the 44 studied samples in the Casagrande plasticity chart. The
808 materials of the failure planes are represented by grey circles.
809
810

388 Tables 7 and Figure 12 show the main geotechnical characteristics of the samples
389 collected in each landslide. The analyzed landslides show low effective and residual
390 angles of internal friction of 16–28° and 8–12°, respectively. The highest values are
391 related to the presence of silts in the involved materials and the lowest values are
392 associated to high clay content deposits.

394 According to Atterberg limits standard (ASTM D4318–00), most of the materials are
395 medium to high plasticity soils (liquid limit LL and plasticity index IP varying in the
396 range 40–91 and 28–58, respectively). The failure plane in the four landslides is
397 associated to layers of silty clays. These clays are high plasticity materials (LL: 59–82
398 and IP: 23–58) with water (moisture) content very close to the plastic limit (Fig. 12 and
399 Table 7).
