Article

Pathologic and Risk Analysis of the Lojuela Castle (Granada-Spain): Methodology and Preventive Conservation for Medieval Earthen Fortifications

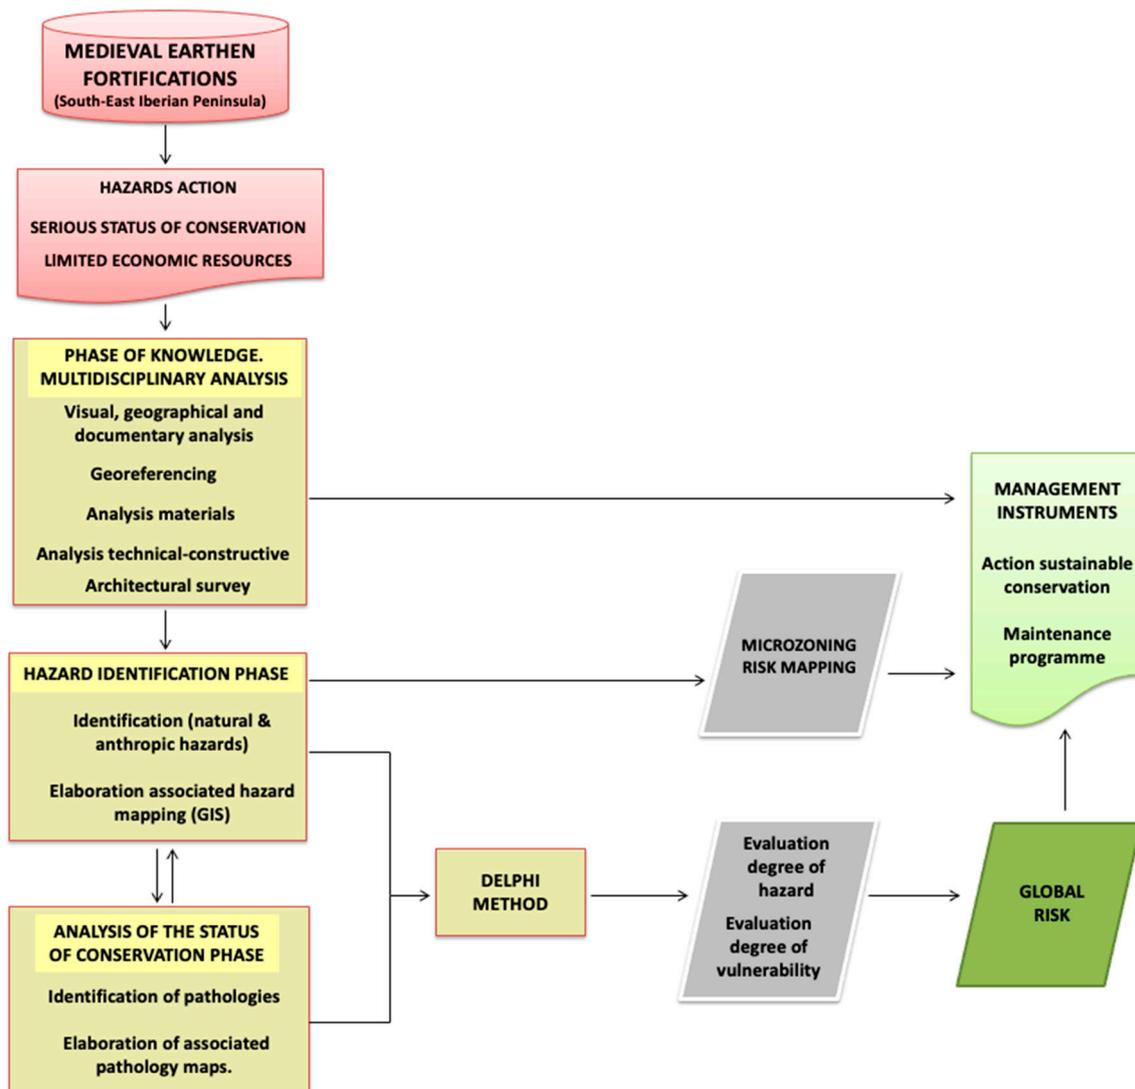
Figure 1. Flow chart showing the phases followed in the study. Source: PREFORTI project.

The method used was based on the study, analysis and evaluation of the Lojuela Castle under systematized parameters in order to be able to combine and understand the relationship between the hazard factors and the set of damages that the asset presents. Hence the methodology (Figure 1) is divided into five phases:

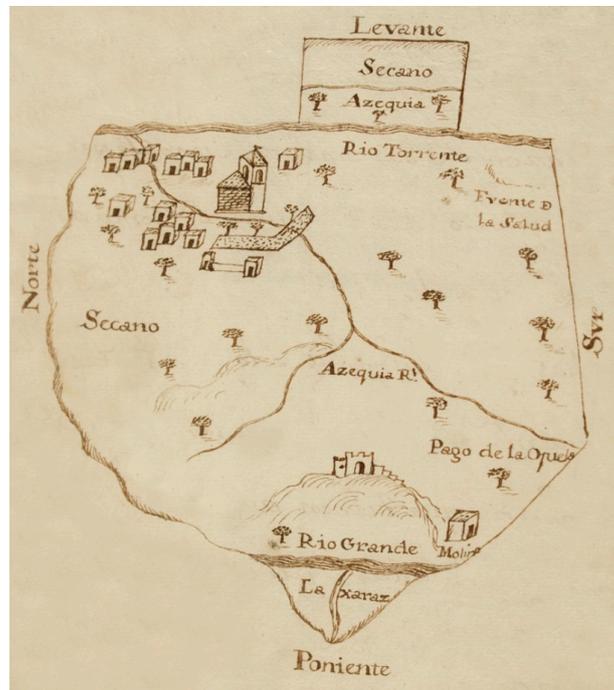
Figure 3. Map of *Murchas* where the fortified structure is sited (without scale). Source: Marqués de la Ensenada Land Registry (1751–1758). Archivo Histórico Provincial de Granada [126].

of *Mulchas* specifically in his description of this region's boundaries [79]. The castle pertained to the *Loxuela o Luxar* farmstead, which was probably annexed to *Murchas*, but with its own administration. The Marqués de la Ensenada land registry makes reference to the castle, locating it in the so-called *Pago de la Ojuela* (Figure 3). More recently it was connected to the first Arab caliphate [80,123].

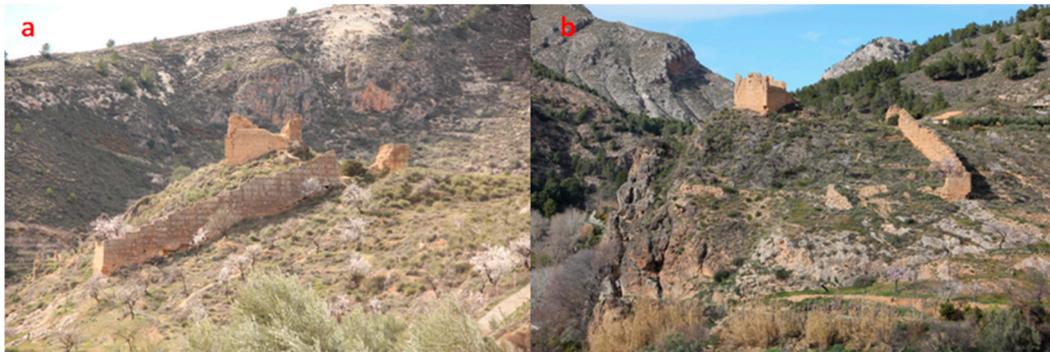
Figure 4. View of the remains of Lojuela Castle from its (a) eastern and (b) southern sides. Source: PREFORTI project.

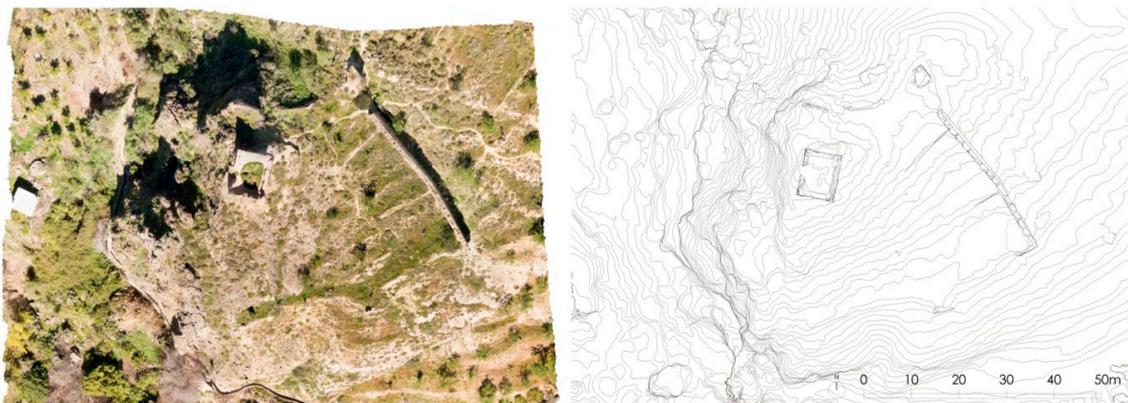
Figure 5. Orthophotography and planimetry of Lojuela Castle remains. Source: PREFORTI project.

Currently the visible structures of the fortification (*hisn*) extend along the slope of the ravine, with the main tower located on the summit of the hill. The studies carried out originally concluded that it comprised at least two areas: one delineated by the walled enclosure and one in its interior where the remains of structures can still be seen, including a large tower (Figure 4). The site has a polygonal arrangement and access is from the north section, where vestiges of the bastion which defended it can be found (Figure 5).

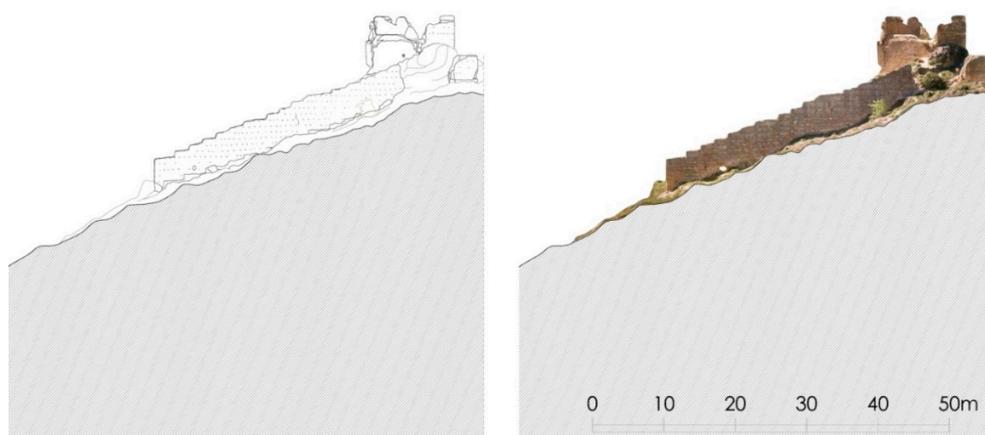
Figure 6. Orthophotography and planimetry of the east elevation of Lojuela Castle, located on the promontory. Source: PREFORTI project.

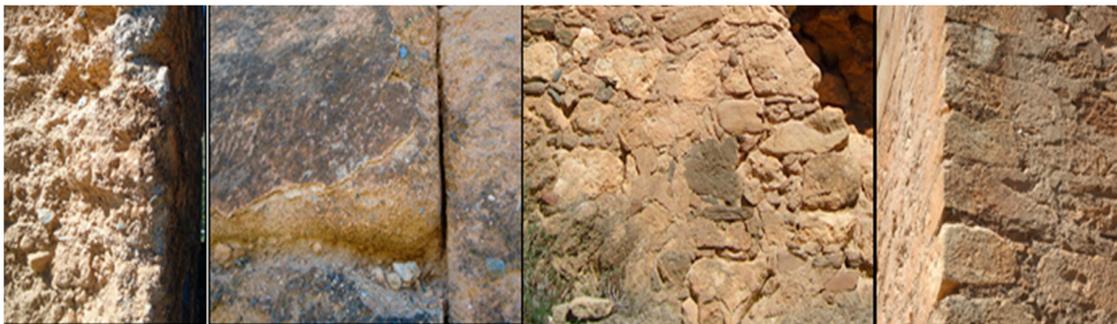
Figure 7. Materials used in the construction of Lojuela Castle (without scale). Source: PREFORTI project.

These were assessed by taking different samples from the surface of the cladding and stretches of the wall (Figure 7). The results indicate that: as regards the wall, its main body was found to be principally lime-based. It consists of mortar made by mixing lime and clay. Siliceous and carbonated aggregates were used, with the granulometry revealing a range of sizes from gravel to sand. The siliceous aggregates are comprised of quartz, muscovite, chamosite and feldspar. The carbonated aggregates are composed of dolomite and possibly, calcite [124].

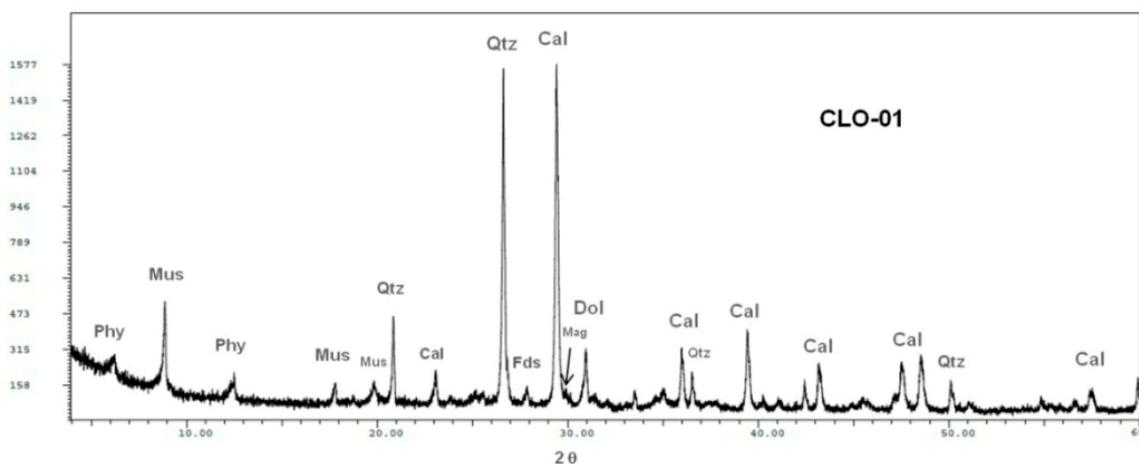
Figure 8. X-ray diffractogram of the sample. Source: PREFORTI project and TESELA S.L.

The XRD analyses carried out on the sample of the calicostrated wall mass detected that the matrix is mainly calcitic. It established that the construction material—as detailed before—is a mortar made with a mixture of lime and clay, in which siliceous and carbonated aggregates were used, with serial grain size from gravel to sand (Figure 8).

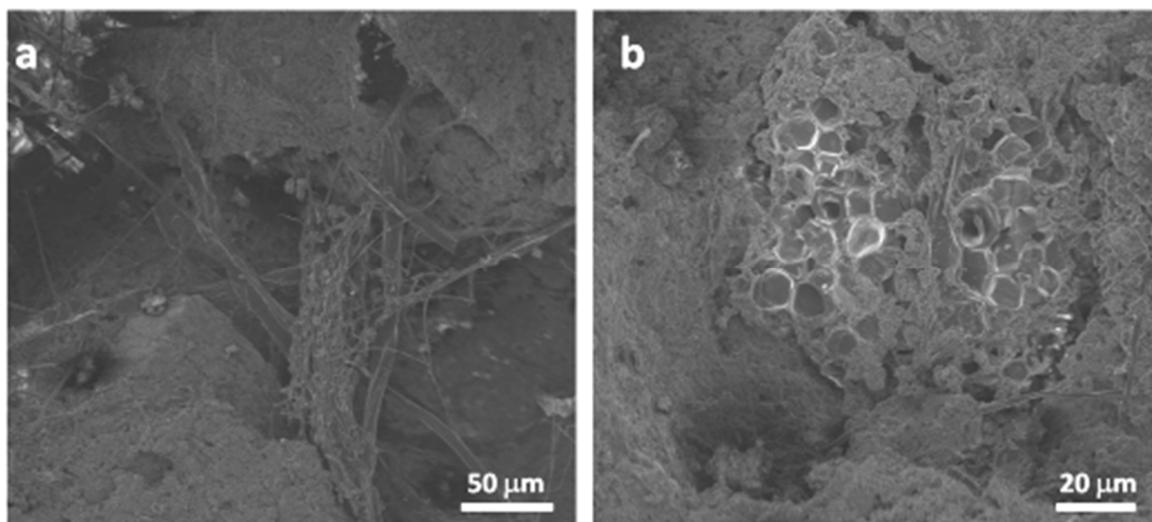
Figure 9. SEM microphotographs of secondary electrons of the crust. Presence of (a) roots and (b) lichens from the natural patina is visible. Source: PREFORTI project and TESELA S.L.

The study carried out by scanning electron microscopy with EDX microanalysis and from the spectra obtained determined that the composition of the matrix of the rammed-earth crust is calcitic. Mica (Muscovite) crystals were also observed wrapped in the matrix. The presence of roots of the natural patina was verified. It generates biodeterioration in the sample since they penetrate inside the crust mortar (Figure 9). In the matrix of the rammed-earth mass, siliceous aggregates are observed enclosed within a microcrystalline matrix formed by a mixture of calcite and illite [124].

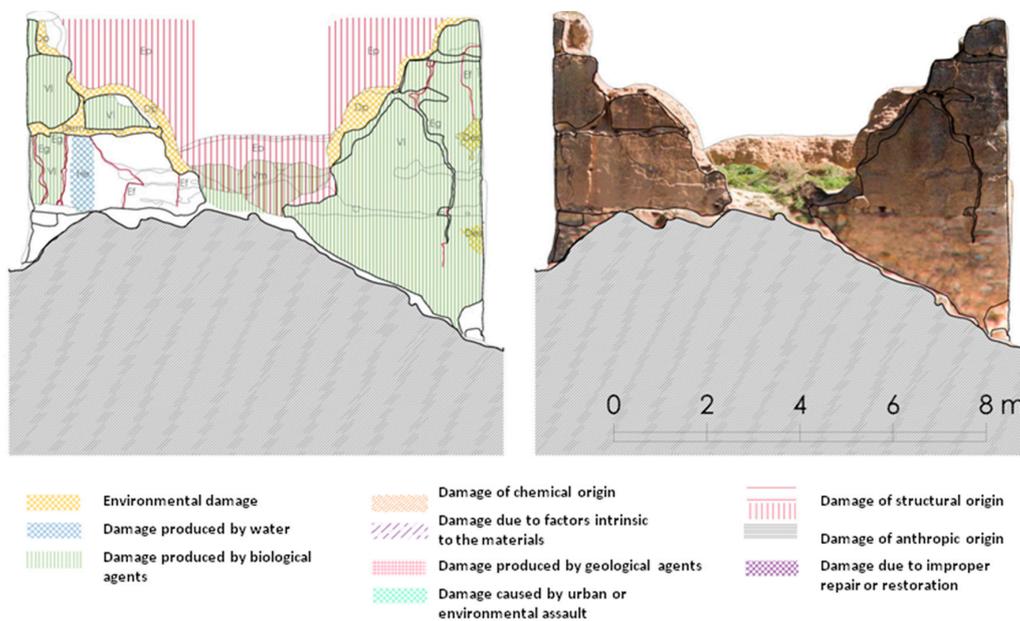
Figure 10. Pathologic analysis of the elevations of the north and west towers. Source: PREFORTI project.

Structure: the site is greatly affected; in particular, the body of the tower is seriously threatened with falling into ruin. Significant vertical cracks and at a 45° due to a misplacement of the end of the wall are compromising the stability of the site, in particular the eastern and southern sides. Although the root cause may be ground movement, another contributing factor is the significant erosion to the lower part of the stonework. It is causing the southeast corner of the structure to act as a cantilever. This erosion also affects the center of the defensive perimeter to the north. In this part, voids have appeared of sufficient size to run through to both sides of the wall. Fragments of rammed earth which have either detached or are in the process of detaching can be found in the site's surroundings. The loss of geometry to these two structures is significant as the cladding on the tower has disappeared, as have some formwork box sections. Almost all of the tower's levels were lost, with only part of the first level remaining. However, the eastern stretch of wall is preserved at the height of its ramparts.

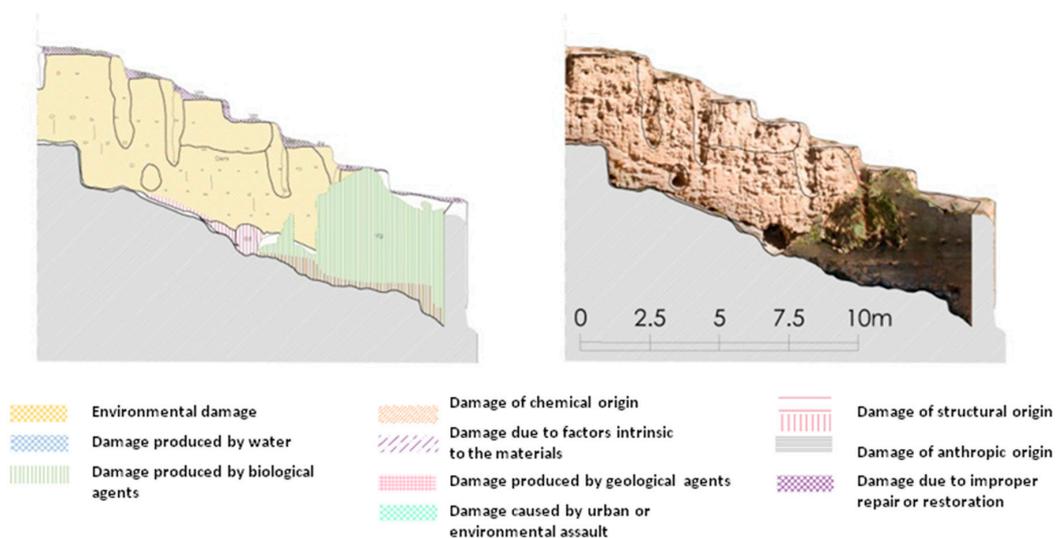
Figure 11. Pathologic analysis of the wall. Source: PREFORTI project.

- Environmental damage: the most notable is associated with the presence of dirt, the existence of surface, medium and deep erosion of the different parts of the wall. Moreover, material gaps are resulting from the loss of material accompanied by generalized surface exfoliation (Table 4);
- Damage produced by the action of water: it has produced an intense washing of the material and decohesion;

- Damage produced by organic agents: manifested in the appearance of microflora, phanerogamic vegetation and medium vegetation;
- Structural damage: has produced large cracks mainly in the tower and fissures underlying the base of walls; The crowns of the rammed-earth walls have been broken up. The walls have been moved from their initial position;
- Damage of anthropic origin: hollows have been created in the rammed-earth walls to varying degrees;
- Damage from incompatible restorations: due to the incorporation of Portland cement mortars covering the wall crowns;
- Damage due to urban and environmental aggression: as a result of agricultural use of the environment with the removal of material of the lower parts of the wall and terracing of the land. Almond tree plantation.

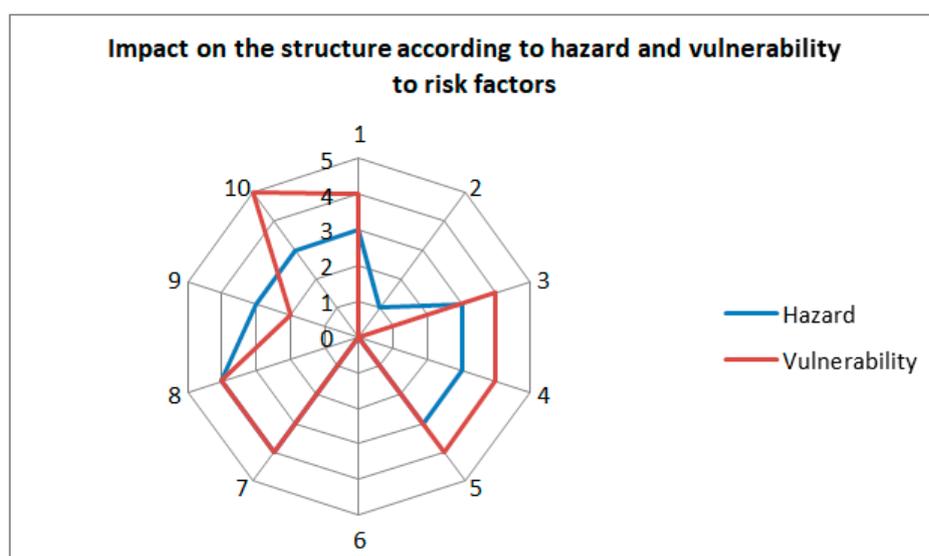
Figure 13. Graphic of impact on the structure according to hazard and vulnerability to risk factors. 1—documentary; 2—geographic; 3—usage; 4 anthropic; 5—water; 6—sea quakes; 7 wind; 8—temperature; 9—forest fire; 10—geomorphological. Source: PREFORTI project.

Given that it is related to the BIC (assets of cultural interest), the variable exposure (E) was considered value to be equal to 1. The value obtained for each hazard group is in the range R_i [0,25] (Figure 12). In the following graph, you can see the incidence of risk on the Lojuela Castle according to hazard and vulnerability to risk factors (Figure 13).

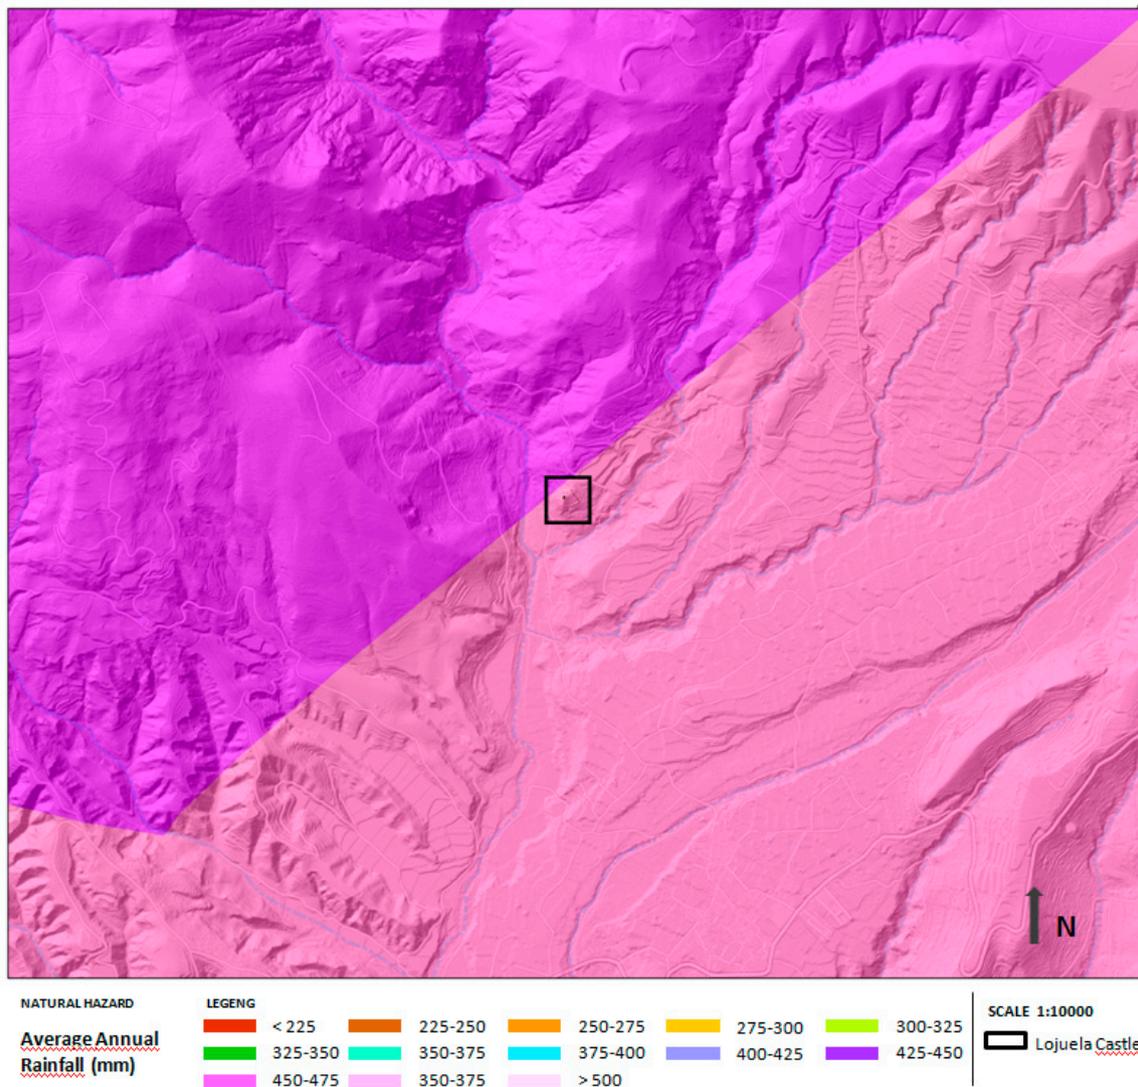
Figure 14. Map of the natural hazards: precipitation (zoom). Source: PREFORTI project.

In this way, it can be seen that natural hazards are more closely associated with the pathologies identified in the Lojuela Castle, namely a medium rate of precipitation in conjunction with moderate northeast winds, as well as average relative humidity (Figures 14 and 15). Water and humidity filtrations through cracks, fissures and wall crowns have deconstructed the masses at an average level and have caused a high degree of stains due to runoff and the dragging of dirt on the wall fronts. To the above, the high presence of biodeterioration—elevations with less sunshine—must be added. Other factors such as sunshine, temperature or ice, contribute to the medium degree to the deterioration of the asset. The combined action of them together with the wind has caused the erosion of crusts that

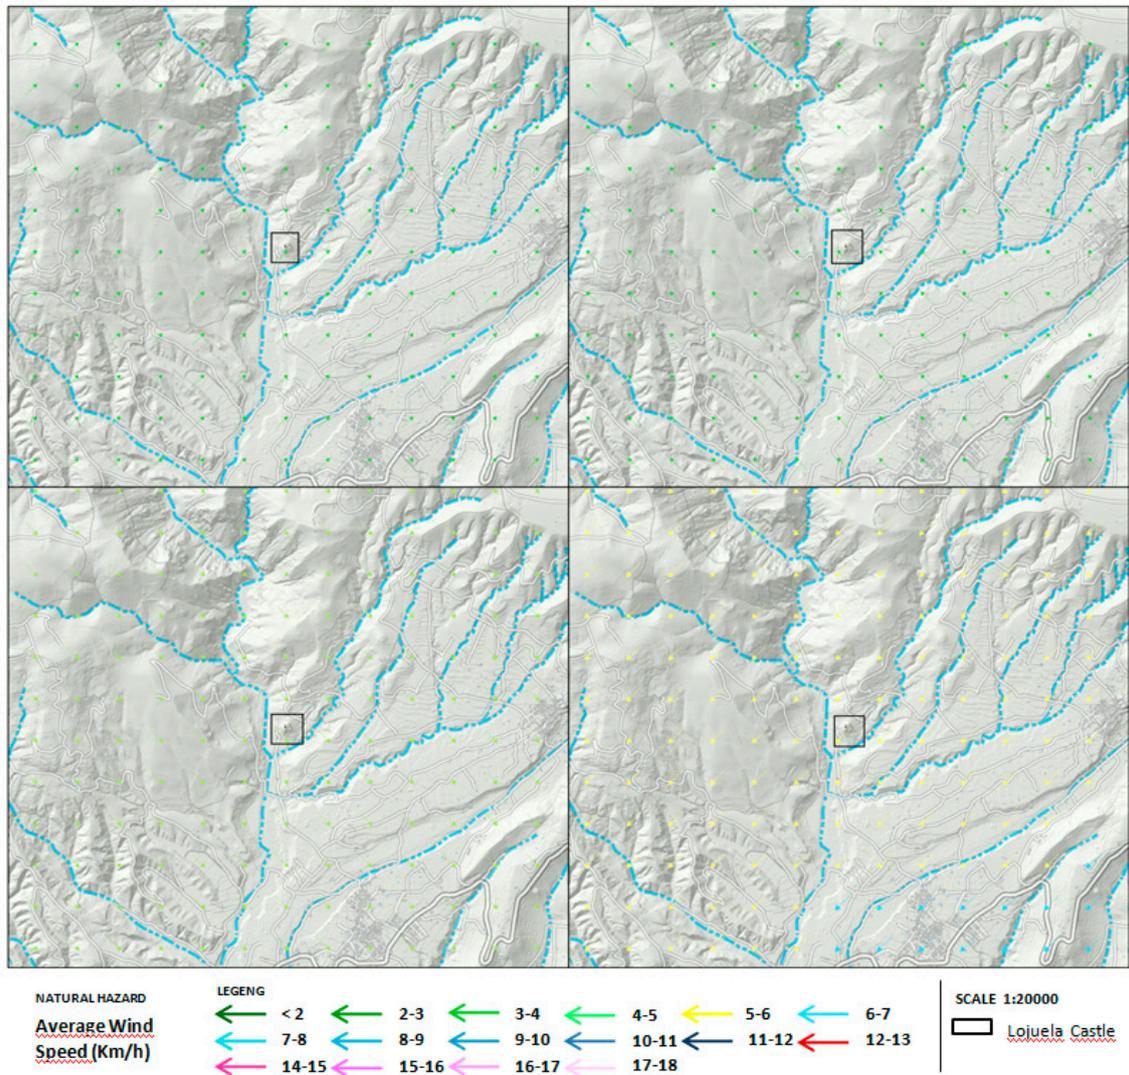
Figure 15. Map of the natural hazards: wind. Source: PREFORTI project.

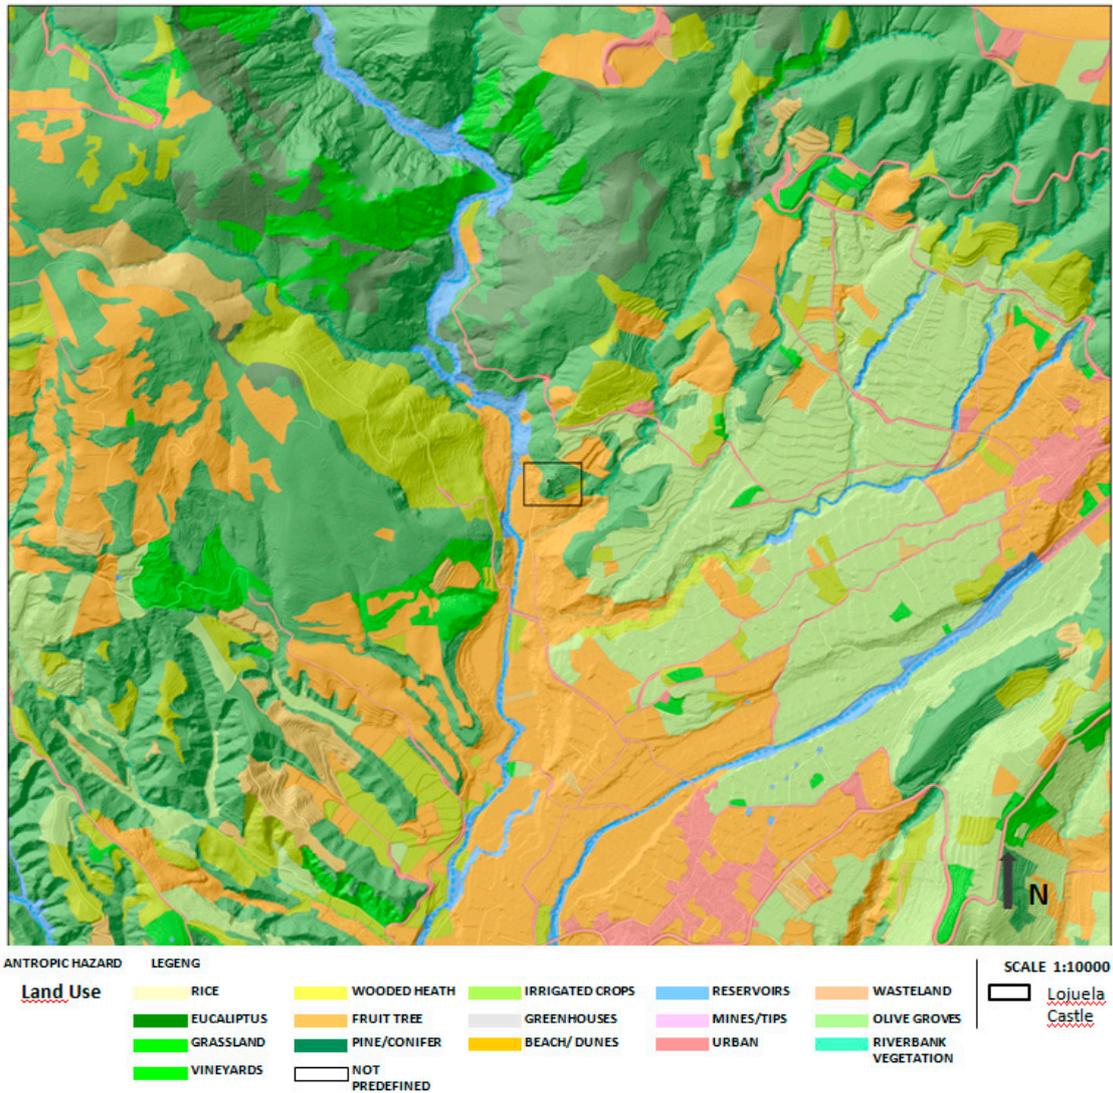
Figure 16. Map of the anthropic hazards: land use. Source: PREFORTI project.

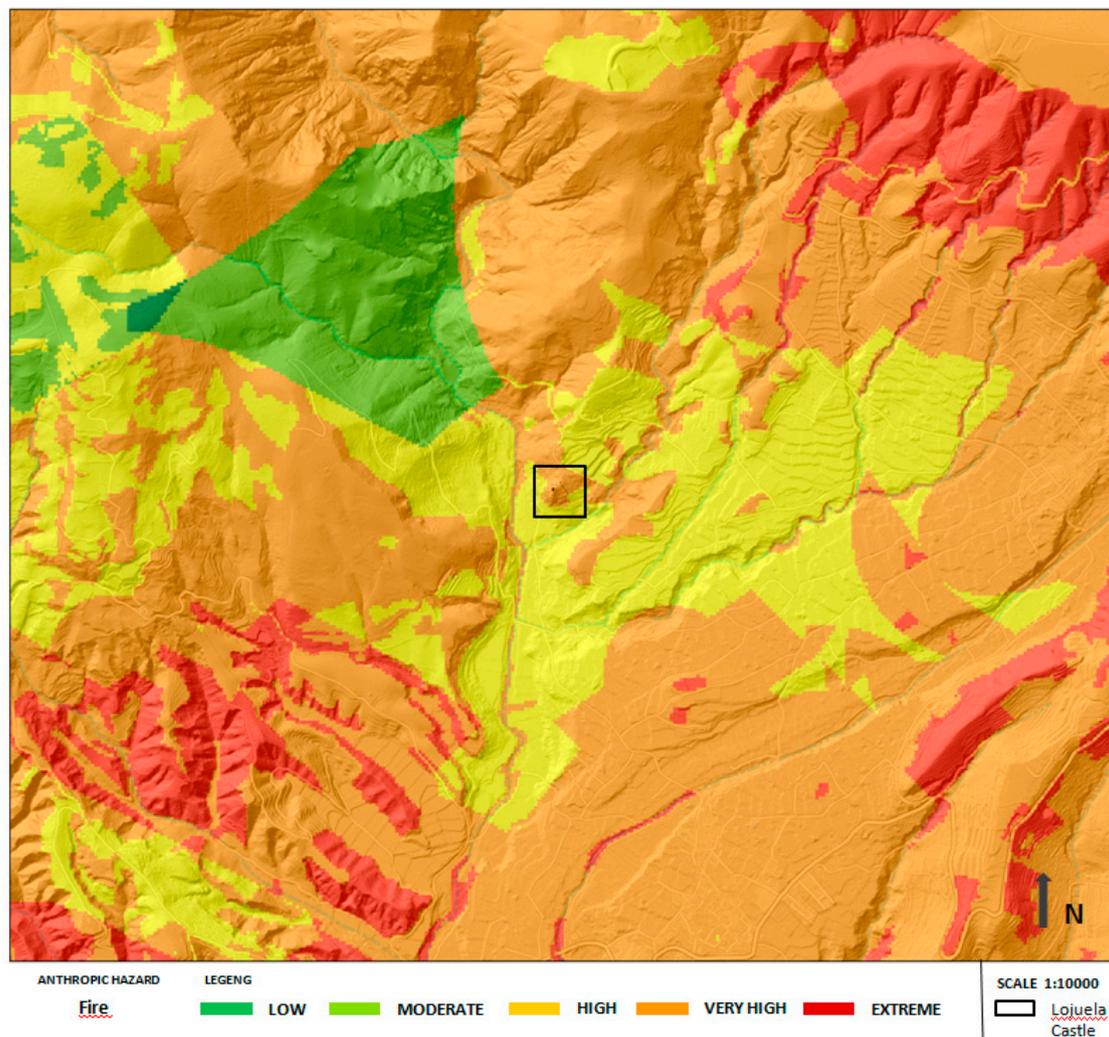
Figure 17. Map of the anthropic hazards: fire. Source: PREFORTI project.

The anthropic factors place the Lojuela Castle in a situation of medium vulnerability. On one hand, local planning does not delimit its protected area, and since it is located in an urban zone, the risk of urban pressure is medium (Figure 16). The land use risk map, extracted from the SIOSE 2013 for the Autonomous Community of Andalusia, places the castle in a scrubland area close to the irrigated cultivation areas. This location is imprecise; a view of the territory shows that dry farming (almond trees) occupies both the internal and external areas of the fortified enclosure. This fact puts the structure of the asset at greater risk. Furthermore, the fire risk map indicates that these dry crops

considerably increase the risk of fire in the area surrounding the castle (Figure 17). Combining these high degrees of anthropic risk with the population density map (which presents a minimum risk), it is determined that their level of vulnerability is medium to high.
