Article

Almoravid Works on Defensive Architecture in Southeast Al-Andalus: Analysis of Their Remains and Proposal for Preventive Conservation

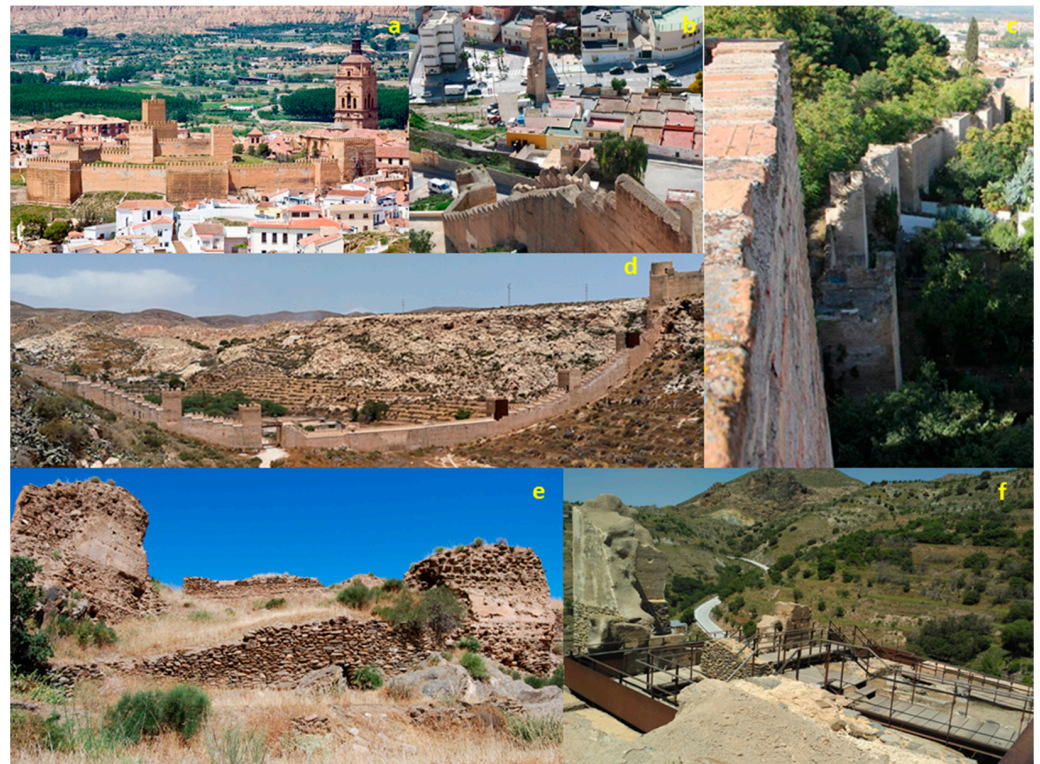
Figure 1. Alcazaba of Guadix, Granada (a); remains of the walls of the rabaḍ al-Ḥawḍ among the houses, Almeria (b); walls of the Alcazaba Qadīma, Granada (c); walls of La Hoya and Cerro de San Cristóbal, Almeria (d); remains of El Castillojeo, Abucena (Almeria) (e); remains of the Castle of Bacares, Almeria (f). Source: PREFORTI Project.

The best-preserved part of the walls of the Alcazaba Qadīma is the 390 m long section located to the north, on the Cuesta de la Alhacaba (Figure 1c). This section connected the Gate of Monaita (located in the northwest) and the Gate of Las Pesas (located in the northeast) (Figure 7). The section between these two gates can be divided into two clearly differentiated parts: to the west, a section with solid square towers on the inner side, smaller and standing much closer to each other than the towers of the other section; to the east, and behind the alteration in the wall line, a part with large semicircular towers next to other towers of quadrangular plan, which are larger than those located more to the west.

The first mention of the Alcazaba of Guadix (Figure 1a) in written sources is found in the *Memoirs* of ‘Abd Allāh, last Zīrī king of Granada (late 11th century) [59] (p. 157). However, the oldest archaeological remains from medieval times documented during the first archaeological works date from the 10th century [60], being from the Zīrī era when the original caliphal construction became a citadel [61].

During the time of Khayrān, the first Taifa king of Almeria (1012–1028), the major part of the city wall was constructed, while the works were finished in the time of his successor, Zuhayr. Among the earliest works were the walls of Jabal Laḥam (currently Cerro de San Cristóbal) and La Hoya, whose function was to overcome the height differences between the Alcazaba and the hill, dividing the space into two differentiated areas [72]. In this way, the city wall was attached to the Alcazaba, together forming one of the best-defended complexes preserved in Al-Andalus (Figure 1d).

In relation to the al-Ḥawḍ suburb, there are some stretches of wall and towers (Figure 1b) related to the Almoravid renovation works on the original Taifa construction [51] (pp. 345–346), located among the urban network of La Chanca. The largest remains correspond to two rammed-earth towers in the northern part of the wall, located on Del Mar Avenue. They are 14.5 m high and 5 m long, despite being in a state of neglect.

With respect to the construction system of the fortress, its walls of remarkable size (between 0.91 and 1.15 m wide) [90] (p. 71) are built in lime-stabilized rammed earth on a masonry base, made of slate stones joined with cement mortar, forming courses. The towers have a barely preserved plaster [89] (Figure 1f).

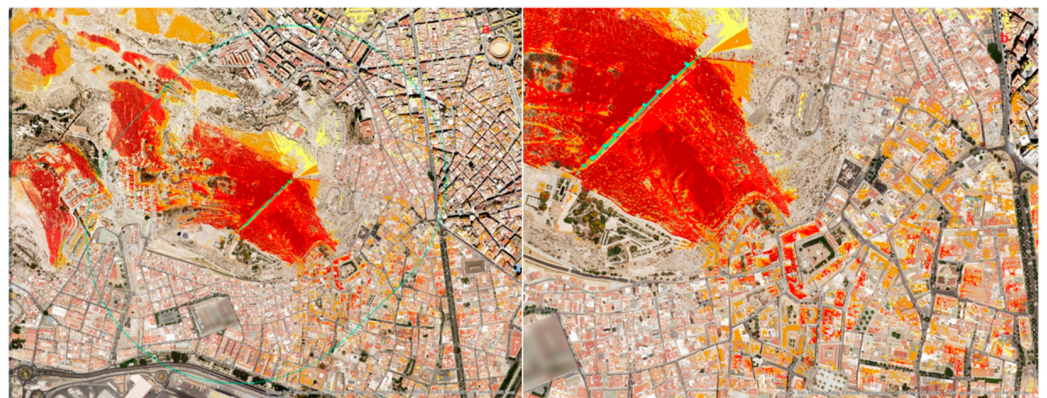
Figure 6. Maps of the visual basin from the walls of La Hoya and Cerro de San Cristóbal, Almeria. (a) General map of the visual basin from the walls of La Hoya and Cerro de San Cristóbal, Almeria; (b) Detail of the visual basin from the walls of La Hoya and Cerro de San Cristóbal, Almeria. Source: PREFORTI Project. E. Molero Melgarejo. The light blue outline indicates the maximum distance with high sharpness (500 m). The color intervals indicate as follows: no color = not visible; yellow = low exposure (1 visible dot only); orange = medium exposure (up to 10 visible dots); red = high exposure (up to 30 dots visible); dark red = extreme exposure (more than 30 dots visible).

Beyond the elaboration of risk maps, GIS have been used in this work to analyse historical and strategic phenomena related to the two cases of study. In this way, maps including the analysis of visual basins from the walls of the Alcazaba Qadīma (Granada, Figure 5) and from the walls of La Hoya and Cerro de San Cristóbal (Almeria, Figure 6) have been also elaborated. In these maps, the visual basins are produced on a 2-m resolution DTM model generated from a Lidar point cloud (IGN 1° coverage). The maximum distance with high sharpness (500 m) is also included. In this way, the cartographical material uses a color scale to show a range of risks, from non-visible points to points of maximum exposure, taking the selected assets as the point of reference.

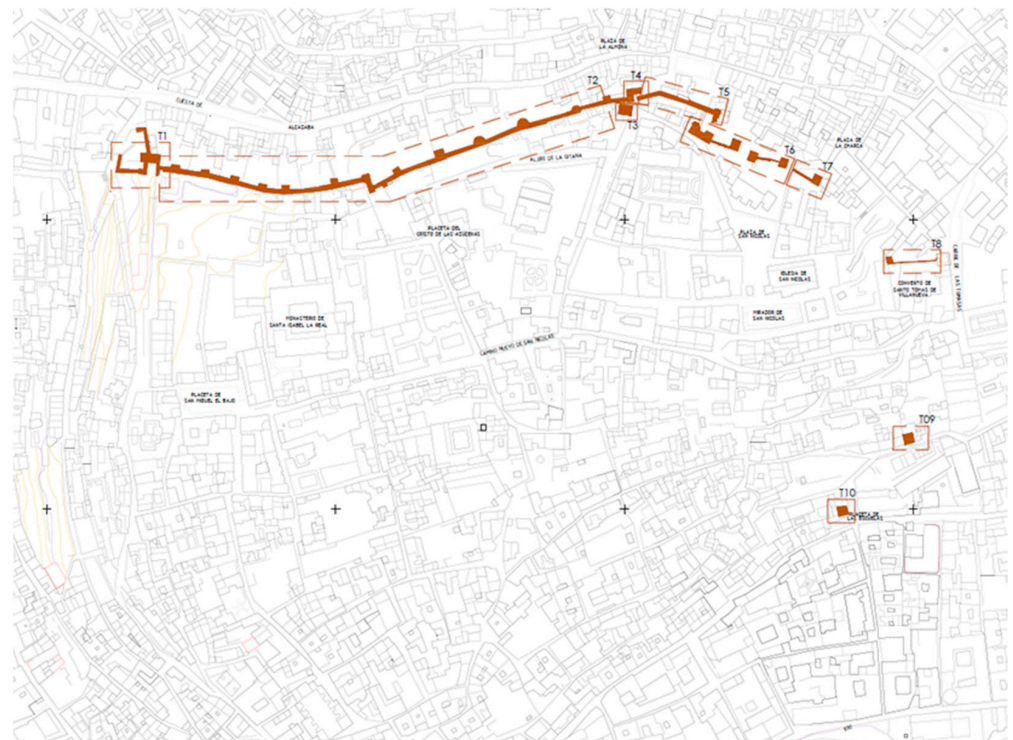
Figure 7. General map of the walls of the Alcazaba Qadīma, Granada. Source: Isabel Bestué Cardiel [55].

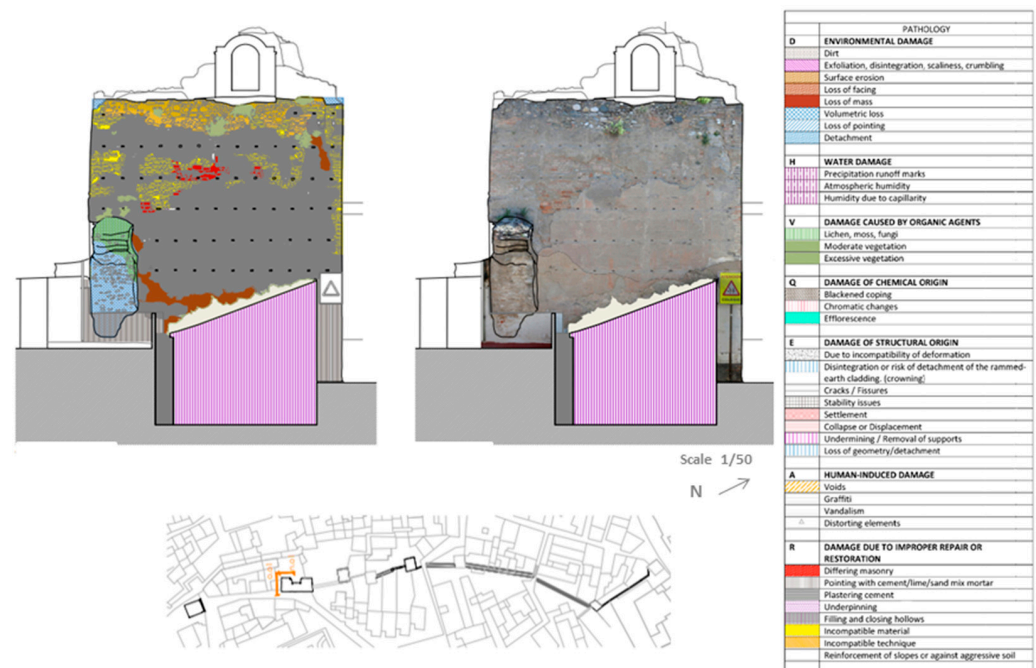
Figure 9. Elevation of pathologies of the Gate of Hernán Román. Source: PREFORTI Project. I. Bestué Cardiel.

The loss of materials has also been caused by landslides caused by the steep slope of the hill, as well as by landslides caused by urban pressure, the latter of which has also meant the presence of buildings attached to the fence, as well as some located on the fence at some of their points. At the same time, damage caused by water has been detected, relating specifically to dampness due to leaks and to capillarity, as well as to rainwater (Figure 9).

The stable state of the structures preserved in height is predominant, with minimal structural damage visible and detectable. One exception should be made regarding the Hernán Román gate, which is currently undergoing restoration and has serious vertical cracks that make the whole unstable.

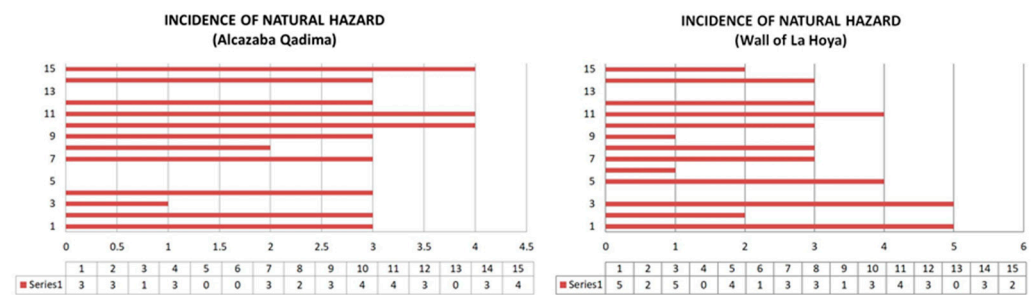
Figure 13. Graph of the incidence of natural hazards. **Left:** walls of the Alcazaba Qadīma, Granada; **right:** walls of La Hoya and Cerro de San Cristóbal, Almeria. 1: Action of capillarity; 2: Environmental humidity and rain; 3: Floods; 4: Snowfalls; 5: Seaquakes; 6: Hurricane; 7 Winds; 8: Lightning; 9: Ice; 10: Temperature; 11: Seismic activity; 12: Landslides; 13: Clay expansivity; 14: Steep slopes; 15: Action of fire. Source: PREFORTI Project.

In the case of the incidence of natural hazards (Figure 13), these hazards have a higher impact in the walls of La Hoya, above all in the cases of the action of capillarity and floods (with an incidence of 5 in a scale from 0 to 5). In both cases, they are followed by the incidence of seismic activity (with an incidence of 4 in a scale from 0 to 5). In the particular case of the walls of the Alcazaba Qadīma, the impact of the action of fire and temperature are significant too (with an incidence of 4 in a scale from 0 to 5), while in the case of the wall of La Hoya the impact of seaquakes is also high (with an incidence of 4 in a scale from 0 to 5).
