PHOTOGRAMMETRIC STATE OF DEGRADATION ASSESSMENT OF DECORATIVE CLADDINGS: THE PLASTERWORK OF THE MAIDENS' COURTYARD (THE ROYAL ALCAZAR OF SEVILLE)

Marta Torres-González^{a*}, Elena Cabrera Revuelta^b, Ana I. Calero-Castillo^c

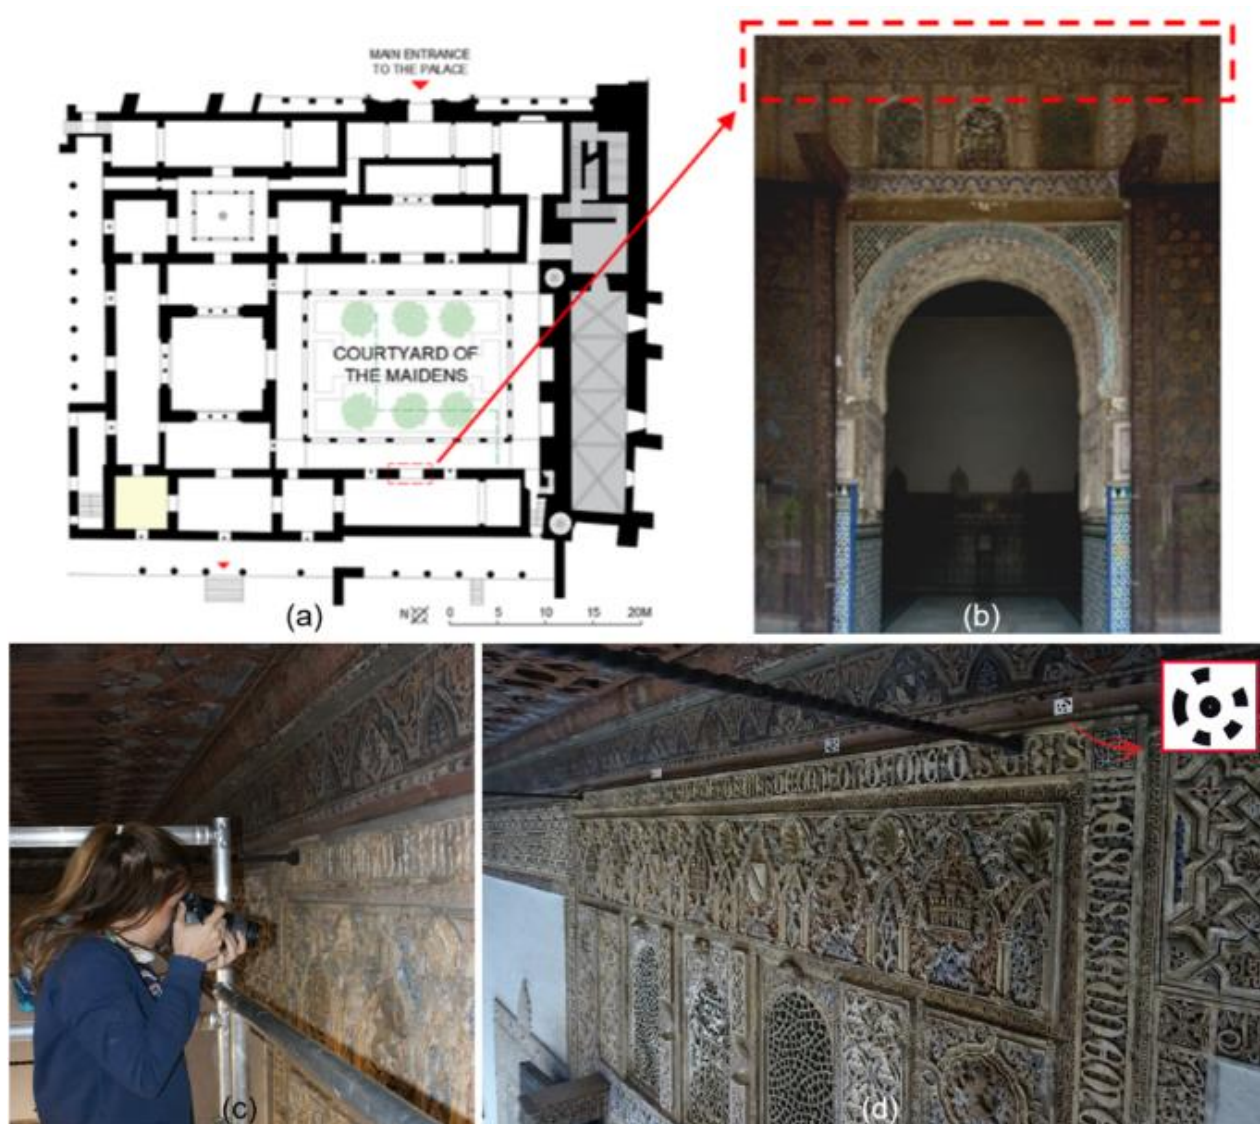
Figure 2: a) Ground floor of the Pedro I Palace (RAS); b) General image of the main entrance to the room of the ceiling of Charles V; c) On-site work; d) Details of the frieze under study and targets used.

To carry out this work, the plasterworks from the upper frieze of the access to the Carlos V Ceiling Hall, located in the Courtyard of the Maidens of the RAS were taken as an object of study (Fig. 2).

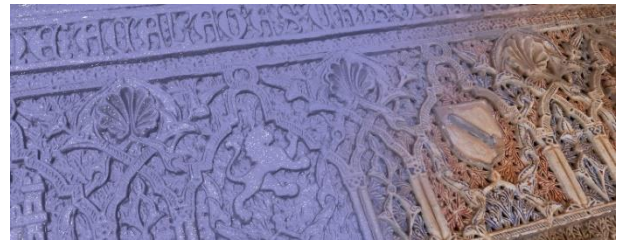
Figure 4: Detail of the model obtained showing wired, solid and textured structure.

In this case, 190 photographs were taken for the realization of the model (Table 1). The dense point cloud achieved is composed of more than 171 million points (Figs. 3 and 4). The textured photogrammetric model was made through the workflow of depth maps, in extra high quality, with more than 18 million faces. The model obtained allows a deep and detailed analysis of the geometry of the variety of plasterworks. It was corroborated that photogrammetry is useful to obtain a high-precision model, allowing the identification of cracks and fissures, and the measurement of thicknesses and depths. On the other hand, the point cloud obtained had a level of detail of 0.25 mm. The model was performed in the highest quality, obtaining a mesh with a level of detail of 1 mm. According to the report provided by the software, the control scale bars error was 0.19 mm, while the check scale bars error was 0.32 mm.

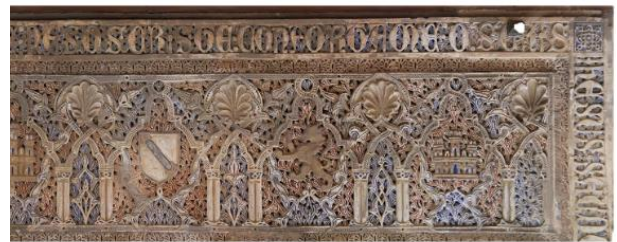
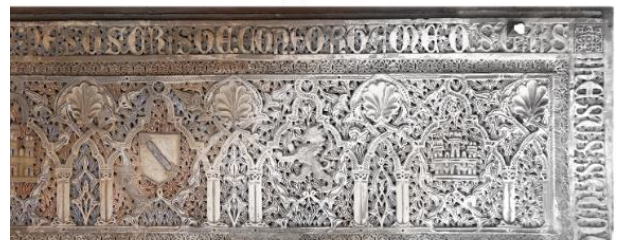
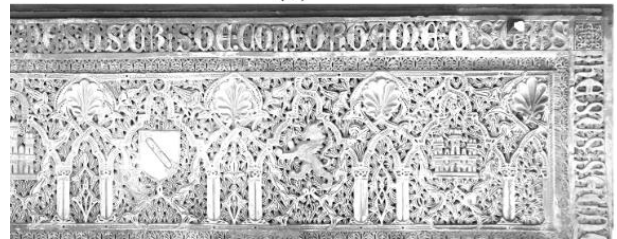
Figure 5: Process followed to obtain the photogrammetric survey: a) orthophoto of the decorative frieze; b) b&w image editing process; c) final conversion into drawing in Adobe Photoshop CS6.

In addition to the point cloud and the textured photogrammetric model, the orthophoto of the complete plasterwork was obtained (Fig. 5).

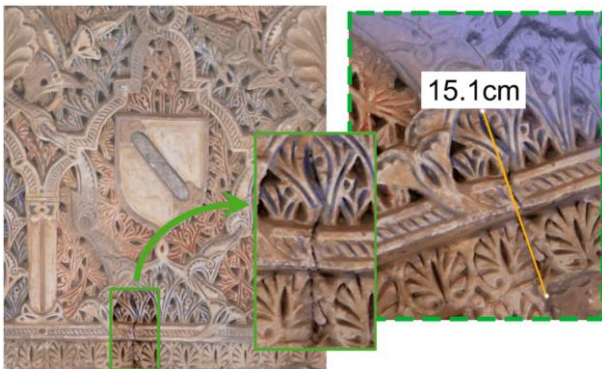
Figure 7: Information on fissures and cracks identified in the photogrammetric model.

The orthophoto obtained from the photogrammetric model allowed the elaboration of a digital mapping of damages (Fig. 6) where the fissures and cracks identified during the photogrammetric survey on-site were located. As an example, Fig. 7 shows a 15.1 cm in length crack.

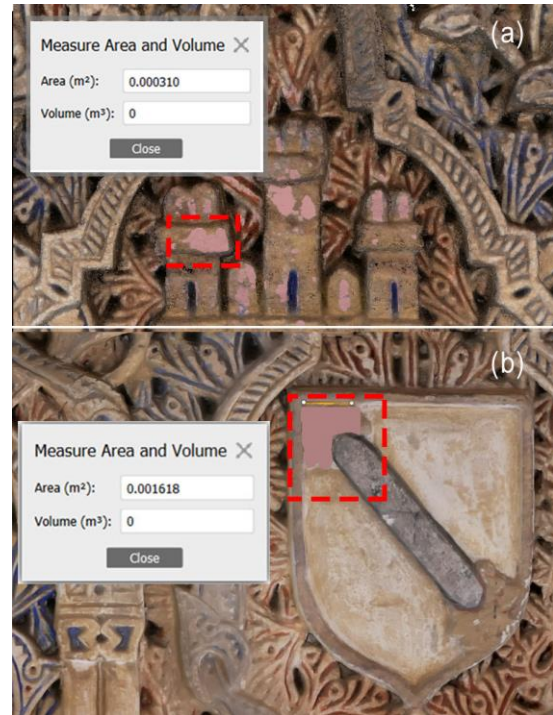
Figure 8: Measurement in Agisoft Metashape Pro of: a) colour gaps and b) detached fragments.

points by colour from the dense point cloud, to obtain the surface painted with a specific polychromy. By contrast, it is also possible to detect places where the polychromy has been detached (Figure 8).

Similarly, it is possible to quantify detached areas or volumes with sub-millimetre precision by using the photogrammetric model, thus surpassing traditional measurement techniques (Figure 9).

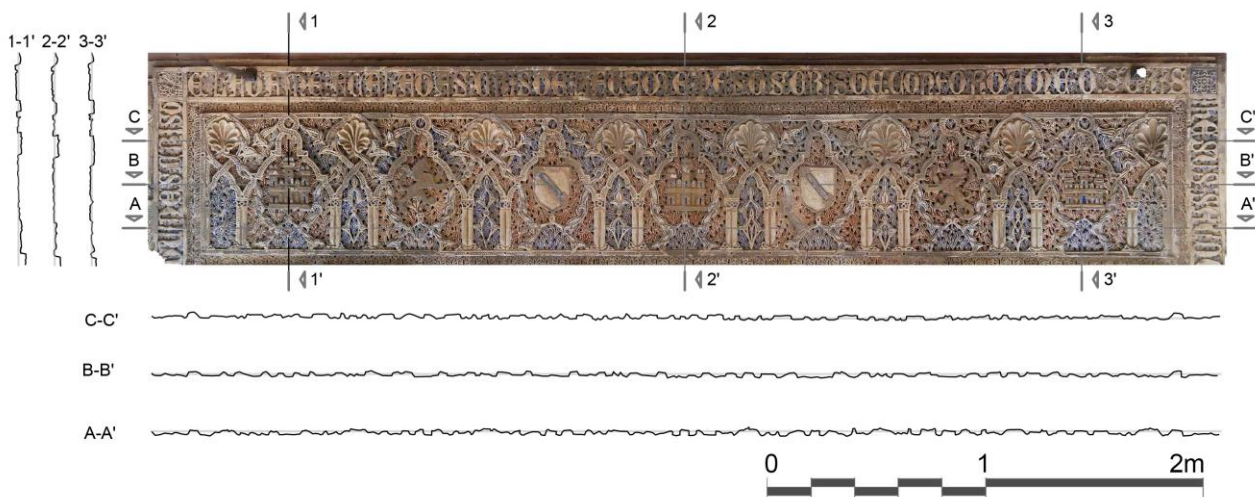
Figure 9: Horizontal (A-A', B-B', C-C') and vertical profiles (1-1', 2-2', 3-3') of the frieze under study.

From the photogrammetric model obtained, the deformations of the plaster frieze were analysed. To do this, a series of sections have been executed using the dense point cloud. Vertical sections 1-1', 2-2' and 3-3' and horizontal sections A-A', B-B' and C-C' (Fig. 9). These sections allowed analysing of the similarities in the profile of three parts of the plasterwork of similar geometric composition (Fig. 10).

First, the differences between verticality and the union of the ends in sections 1-1', 2-2' and 3-3' were analysed. These sections are slightly inclined forward at the top, resulting in angles of 1.565°, 1.373° and 1.144°, respectively. This means that the verticality of the frieze is variable along it, being more vertical as we move to the right. On the other hand, sections A-A', B-B' and C-C' were joined to analyse their profiles. In this case, the sections are predominantly maintained frontal, differentiating angles of 0.135°, 0.122° and 0.115°, respectively.

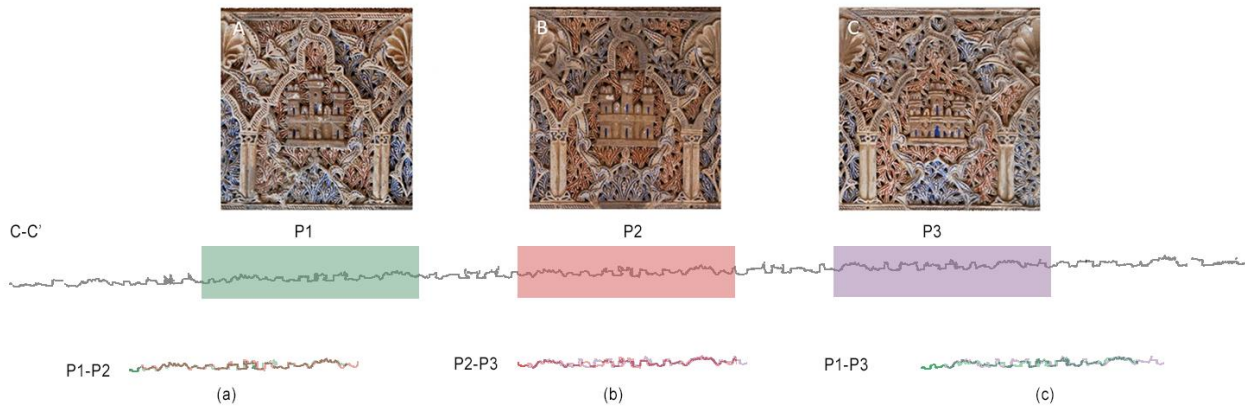
Figure 10: Deformations of the photogrammetric model in the horizontal profile C-C': a) overlapping of P1 & P2 profiles; b) overlapping of P2 & P3 profiles; c) overlapping of P1 & P3 profiles.

In addition, it was possible to analyse the geometric similarities of the sections made on parts of a similar geometric composition (e.g. the three castles carved on the plasterworks). The overlaps of their profiles revealed a great geometric coincidence between certain specific parts of the plasterwork. Therefore, it can be said that the graphic documentation obtained from photogrammetry offers an unprecedented amount of data for a complete analysis and study.

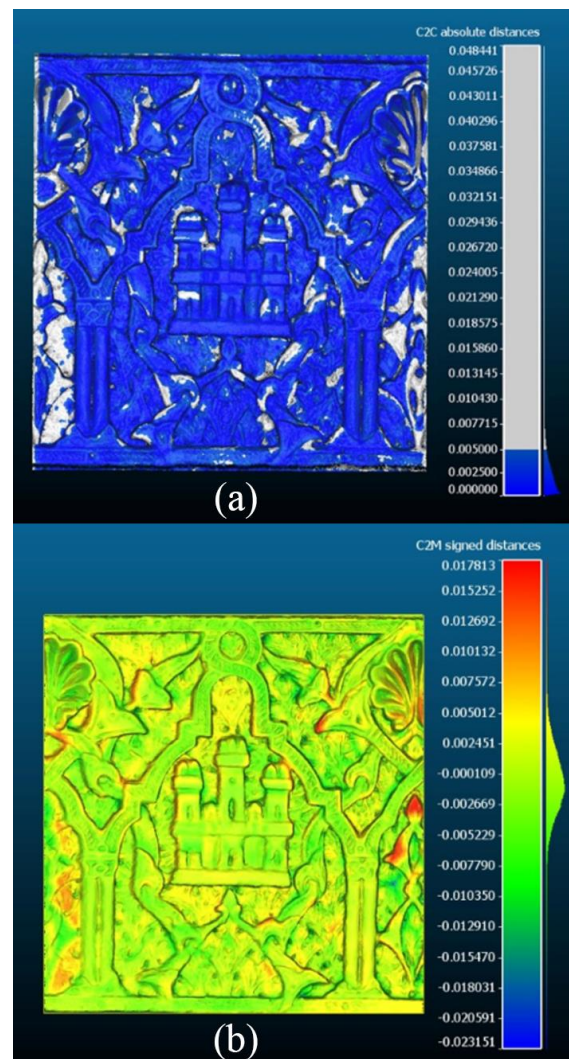
Figure 11: Comparison of distances in Cloud Compare. a) C2C comparison; b) C2M comparison.

Likewise, the superposition of the point clouds of the different carved decorative motifs can yield information regarding the deformations or in terms of the geometric differences detected in the carving of the plasterwork. Figure 11 shows two different comparisons made on two parts with similar geometric compositions. On the one hand, the Cloud-to-Cloud distance comparison (C2C) in Cloud Compare (Fig. 11a) shows the absolute distances between two clouds. In this comparison the mean value obtained was 2.28 mm, and the standard deviation was 2.41 mm. On the other hand, the Cloud-to-Mesh distance comparison (C2M) (Fig. 11b) shows the distance between two meshes. In this case, the mean value obtained was -0.65 mm, while the standard deviation was 2.9 mm.

In this case, there are no major deformations, but the differences in carving, not noticeable by the human eye, were highlighted.

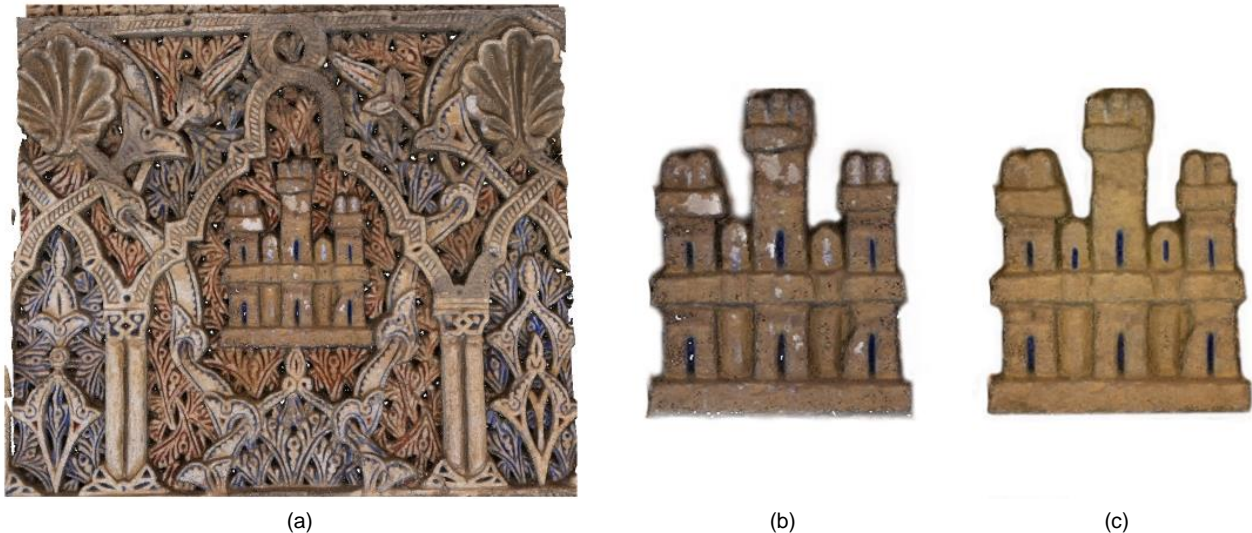
Figure 14: Working process with the volume corresponding to the castle: a) photogrammetric 3D mesh; b) isolated detail of the photogrammetric 3D mesh; c) reconstruction of the polychromy according to samples 3 and 6.

Finally, the high-precision photogrammetric 3D model allows the post-processing of the point cloud and/or textures and volumetric reconstructions can be performed by isolating details and exporting the elements to third-party modelling software.

In this way, not only would it be possible to undertake an intervention to rebuild detached fragments, but the necessary counter molds could be generated to replicate these decorations (Fig. 14). In fact, the reconstruction of plasterwork using digital tools and modern techniques such as computerized numerical control milling (CNC milling) and laser cutting (Marshall, 2007) or scanning and reproduction by 3D printing in polylactic acid (PLA) is currently being promoted (Ávila Rodríguez, 2019; Norin *et al.*, 2019). Likewise, it would also be possible to hypothesize the original polychromies or polychromies that can be applied in future restoration interventions to validate the intervention (Torres-González *et al.*, 2022).
