# INFLUENCE ON ENERGY PERFORMANCE IN HISTORICAL BUILDINGS CAUSED BY THE URBAN ENVIRONMENT AND PROJECT MODIFICATIONS: THE CASE OF THE DUCLÓS HOUSE

## INFLUENCIA EN EL RENDIMIENTO ENERGÉTICO EN EDIFICIOS HISTÓRICOS PROVOCADO POR EL ENTORNO URBANO Y LAS MODIFICACIONES DE PROYECTO: EL CASO DE LA CASA DUCLÓS

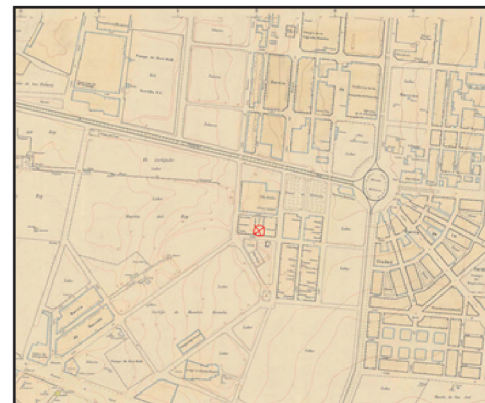
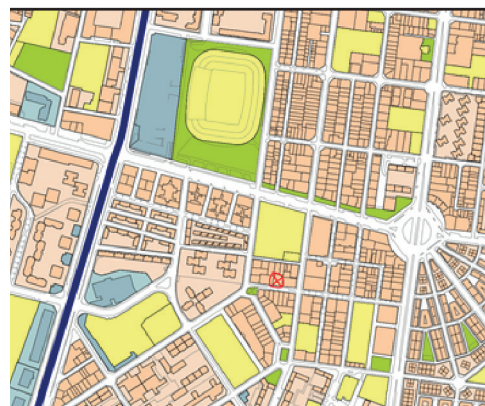
Figure 1. Plans of the area around Duclós House in 1945 (left) and today (right). Source: Preparation by the authors using plans from the map library and the Seville City Council's General Urbanistic Ordinance Plan.

The building was located in an area far from the urban hub when it was built: a smallholding marked out by the architect Aníbal González on lands of the University Chancellor's farmhouse, which later became popularly known as the Nervión neighborhood (Bono Ruiz de la Herrán, García Vásquez, Pérez Escolano, Pico Valimaña & Ortega, 1996). It was an unconsolidated suburban development area, even a decade after its construction, just as can be seen in Figure 1. However, urban expansion throughout the 20<sup>th</sup> century enveloped Duclós House, leaving it located on a narrow street, surrounded by high-rise buildings (Figure 1).

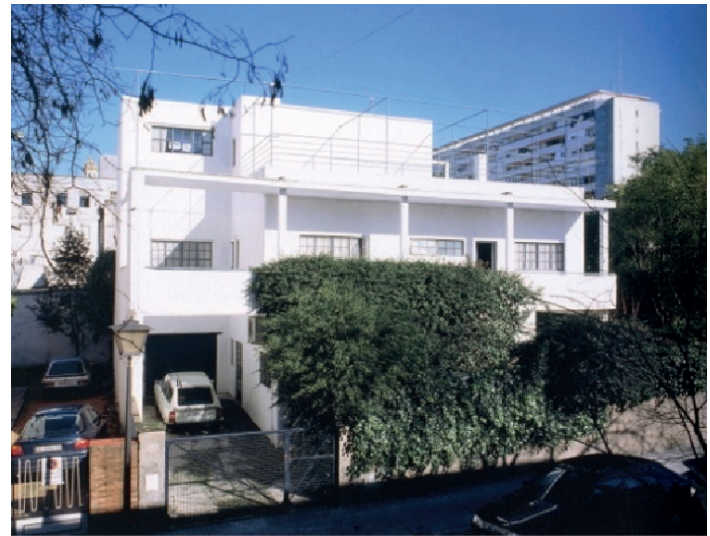
Figure 2. Outdoor photograph of Duclós House. Source: Quesada (2008, p. 194).

Duclós House is located in Seville. It is a single-family dwelling located on a 535 m<sup>2</sup> smallholding (Figure 2) that occupies a surface area of 169 m<sup>2</sup>. The house's vertical distribution comprises the following floors: semi-basement, ground floor, second floor and attic. Connection between the different levels is made through single flights of stairs (Quesada, 2008).

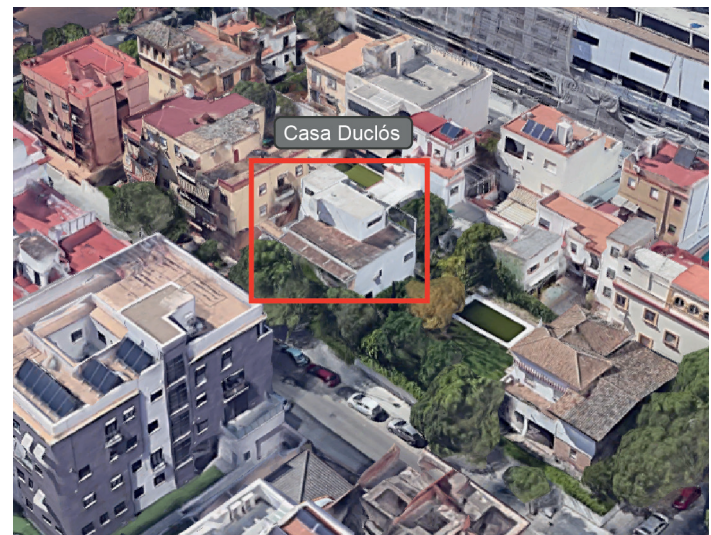
Figure 3. Aerial view of Duclós House and the buildings around it. Source: Preparation by the Authors.

As has been indicated, the building is currently surrounded by large voluminous high-rise buildings (Figure 3), that limit the incidence of direct solar radiation on each of its enclosure elements, as such the different shading premises considered in the project's preparation may have been left inoperative, impeding, in winter, the solar incidence that can generate greater thermal comfort in the different rooms.

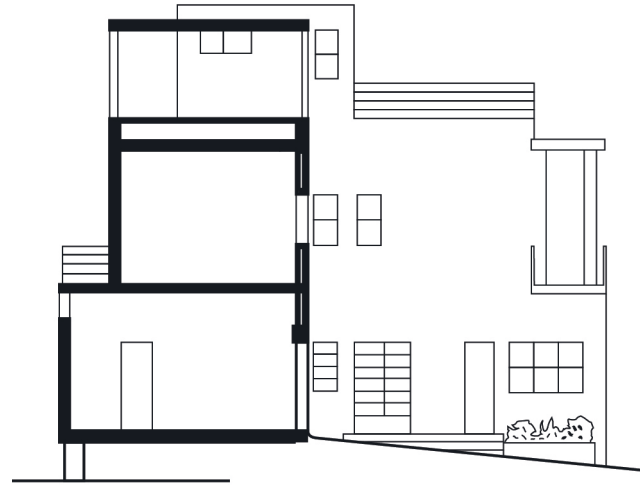
Figure 4. Duclós House floor plan. Source: Preparation by the Authors.

On analyzing the project's graphical documentation, the space set aside for an air chamber can be seen, on the building's floor plan (Figure 4), which corresponds to the project's original idea; although there is evidence, like the lack of vents or the 13x28 cm ceramic tiles, that indicate the terrace roof was built following the canyons of traditional Andalusian roofs (Lousame, 2011).

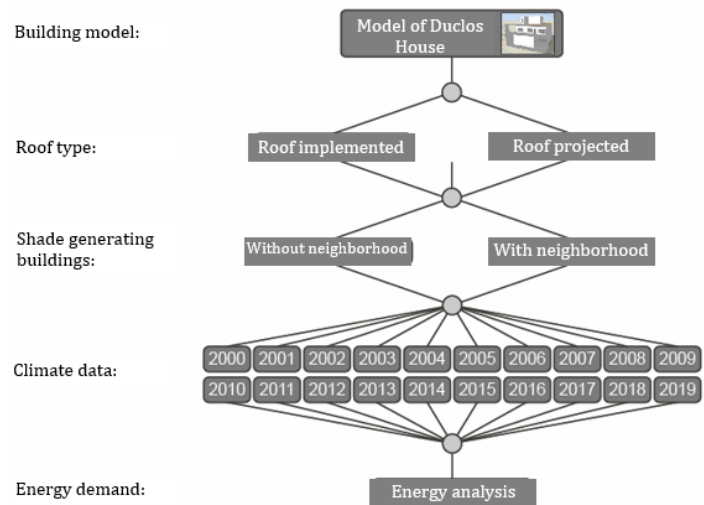
Figure 8. Work flow followed in the research. Source: Preparation by the Authors.

are summarized in Figure 8. Just as can be seen, Duclós House was modeled first (Figure 9). For this, the available planimetric data of the project was used and the enclosures were defined using the construction details described in the previous sections. Table 1 indicates the thermal conductivity values and the thicknesses of the layers of the main elements of the envelope. The thermal conductivity values used are those established in the Construction Elements Catalog and in the energy certifications tools in Spain. It is worth highlighting that two models were defined considering the roof type: projected roof (with chamber) and implemented roof (flat Andalusian). In Table 2, the thermophysical properties set out for each roof are detailed.

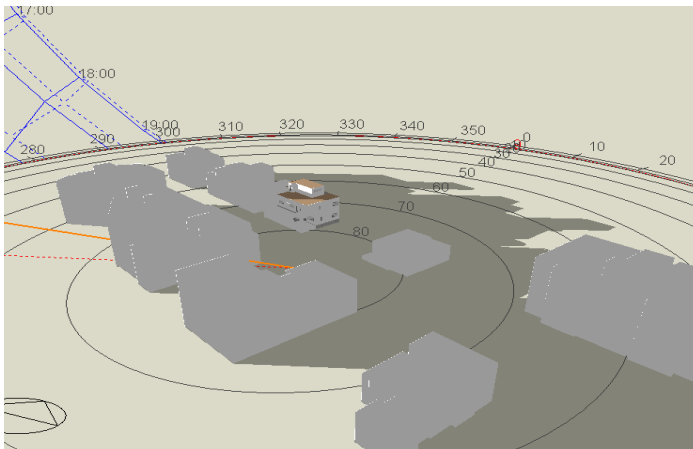
Figure 10. Model of Duclós House with the surrounding buildings in DesignBuilder. Source: Preparation by the authors.

the energy performance of the building if large buildings had not been built around it, while analysis with the surrounding buildings allows valuing the current energy performance. With this purpose, the cartographic database was downloaded to model the neighboring buildings, considering a height of 3 meters per floor (Figure 10).

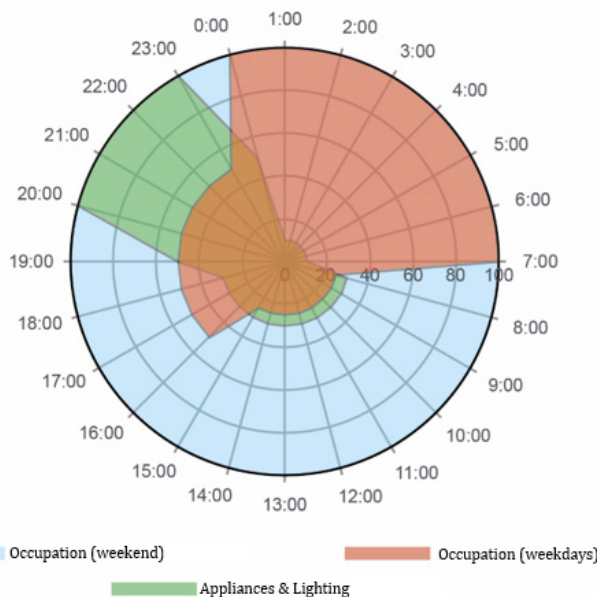
Figure 11. Percentage distribution of the residential profile loads of the Technical Building Code. Source: Preparation by the Authors.

weekend). In Figure 11, the percentage load distributions of said profile are shown. The maximum load value of the equipment and lighting systems is 4.4 W/m<sup>2</sup>; while, for occupation, a maximum value is established for the sensitive load and for the latent load of 2.15 W/m<sup>2</sup> and 1.36 W/m<sup>2</sup>, respectively. As for the operational pattern of the air-conditioning systems, the Technical Building Code distinguishes two periods of operation considering the time of the year. In Table 3, the temperature setpoint values and hours considered in said residential profile are indicated. It is important to clarify that by including, in the comparisons, the status of the buildings without the neighborhood does not cover the objective of determining the energy performance in 1930, as at that time there were no active systems for these purposes; what is intended is to evaluate the consequences urban expansion has had on the building's energy performance, considering the demands of users in the 21<sup>st</sup> century.

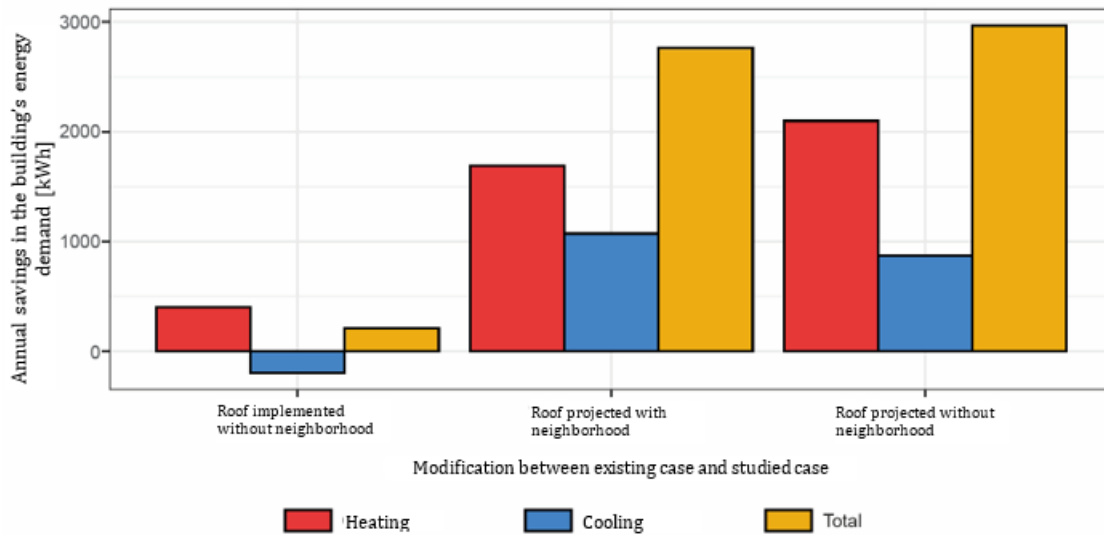
Figure 14. Average saving in energy demand between the current status of Duclós House (executed roof and surrounding buildings) and the other models considered. Source: Preparation by the Authors.

implemented without neighborhood and of up to 3,104.14 kWh in comparison with the building projected by Sert. This means significant percentage deviations (Figure 14) and proves the worse energy performance that Duclós House currently has.

Figure 14 shows the average saving obtained between the different assumptions of Duclós House compared to the existing case. In this way, it can be seen that the changes in the design and the surroundings have led to a worse energy performance. In this sense, although the urbanistic growth has implied an improvement in the cooling energy demand (with an average saving of 193.70 kWh), the effect on the total energy demand is negative (with an average increase of 207.68 kWh in the energy demand). However, where the highest difference is detected is between the type roof typologies analyzed: the roof projected by Sert implies significant average savings in all energy demands (of 2,762.91 kWh in the case with neighborhood and of 2,966 kWh without it). As was to be expected, the surrounding buildings have a different saving effect in terms of the energy demand, but, due to the operational criteria established by the Technical Building Code, this generates a better performance, when this is a setting without buildings. In any case, this performance could change in the coming years, on facing a progressive increase of the outdoor temperature as a result of climate change.
