# Non-Destructive Multi-Feature Analysis of a Historic Wooden Floor

Non-Destructive Multi-Feature Analysis of a Historic Wooden Floor. *Buildings* **2022**, *12*, 2193. <https://doi.org/10.3390/buildings12122193>

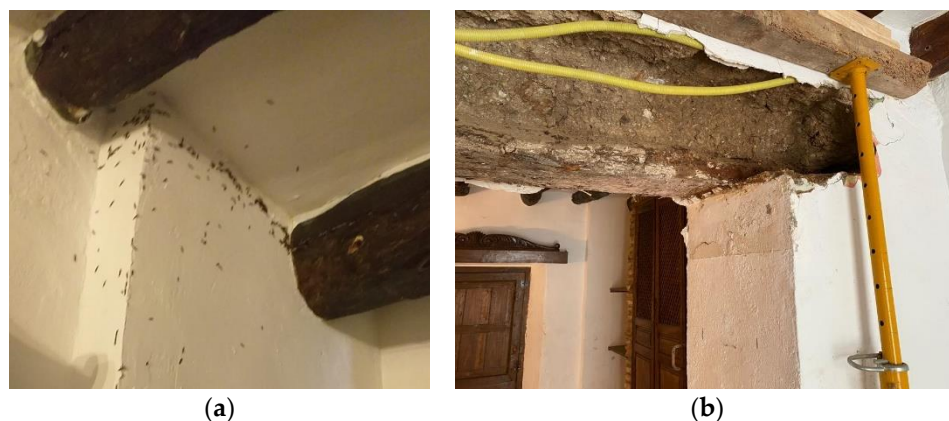
**Figure 1.** (a) Termite attack detected in a private home in Albuñuelas (Granada, Spain); (b) Intervention to replace damaged beams.

The damage generated by xylophages, mainly woodworms and termites, can even lead to a total loss of resistance (Figure 1). Early detection of xylophages is essential, and may be approached through traps or fumigation techniques [3]. Most often, xylophages are detected by visual inspection to spot the tunnels they form, or by hitting to note if a hollow sound is produced [4]. These procedures are imprecise, however; they cannot distinguish whether the galleries are due to current or past activity [5]. Visual inspection also takes time and can only be carried out on accessible faces of the beam that are not hidden by other materials. The bait-based detection method is effective for treatment [6], but the materials need to be opened to control termite activity. Thermography techniques can also be applied for the evaluation of woodworm tunnels, knots, and non-homogeneities at some depth in wood specimens [7–11]. Techniques based on recording the noise generated during insects' activity are more commonly used by companies contracted for the assessment of real buildings [6]; yet, acoustic devices may also record environmental noise

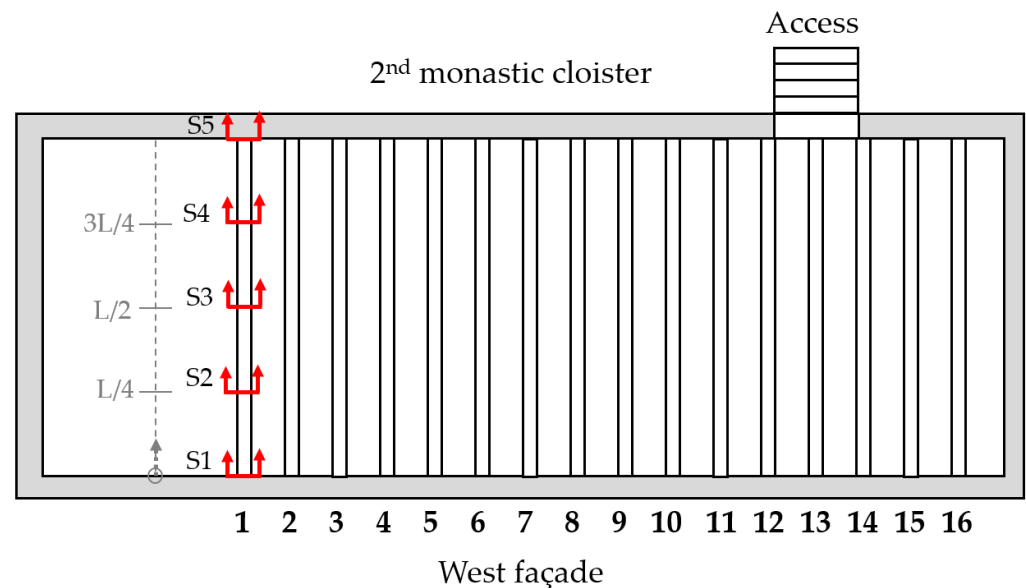
**Figure 3.** Scheme of the 16 wooden beams of the floor under analysis. L: Total length of each wooden beam. S1, S2, S3, S4 and S5: Measurements points of the beam section.

The floor of the study is located on the Convent's first floor, and is made of local *Sylvestris* pine beams supported on lime-earth walls about 800 mm thick. The floor has 16 beams with an average section of  $210 \times 300$  mm and an average length of 6800 mm, the average distance between axes being 77 mm (Figure 3). The beams were in the walls for around 200 mm without being embedded, thus constituting a bi-supported slab. The beams along their length presented variations in section. For this reason, five section measurement points were established, two at the beam heads (S1 and S5) and three more at L/4, L/2 and 3L/4, L being the total length of each element.

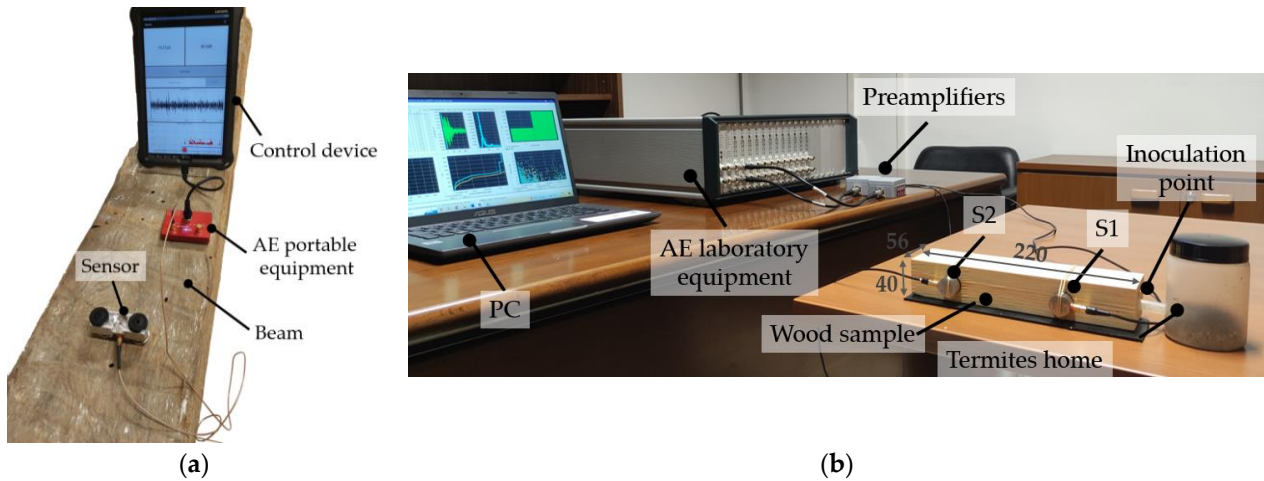
**Figure 6.** Acoustic emission setup (a) in situ on the wooden beams of the floor and natural environment conditions (portable acquisition system); (b) in laboratory on wooden samples under controlled conditions (laboratory acquisition system). Distances in mm.

established during the acquisition of the signals to avoid mechanical and electromagnetic environmental noise. Acoustic emission measurements were made at the ends of each beam and along every 30 cm of each beam. The photograph in Figure 6a depicts measurement on one of the beams.

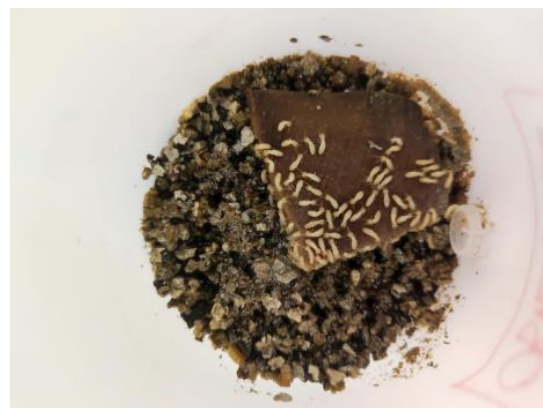
**Figure 7.** *Reticulitermes* termites before inoculation.

For the tests carried out in the laboratory, *Reticulitermes* termites (Figure 7) were inoculated in a specimen of *Sylvestris* pine wood measuring  $220 \times 56 \times 40$  mm. The termites, specifically 200 workers and 8 soldiers, were stored in a plastic container. It had a small amount of moistened substrate, along with small pieces of wood from the same test tube as the food, to observe how the termites made their way through the connecting tube to the perforation provided in the specimen (Figure 6b). In the part closest to the edge of the specimen, the perforation was 2 cm long and 10 mm in diameter, followed by a second, narrower perforation 5 mm in diameter and 2 cm long.

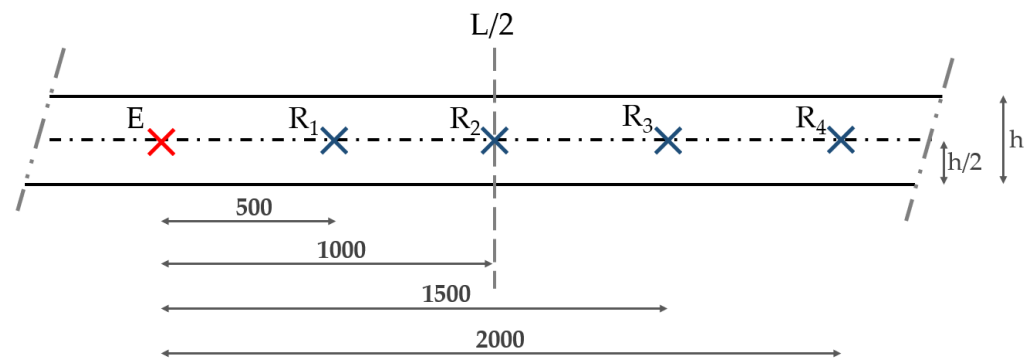
**Figure 8.** Layout of the sensors for the experimental determination of the  $MoE_{dyn}$  of each wooden beam. Distances in mm.

For each wooden beam of the floor, the dynamic modulus of elasticity ( $MoE_{dyn}$ ) was obtained by means of the elastic wave technique. It was applied on a central area of the element, 200 mm long, in which the bending moment is maximum. Fakopp SD-02 sensors were driven into the wood with a pointed end in a  $45^\circ$  direction, in order to properly transmit the P mode of the elastic waves generated with an impact hammer weighing 100 g on the one of the sensors (Figure 8). To record the signals, a Picoscope<sup>®</sup> oscilloscope (Saint Neots, UK) with a bandwidth of 20 MHz and a sampling frequency of 80 MS/s was used. The sensor tips were driven to a depth of 15 mm. Using a system of two separate sensors with a separation  $d$ , the time of flight of the elastic wave (ToF) was obtained ( $\Delta t = t_2 - t_1$ ), where  $t_1$  and  $t_2$  are the arrival times of the wave to each sensor and  $c = d/\Delta t$  is the propagation velocity.

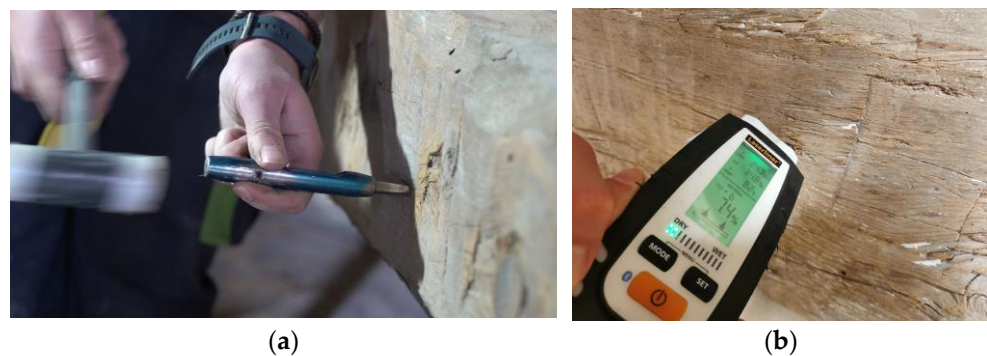
**Figure 9.** (a) Micro-core extraction using the Trephor35 auger. (b) Measurement of the moisture content of a beam using a hygrometer.

where  $\rho$  is the density of the beam. The density was obtained by extractions (micro-cores) carried out with a Trephor35 auger (Figure 9a). The sample was taken from areas of each beam away from knots, cracks and other pathologies. These micro-cores were 4 mm in

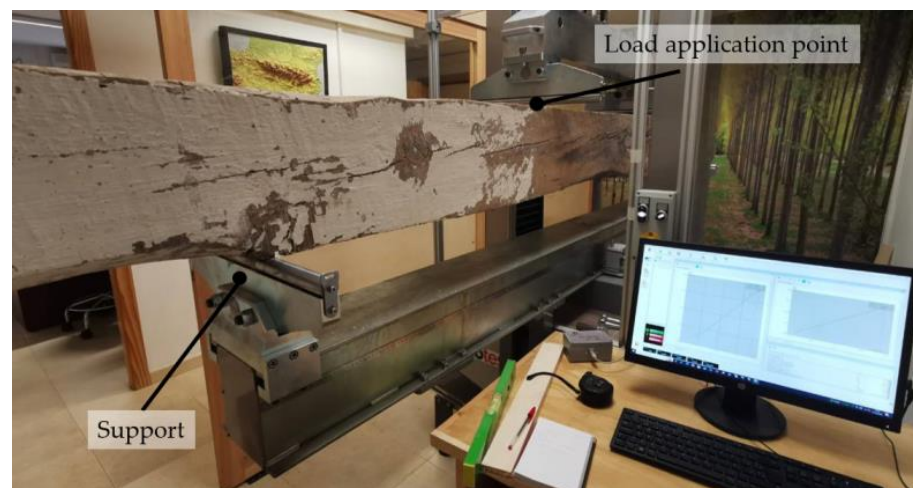
**Figure 10.** Beam subjected to four-point bending test.

For comparison reasons, the floor owner supplied only four of the 16 beams (beams numbered 1, 2, 14 and 15) when they were removed from the building. It was not possible to obtain more beams. These four beams were subjected to a mechanical four-point bending test in the elastic zone using a multi-testing machine (Figure 10). In this way, the elastic modulus,  $MoE_{st}$ , and its corrected value at 12% moisture content,  $MoE_{st,c}$ , were obtained.

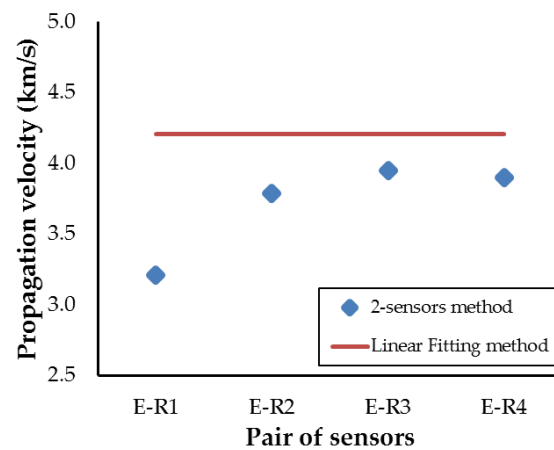
**Figure 21.** Elastic wave propagation velocity obtained for beam 1 using the AIC technique. In blue rhombuses: obtained individually by means of the pair sensor E-R<sub>i</sub> (i:1–4). On a horizontal line: obtained by a linear fitting.

Alternatively, Figure 21 shows, for beam 1, the velocities obtained using the emitting sensor E and all the receiving sensors  $R_i$  ( $i: 1-4$ ), by means of the arrival time obtained using the Akaike technique. The horizontal line represents the velocity obtained by the linear fitting. There are substantial differences between this average velocity and the individual ones, up to 31%.

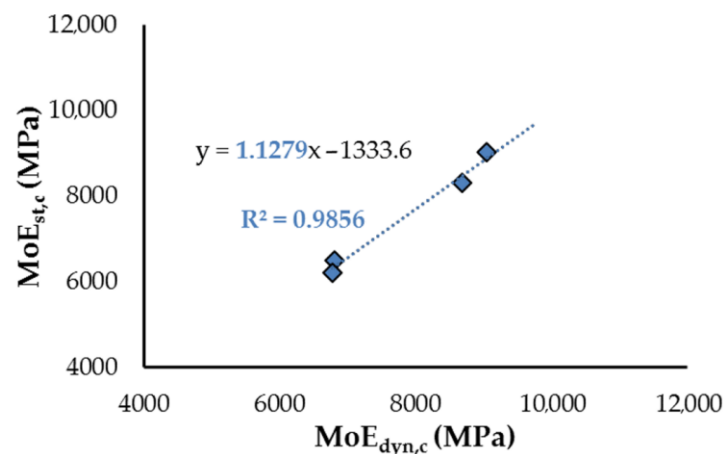
**Figure 22.** MoE<sub>st,c</sub> versus MoE<sub>dyn,c</sub>.
