Article

Bioconsolidation of Damaged Construction Calcarenites and Evaluation of the Improvement in Their Petrophysical and Mechanical Properties

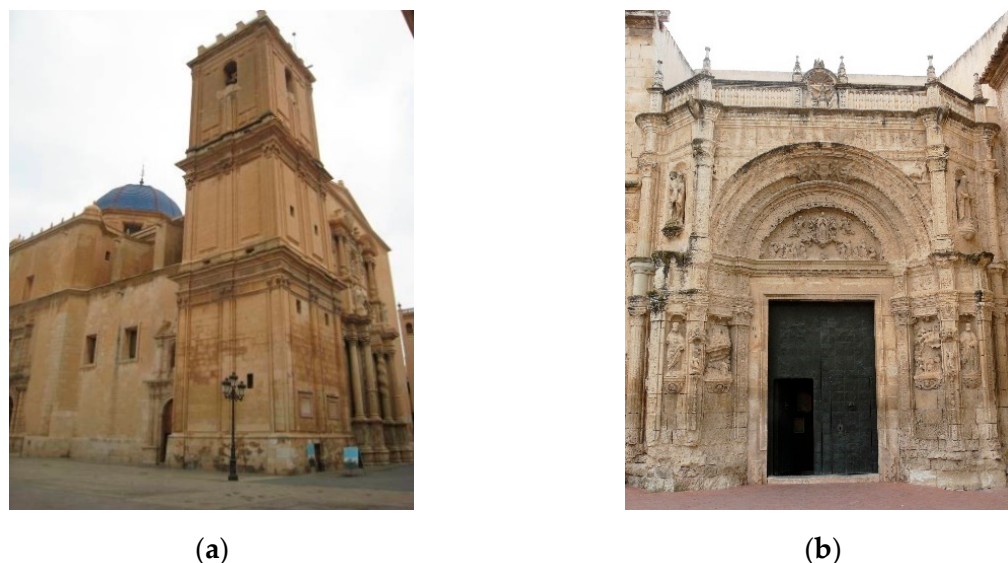
Figure 1. Historical buildings built with calcarenite stone; (a) Basilica Santa Maria (SM) in Elche (Serravallian stone); (b) Church of Nuestra Señora de La Asunción in Biar (IB) (Eocene stone).

Serious stone damage was evident in both buildings showing severe alterations and extensive surface sanding caused by the granular disintegration of whole pieces. For example, Figure 1b illustrates the main entrance of Biar church, featuring a remarkable Proto-Renaissance-style façade dating back to the early sixteenth century, where significant areas of its external surface have experienced a loss of thickness exceeding 15 cm.

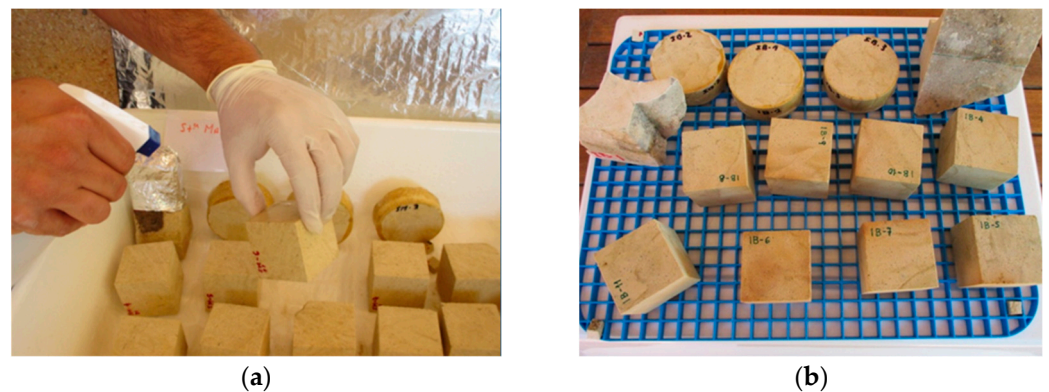
Figure 2. Appearance of the SM and IB samples used for bioconsolidation treatment; (a) Application of the treatment by spraying M-3P on the samples; (b) Disposition of the samples during the time the treatment lasted.

The sterile nutritional solution M-3P [32] was applied by spraying twice a day for 7 consecutive days (Figure 2a). This frequent application was essential to maintain the stone in a saturated state throughout the treatment period. The composition of the M-3P nutritional solution includes 1% Bacto-Casitone (a hydrolyzed casein), 1% $\text{Ca}(\text{CH}_3\text{COO})_2 \cdot 4\text{H}_2\text{O}$ (total calcium: 43.44 mM), 0.2% $\text{K}_2\text{CO}_3 \cdot 1/2\text{H}_2\text{O}$ (total potassium: 35.6 mM; total carbonate: 17.8 mM), and 10 mM phosphate buffer in distilled water (pH 8). Both during treatment and up to two/three days after its completion, the treated blocks remained covered with aluminum foil (stiffened with metal wires) to avoid the direct effect of sunlight and to minimize the evaporation of the M-3P solution. The treatments were conducted with strict temperature control to maintain a range of 20 to 30 °C on the treated areas. All samples were kept for at least 30 days before performing any treatment evaluation. Figure 2 shows the samples during the application of the treatment and their appearance afterward.

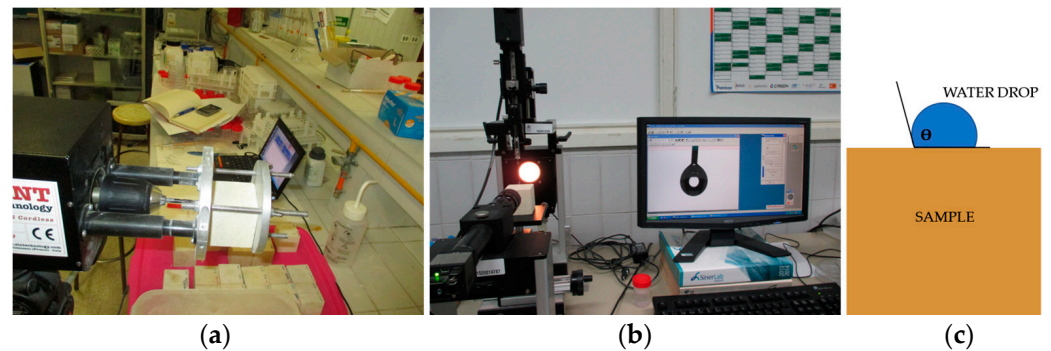
Figure 3. Different aspects of the tests; (a) DRMS; (b) Static contact angle test; (c) Contact angle test scheme. Essays carried out by the authors at the University of Cádiz.

Both untreated and treated stone cubes measuring 4 cm × 4 cm × 4 cm in size were used for the evaluation of the drilling resistance of the stones. DRMS is designed by SINT Technology (Calenzano, Italy) to perform a precise “drilling resistance” test through the continuous measurement of the force necessary to drill a hole in the material under specific operating conditions. The test conditions were as follows: (i) a 4.8 mm diameter flat-edged diamond-tip drill bit [49]; (ii) a penetration rate set at 20 mm/min; and (iii) a rotational speed set at 200 rpm. The system is equipped with software that allows continuous recording (giving data every 0.1 mm drill) of the force, expressed in N, in relation to the drilling feed [49]. During testing, both rotational speed and penetration rate were maintained constant. Five drill holes per specimen were performed to obtain average values. This test was carried out in the Department of Physical Chemistry at the University of Cádiz.

The stone samples were subjected to this test as recommended in UNE-EN 15802 [45]. Control and treated samples were used for the treatment evaluation (in this case, only two samples of each stone type were available). For each sample, a micro-droplet of distilled water was applied with a needle onto the stone surface, generating a determined static contact angle. The image of the droplet was immediately captured for the measurement of the static contact angle (Figure 3b). The whole process was controlled on a monitor that

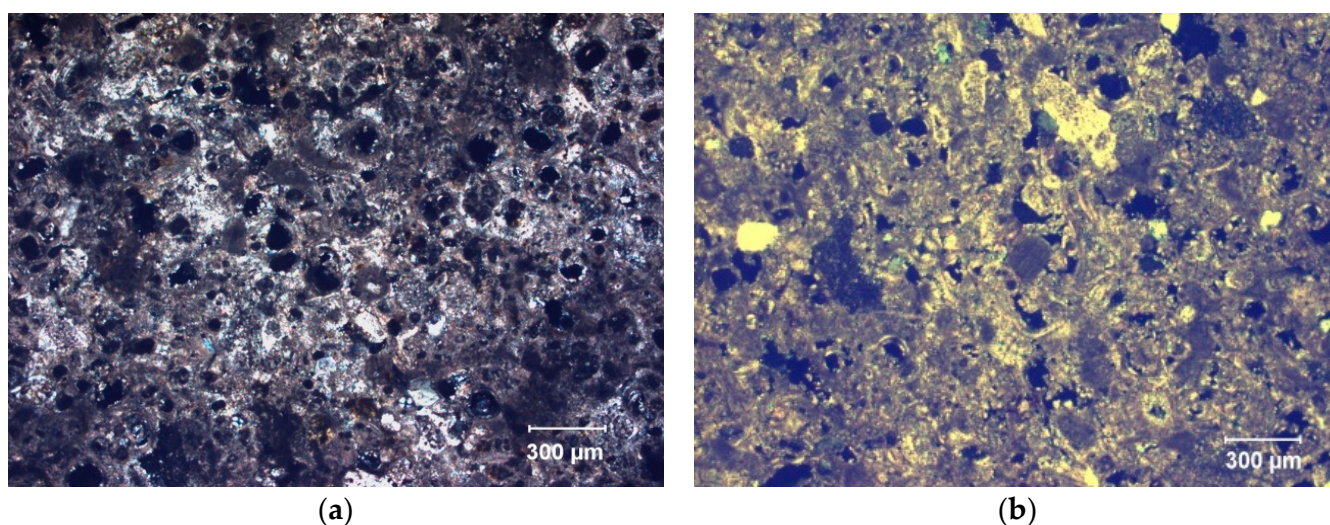
Figure 4. Microphotographs of thin sections (petrographic polarizing microscope with crossed Nicols); (a) SM sample, biomicritic limestone with foraminifers; (b) IB sample, biosparitic limestone with fossils (bryozoans and red algae). Both samples show irregular and heterogeneous porosity (pores are black).

Data obtained from visualizing the samples using a petrographic polarizing microscope (Figure 4) and a scanning electron microscope (Figure 5) revealed that the stone of SM is a somewhat loamy biomicritic limestone. This type of limestone contains various fossils, including foraminifers, brachiopods, and echinoderms. Additionally, observations identified the presence of clays, particularly illite, as determined by XRD analysis. These clay minerals were transported from the continent and deposited along with the calcareous fossils in a shallow marine environment, subsequently subjected to cementation during the diagenesis of these calcarenite rocks. This stone composition implies a higher intrinsic predisposition to decay by extrinsic agents. Specifically, the stone is prone to phenomena such as disaggregation, flaking, and scaling of the stone surface when in contact with water. In terms of mineralogical composition, determined by XRD analysis, this stone contains 88% calcite, 2% quartz, and 10% dolomite. IB stone was shown to be a fine-grained biocalcarenite (biosparitic limestone), containing terrigenous materials with different concentrations of quartz and feldspar, oscillating between 5% and 15%. It contains fossils mainly formed by planktonic foraminifers (commonly represented by Globigerinoides), red algae, and bryozoans. According to XRD analysis, the mineralogical composition of this stone consisted of 94% calcite, 3% quartz, and 3% microcline.

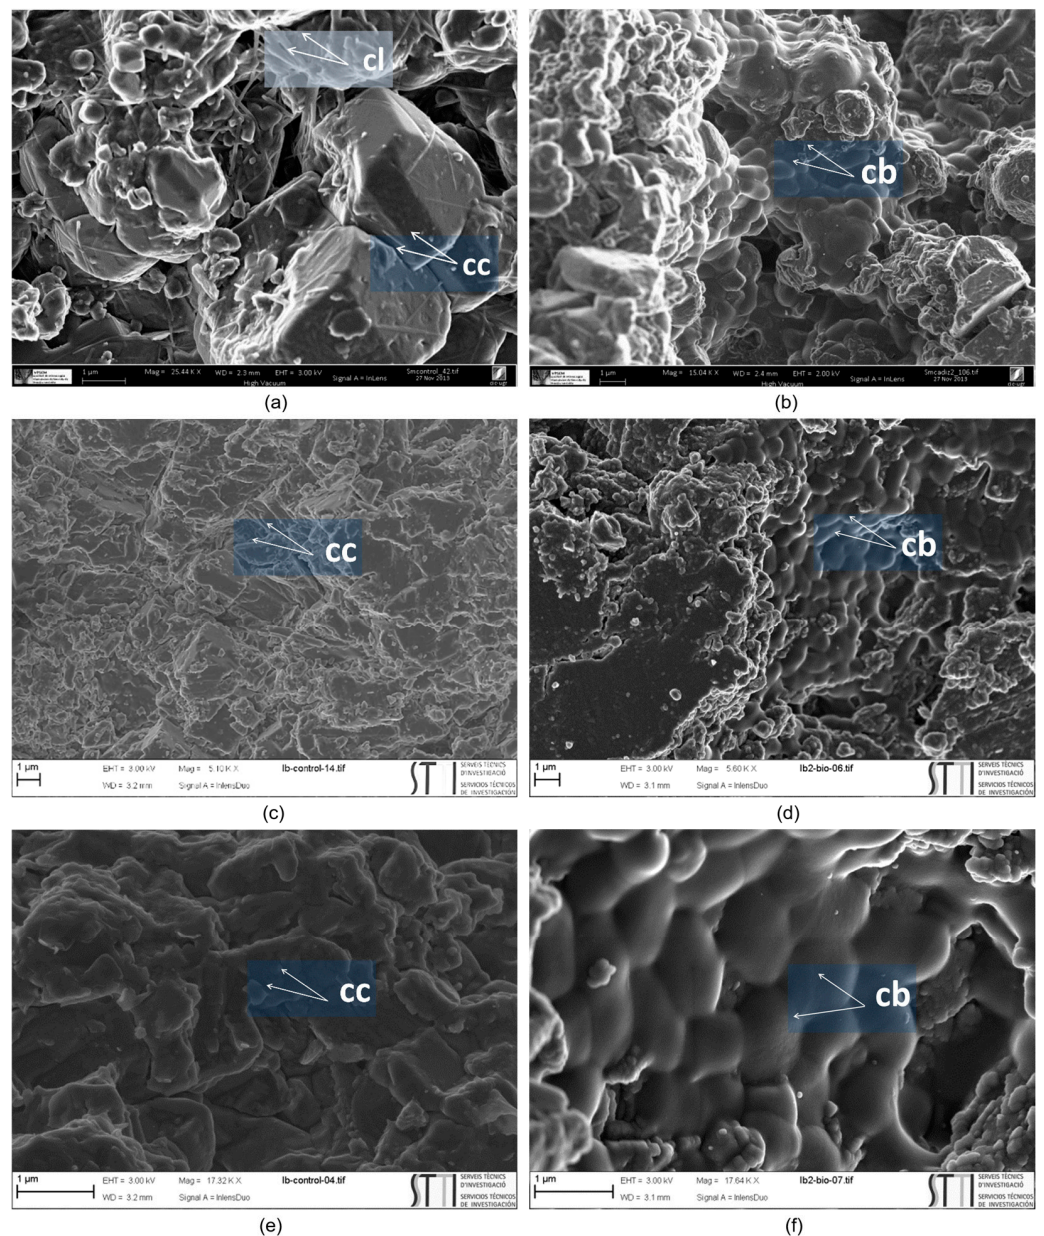
Figure 5. SEM photomicrographs of the samples; (a) SM-untreated stone; (b) SM-treated stone showing biomineralization; (c) IB-untreated stone; (d) IB-treated stone showing biomineralization; (e) Detail of IB-untreated stone; (f) Detail of IB-treated stone showing biomineralization and a cover of calcified bacteria; **cb** = calcified bacteria, **cc** = calcium carbonate crystals, **cl** = clays.

SEM photomicrographs of treated stone samples showed newly formed cement of calcium carbonate in both historical buildings made with SM and IB stones (Figure 5). In both cases, based on the microstructural morphologies observed, spherulitic-shaped crystals, as well as calcified EPS and calcified bacterial cells (i.e., bacterial cells embedded or entombed within the bacterially produced calcium carbonate crystals), were distinguished within the stone substrates. The newly formed bacterial calcium carbonate cemented the stone substrate and improved its resistance to decay (see below). Moreover, as shown in Figure 5b,d, the EPS produced by the carbonatogenic bacterial activity is able to cover and bind calcarenite grains and newly formed bacterial calcium carbonate. Such an effect may contribute to the reduction of water absorption, as previously demonstrated by Le-Métayer-Levrel et al. [53]. Furthermore, the fine, newly formed biocement consolidated the stone without blocking or plugging the stone pores, thus allowing gas exchange with the outside. These results were consistent with previous research involving the same bioconsolidation treatment on historical buildings in Granada, i.e., San Jeronimo Monastery, Royal Hospital, and Royal Chapel. Despite the different types of stone used in those buildings (calcarenite without clays) and a distinct mineralogical composition (over 95% calcite and less than 5% quartz) from that of SM and IB stones, the results demonstrated noticeable and lasting strengthening effects associated with the production of bacterial calcium carbonate cement [31,33,37]. In those projects, in all cases, the bioconsolidation treatment proved to be effective in the medium- and long-term, significantly enhancing the structural integrity of the stone and providing enduring conservation benefits [37,54]. These consistent outcomes across various stone types and mineralogical compositions, including those containing some clays in their composition, such as those of SM and IB, highlight the reliability and potential of the bioconsolidation approach as a valuable and lasting conservation strategy for historical buildings constructed from calcarenite materials.

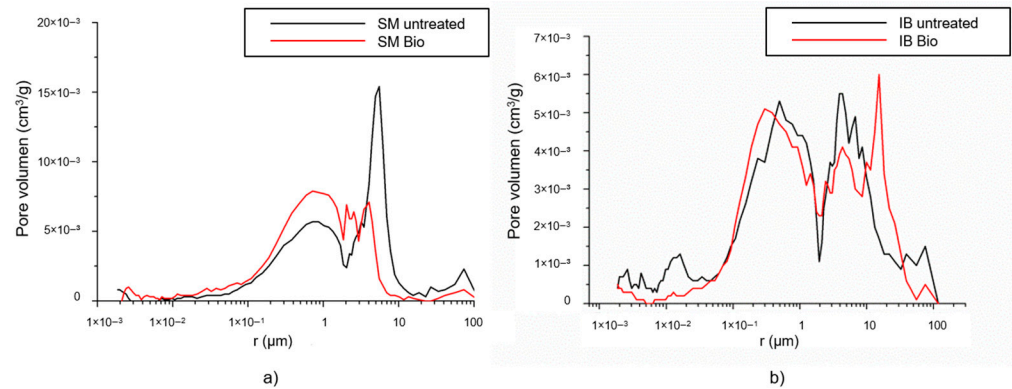
Figure 6. Comparison of mercury intrusion porosimetry curves of treated and untreated samples; (a) SM samples; (b) IB samples. Black lines correspond to untreated samples and red lines to treated samples.

Comparing the MIP data of treated and untreated samples, a reduction of hardly 1% porosity was observed in SM samples, while no detectable reduction was observed in the case of IB samples, maintaining the average stone total porosity. MIP curves moved slightly toward lower diameters but remained in similar ranges so that the behavior against capillary phenomena or salt crystallization, or freeze–thaw cycles were not observed to be

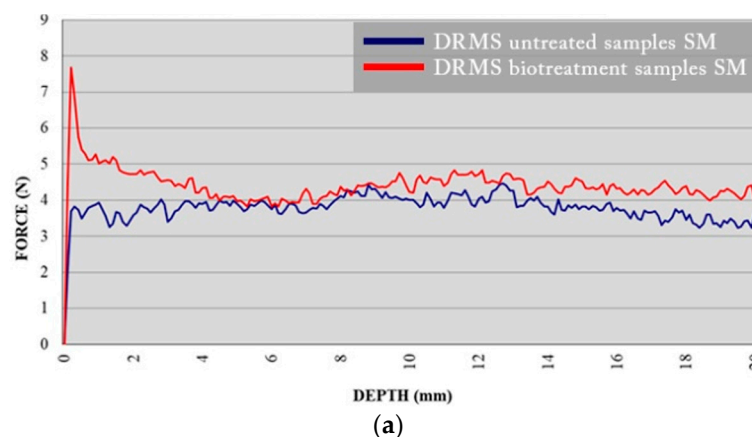
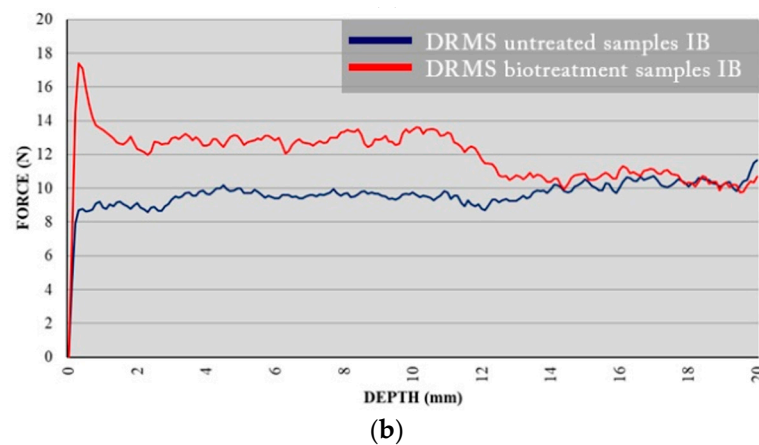
Figure 7. Results of DRMS test performed show the resistance in N that opposes the material to be drilled as it advances inside the sample; (a) SM specimens; (b) IB specimens. The blue and red curves correspond to the untreated and bacterially treated samples, respectively.

Drilling resistance curves of SM samples and IB samples are presented in Figure 6, where the average values of five drill measurements are plotted in Newtons in accordance with the depth of drilling in mm. Blue curves showed the results before the treatment and the red ones after the bioconsolidation treatment. In both cases, after the bioconsolidation treatment, a clear increase in drilling resistance was observed, especially in the first few millimeters, where it doubles in comparison with the untreated samples. In the case of SM samples, significant strengthening is observed up to a depth of 4 mm (Figure 7a). In the case of IB samples, the strengthening effect on the treated stones was very high and extended up to a depth of 14 mm (Figure 7b). This greater depth of consolidation might probably be related to the high capillary absorption coefficient and to the different mineralogy of each type of stone [57]. Note that the best consolidation effect in terms of drilling resistance was observed following the bioconsolidation treatment applied in the case of IB. In addition, the resistance of both stones before and after bioconsolidation treatment was more noticeable in IB than in SM. This is probably due to the lower porosity of IB stone.

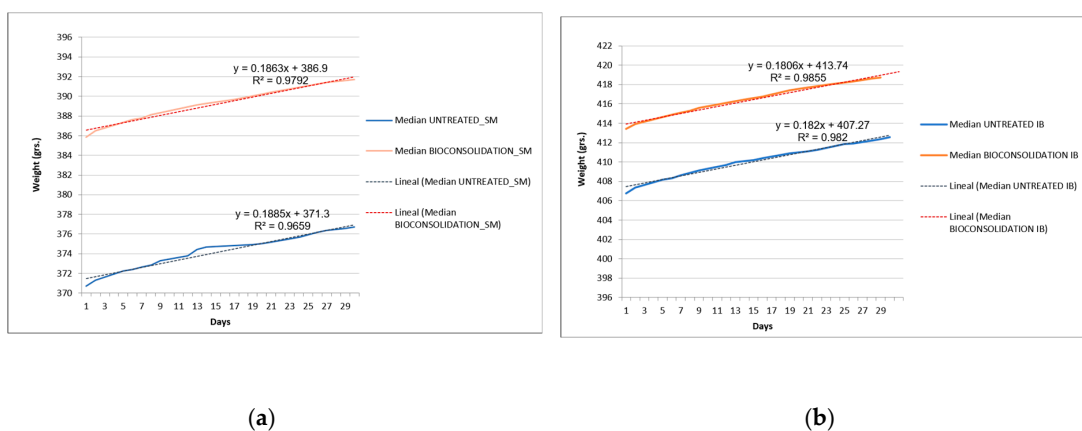
Figure 8. Permeability to water vapor curves; (a) SM-treated and untreated samples; (b) IB-treated and untreated samples. The blue and red curves correspond to the untreated and bacterially treated samples, respectively. The slopes of the curves are included. The initial weight in each case is different due to the weight of the containers. In both cases, the slope of the curve is slightly reduced with the biotreatments.

The results of water vapor permeability are shown in Figure 8. The values have been determined as vapor permeability in accordance with the weight. The curves showed a slight reduction of permeability in both cases. Quantification of the mean weight increase and calculation of the coefficient of water vapor permeability were performed for each case. After 30 days, the SM-untreated sample allowed the transit of 6 g of water vapor, while the treated one allowed 5.85 g, so the permeability was only reduced by 2.5%. The coefficient of water vapor conductivity of the SM-untreated sample was $\delta = 6.56 \times 10^{-4}$ (g/m²), and that of the treated sample was $\delta = 6.36 \times 10^{-4}$ (g/m²s). Concerning IB samples, after 30 days, the untreated sample allowed the transit of 5.76 g of water vapor, while the treated one allowed 5.53 g, so the permeability was reduced by about 4%. The coefficient of water vapor conductivity of the untreated sample was $\delta = 6.30 \times 10^{-4}$ (g/m²s), and that of the treated sample was $\delta = 6.05 \times 10^{-4}$ (g/m²s).

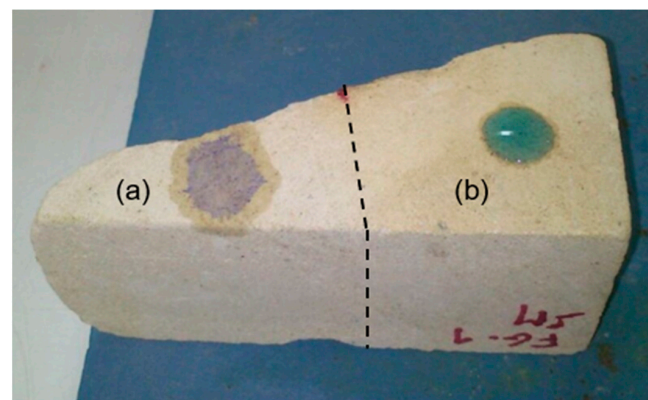
Figure 9. Droplet absorption test on the SM-FG1 stone sample; (a) Untreated part; (b) Treated part.

The results of this test are presented in Table 2, showing that in both cases, an increase in the absorption time of the water drop occurred, being much more noticeable in the case of IB samples. Because of the porosity of the stone, results are very heterogeneous, depending on the exact spot where the drop has fallen, which is a common occurrence in this type of stone [47]. During this test, all treated samples showed a repellent effect against water; the droplets expanded less and showed more contained edges, as shown in Figure 9, in which two droplets were deposited simultaneously in areas A (untreated) and B (treated) of an SM fragment. In all consolidation treatments, considerably lower values of water absorption rate were observed. These results can be explained by the fact that new consolidation materials were precipitated in both samples—results previously shown in this work obtained by the SEM analyses discussed above.

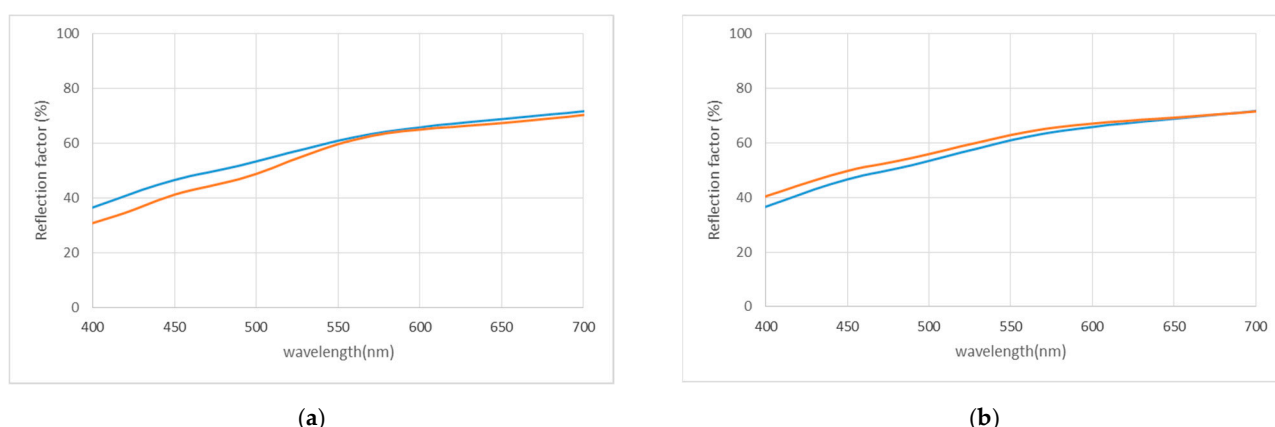
**Figure 10.** Visible reflectance spectra of treated and untreated samples; (a) SM; (b) IB. The blue and red curves correspond to the untreated and bacterially treated samples, respectively.

Table 3 and Figure 10 present results obtained on stone color measurements before and after bioconsolidation treatments in SM and IB samples. The curves of each type of stone (Figure 10) demonstrated similarity before and after the application of the treatment, meaning that no significant differences in color were observed. This result is particularly noteworthy, as one of the primary concerns regarding in situ treatment application is the potential for visible color changes in the treated stone. However, our study's results showed that the bioconsolidation treatment produced no significant color changes in both SM and IB stones. The ΔE values after treatment were 1.08 and 1.90 in SM and IB, respectively. These values are below 2, which is considered an acceptable threshold value for any stone treatment, and they are regarded as extremely low according to the ISO 12647 standard [59–61], as demonstrated by numerous previous studies [61,62]. These findings provide reassurance that the in situ application of the bioconsolidation treatment does not produce any undesirable and visually apparent alterations to the original appearance of calcarenite stones. In addition, the results demonstrated similar color outcomes to those previously obtained in many historical buildings, such as San Jeronimo Monastery, Royal Hospital, and Royal Chapel in Granada, Spain [21,37], all of which are constructed from a porous bioclastic calcarenite stone, different in composition from the stones studied here.
