Experimental validation of a CFRP laminated/ fabric hybrid layout for retrofitting and repairing timber beams

This paper proposes a new hybrid layout to retrofit and repair timber beams by means of carbon composite material. It is based on the combination of a carbon laminate strip attached on the tension side, and a carbon fabric discontinuously wrapping the timber element. This layout has been experimentally validated by means of a study involving large-scale timber beams with many years in service. Results demonstrate not only that the bending load capacity of the broken beams can be totally recovered, but that it may even be increased by 70% with respect to the non-broken ones.

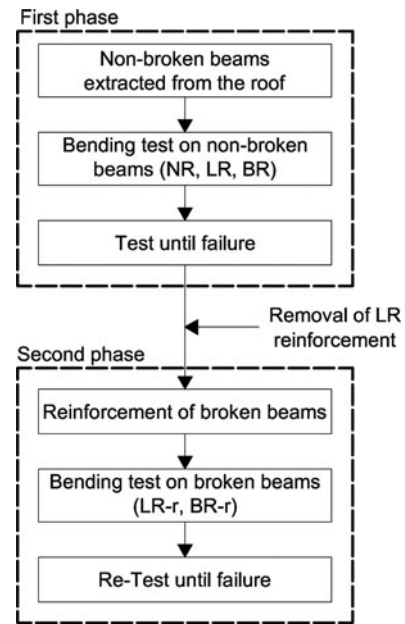
Figure 3. Phases of the experimental program.

Both reinforcement layouts, LR and BR, were tested under laboratory conditions in two experimental phases (Figure 3). During the first phase, beams directly extracted from the roof, previously subjected to a service load during 200 years, were tested. In the second phase, beams which were broken during the first phase in the laboratory were reinforced and tested again. The objective, in this second phase, was to evaluate the possibility of a total or partial recovery of a highly damaged element by using CFRP reinforcements.

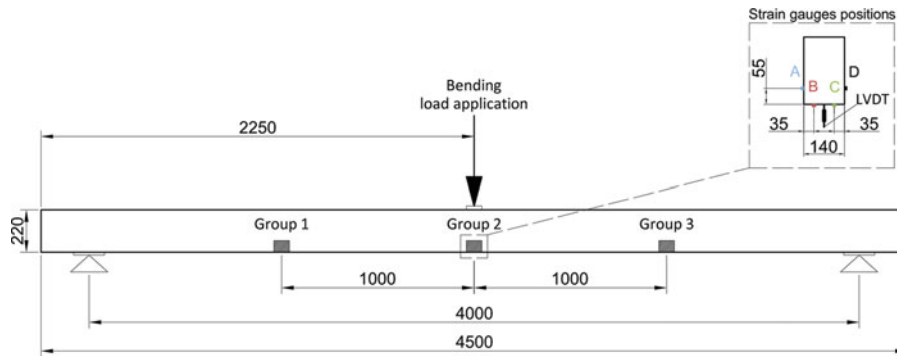
Figure 4. Experimental set-up (distances in mm).

Both non-broken and recovered broken beams were subjected to three-point bending tests, as Figure 4 shows. A monotonic loading was applied until final failure (displacement speed kept constant to 1.5 mm/min). Tests were performed on a machine from the company SERVOSIS S.L., CH4-ST-100 model. The span was set at 4000 mm between fixed supports, measuring the strains and deflections using strain gauges and linear variable differential transformers (LVDTs), respectively, with equipment from HBM, QUANTUMX MX 1615B model. For non-broken beams, three groups were established with four strain gauges and one LVDT for each group, as shown in Figure 4. For recovered broken beams, only strains and displacement at the mid-span (group 2) were measured.

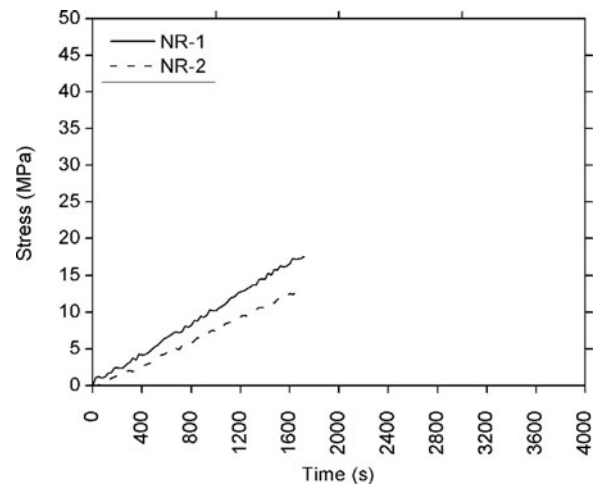
Figure 6. Bending stress vs. time for NR beams.

Non-broken beams were divided into three groups, NR, LR, and BR. Figure 6 and Table 2 show the bending stress as a function of time, and the main mechanical properties for the control beams (NR).

For both NR beams, the mechanical behavior was elastic with a relevant dispersion between them and a brittle final failure. The average corrected MOR was of 16 MPa with an average modulus of elasticity (MOE) and maximum deflection of 7812 MPa and 35 mm, respectively. The final failure was caused by the knots located at the center of the beams, corresponding with the maximum tension zone (bottom of the beam), as seen in Figure 7, which depicts the typical failure pattern for this type of timber beam with defects.

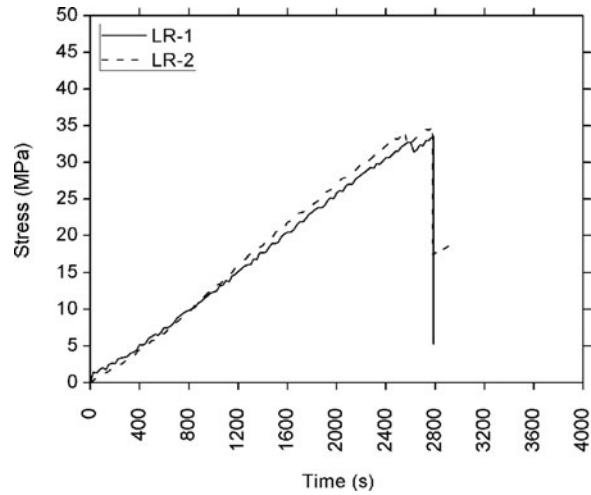
Figure 9. Bending stress vs. time for longitudinal reinforced beams (LR).

bending capacity was clearly improved for both specimens, a high stabilization of the mechanical properties and behavior being observed with respect to the NR beams. The corrected MOR increased a 119%, while the MOE and maximum deflection increased a 60% and 71%, respectively. As was predicted, these beams had a linear behavior until final breakage. Figure 10 shows some images corresponding to the two beams with a typical tension failure pattern owing to the important knots located at the tension zone, with a quick and subsequent delamination between timber and CFRP strip, due to the high stress values reached.

Accordingly, Figure 9 and Table 3 show the results for the beams reinforced with LR layout. It can be observed that the

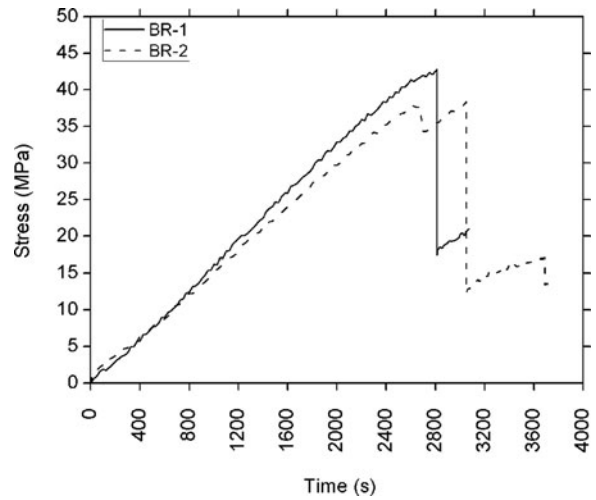
Figure 12. Bending stress vs. time for the braided reinforced beams (BR).

Finally, the bending stress versus time and the mechanical results for the braided reinforced beams are, respectively, shown in Figure 12 and Table 4.

A very significant improvement of all mechanical properties with regard to the NR and longitudinal reinforced beams is also clearly achieved. It is noteworthy that after reaching the maximum bending stress, the beams did not completely exhaust their strength capacity, remaining at 40% and 33% of the maximum value reached for BR-1 and BR-2 beams, respectively. After that point, the bending stress capacity increased again until a particular stress level, with no collapse of stress observed. In other words, a clear improvement in ductility is achieved by means of the braided reinforced layout as opposed to the NR and LR reinforced layouts. The corrected MOR improvement, MOE, and maximum deflection as opposed to NR beams were, respectively, 156%, 95%, and 71%, on average. Figure 13 shows the failure pattern for the two specimens, produced by a final slipping of the CFRP lamella followed by sudden delamination at the areas not covered by CFRP fabric.

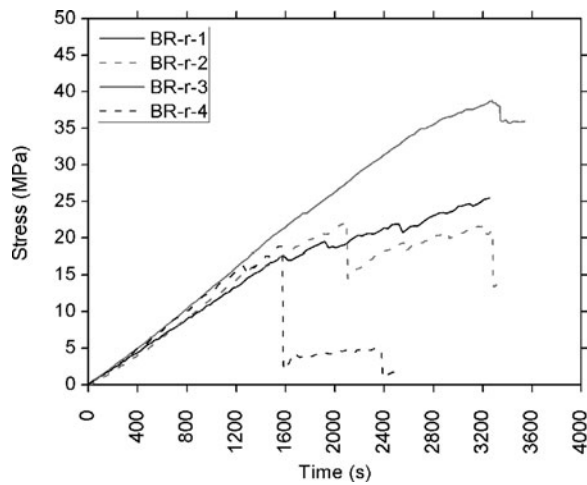
Figure 16. Bending stress vs. time for the repaired broken beams with the BR-r layout.

In turn, results for the broken beams repaired with the BR layout are shown in Figure 16 and Table 6. This layout not only provided for full recovery of the bending capacity of the non-broken beam and a significant increase in ductility, but it led to an increase in the corrected MOR of 69% . This finding bears huge relevance when a broken beam needs to be repaired, since it is not necessary to disassemble a roof partially or completely when only some beams are damaged. Beam BR-r-3 does not

show the ductile behavior observed in other cases because the test machine was close to the end of the stroke and the test had to be stopped for security. The mean MOE and maximum deflection improvements were of 35% and 109% , respectively. The remarkable increase of the maximum deflection (even improving upon the BR layout of the non-broken beams) was associated with the adaptation of the fabric placement for each beam.

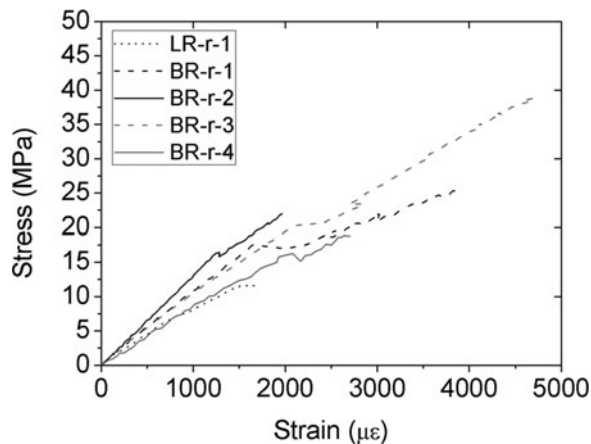
Figure 17. Stress vs. strain during bending tests for the strain gauge 2B.

Figure 17 displays the strain analysis for the strain gauge placed at the mid-span (maximum deflection) and at the tension side. In all cases, a linear behavior is observed until a particular level of stress, at which the beams appear to have a plastic behavior. Nevertheless, this change in slope was also associated with the reopening of existing cracks. Note that for all beams, the mean MOR value when the stress-strain slope changed was of 16 MPa, while the mean MOR for non-broken NR beams was of 16 MPa. This fact corroborates the total restoration of the mechanical properties by means of the BR reinforcement layout.

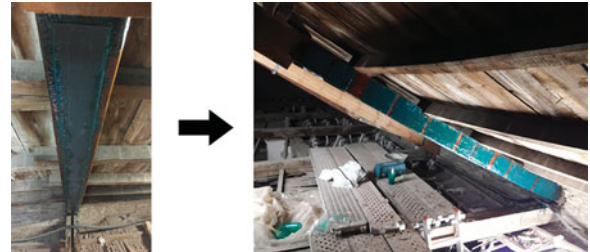
Figure 19. Rehabilitation process of the rafter. Left-hand side: placement of the CFRP lamella. Right-hand side: final state of the reinforced element. Image by authors.

Once the BR layout had been designed, it was necessary to recover in so far as possible the deflection of the beam with the help of mechanical jacks. After that, the reinforcement was applied following the same process as for laboratory specimen elaboration. Figure 19 shows images taken during the repairing process. Finally, after visual tracking, during one month, no application problems were detected.
