INTERRELATIONS BETWEEN THE TYPES OF DAMAGES AND THEIR ORIGINAL CAUSES IN THE ENVELOPE OF BUILDINGS

Manuel J. Carretero-Ayuso¹, C.E. Rodríguez-Jiménez^{2*},
David Bienvenido-Huertas² and Juan J. Moyano³

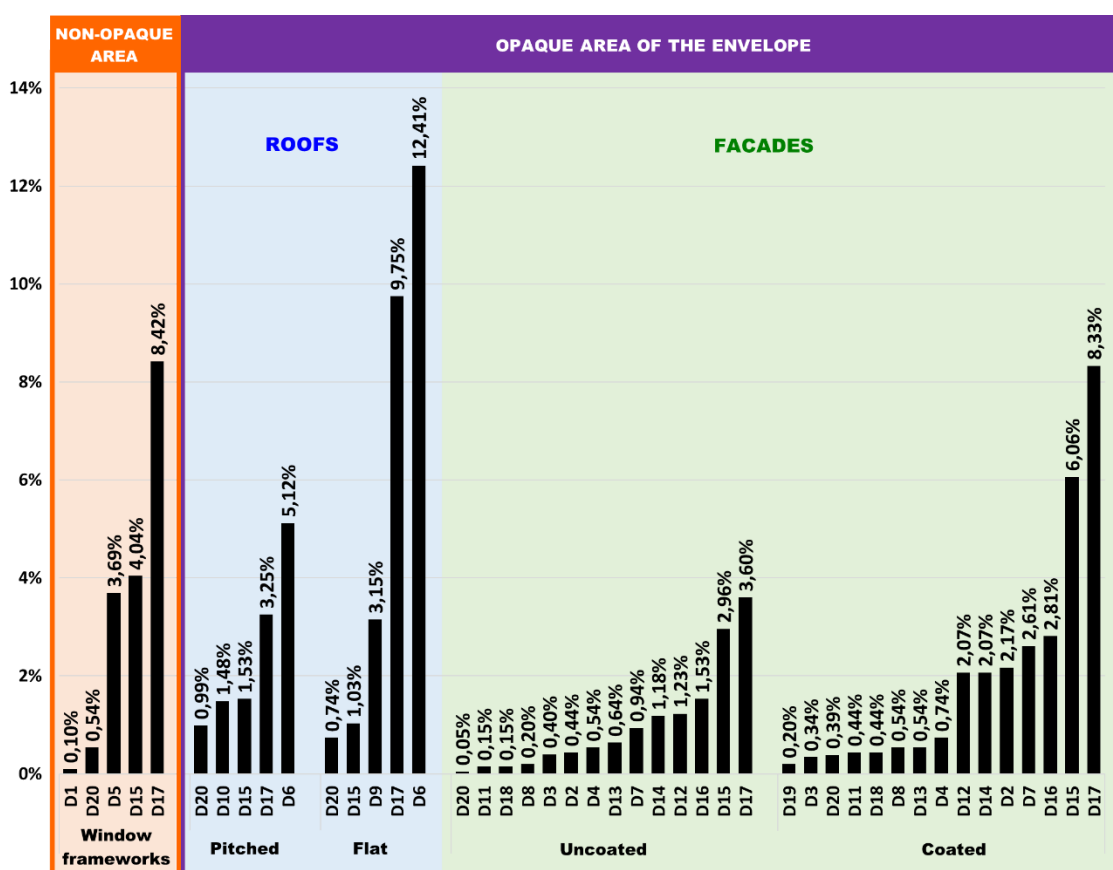
Figure 5 shows the relationship between the type of damage (descriptor 2 from Table 1) and the construction unit in which they occurred (descriptor 1 from Table 1) to precisely know which damages are involved in each place and to have detailed information to be used later in the prevention during the design stage.

Following a combined nomenclature based on Table 1, the damages with a greater percentage in comparison with the total of the study were $D6_{U3}=12.41\%$, $D17_{U3}=9.75\%$, $D17_{U1}=8.42\%$, $D17_{U5}=8.33\%$, and $D15_{U1}=6.06\%$. Thus, the 'infiltration humidity' (D17) was on the top in 3 out of these 5 times.

Furthermore, the types of damage D6, D15, D17, and D20 were present in the two types of roof (U2 and U3). As for the two variants of facades (U4 and U5), the same types of damage were repeated, except D19 (breakage of pieces or elements) which only occurred in the uncoated facades. Finally, the types of damage which were common in the 5 construction units were 'condensation humidity' (D15) and 'infiltration humidity' (D17), and again the key role of humidity in the study was notable.

Figure 5 – Distribution of the damages in each construction unit
