The Characterization of the Building Materials Used in the Refectory of the Manzana Jesuítica in Córdoba (Argentina) on the Basis of a Study of Its Historical Background and the Archaeological Evidence

Soledad M. Gallegillo¹, Anna Arizzi^{1,*}, Eduardo Pardo Sebastián¹, María Rebeca Medina² and Alfonso Uribe³

Keywords: raw materials; Jesuits; construction techniques; local resources; lime mortars; bricks

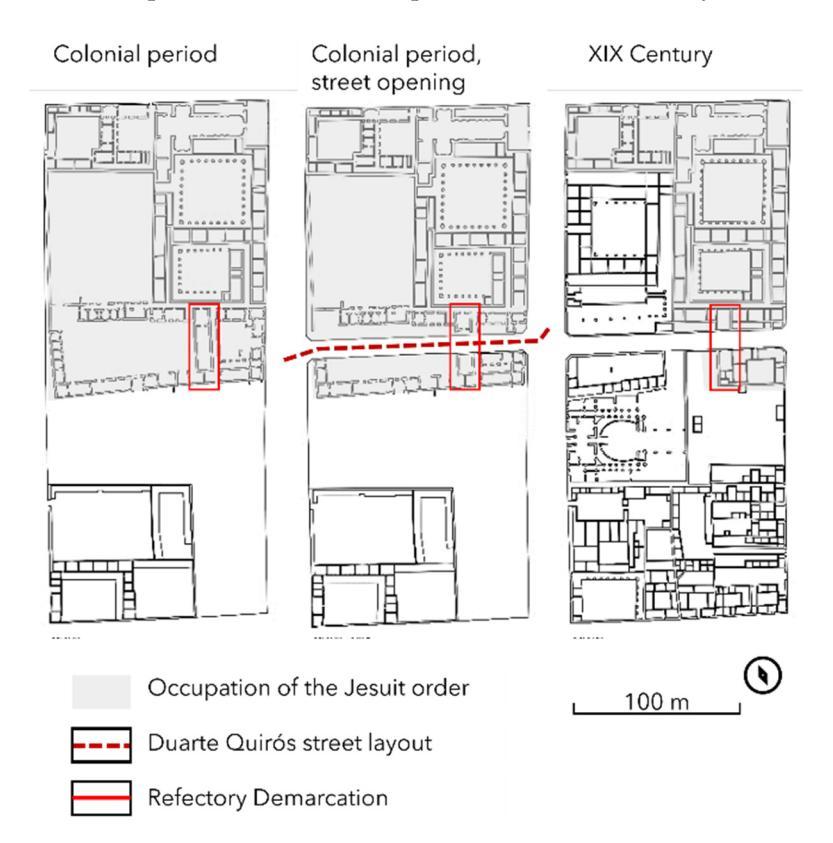
Figure 2. A summarised evolution of the Jesuit complex from the colonial period to the 19th century.

Towards the end of the 19th century, the complex was affected by the pressure of urban growth. In 1875, a new street was opened up (the Calle Duarte Quirós, formerly known as the Calle San Luis), which divided the original block into two, and affected a series of buildings located along its route. As a result, a new lateral façade was created in what had previously been part of the interior of the complex. Figure 2 shows the evolution of the complex from the colonial period to the 19th century.

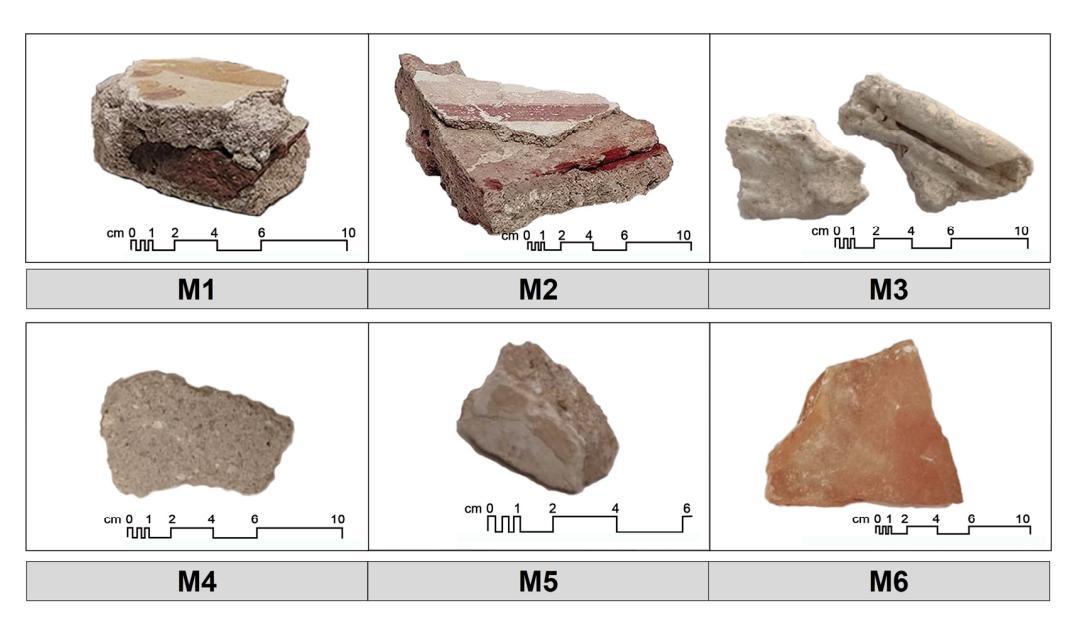
Six samples (Figure 4) were taken from different areas of the refectory of the *Manzana Jesuítica* in Córdoba (Argentina).

Figure 4. Macroscopic appearance of studied samples.

The samples, dated by archaeological research to between 1750 and 1767, were obtained as remains from an excavation site measuring 1.50 m. wide from the line of the façade. The hypothetical original locations of these samples, based on ongoing historical and archaeological studies, are shown in Figure 5.

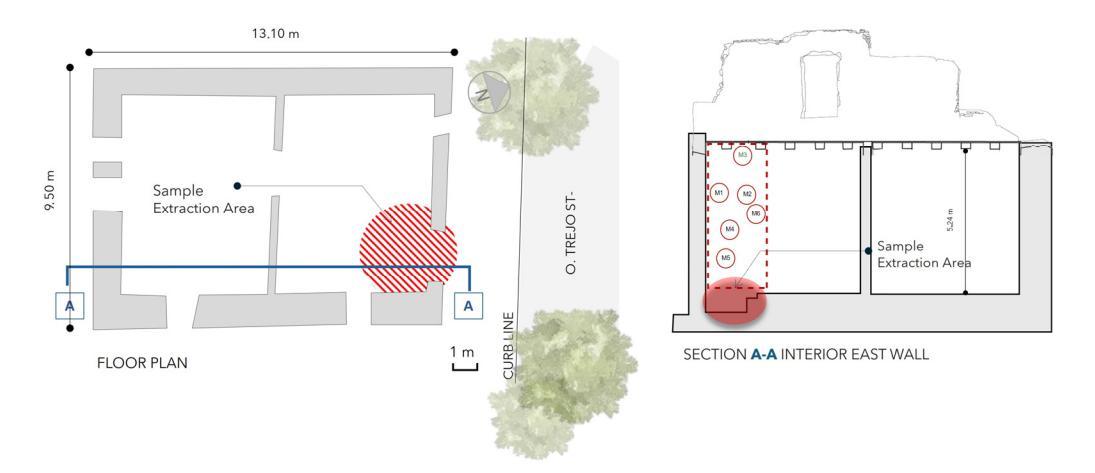
Figure 5. Schemes of the plan and section indicating both the location of the archaeological extraction of the samples (Floor Plan) and its hypothetical position in the wall, observable in section AA.

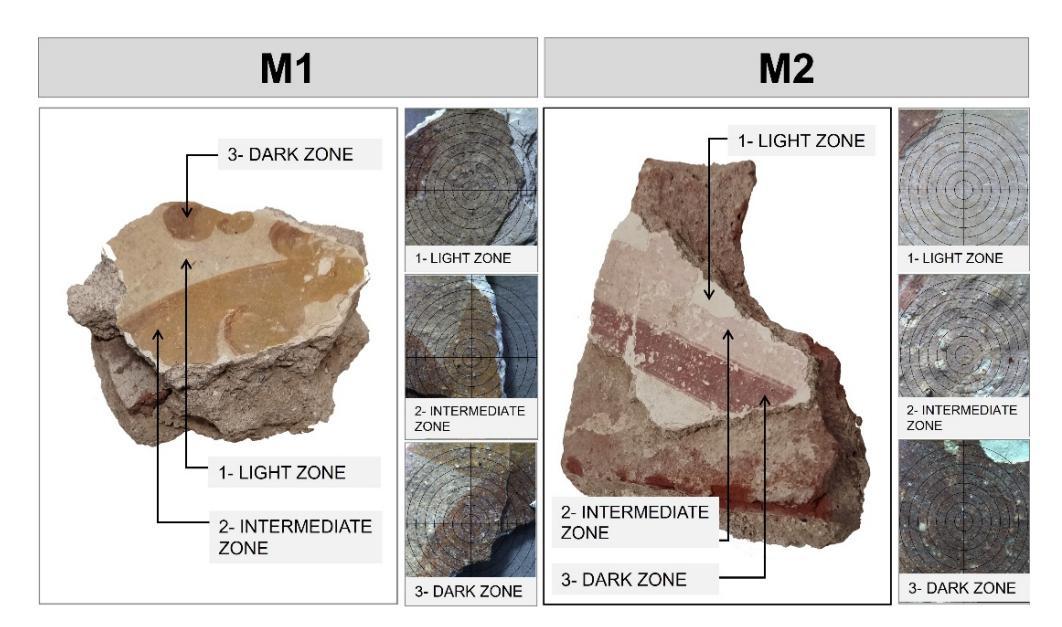
X-ray micro-diffraction (μ -XRD) was carried out on the paint layers of samples M1 and M2 (Figure 6), using a BRUKER D8 DISCOVER diffractometer (Bruker, Billerica, MA, USA) with a PILATUS3R 100K-A detector (Dectris, Baden, Switzerland), under the following conditions: T—25 °C, Cu K α radiation (λ = 1.5406 Å), 50 KV voltage, and 1 MA intensity. Due to the non-destructive nature of this technique, the samples were not reduced to powder. The paint on the surface of M1 and M2 has yellowish and reddish tones, respectively. In both samples, 3 areas with different shades of paint were analysed (light, intermediate, and dark areas (Figure 6)), to assess possible differences in their mineralogical composition.

Figure 6. Areas of the samples studied under micro-X-ray diffraction. (**Left**): Sample M1. (**Right**): Sample M2.

The mineralogical analysis by μ -XRD of the paint layer on the mortars revealed that the light area of both samples contained calcite and quartz (Table 3), the main components of the mortar on which the paint was applied. In M1, dolomite, muscovite, and albite were also found, which could explain why M1 had a somewhat darker tone than M2. In sample M2, the mineralogical composition of the intermediate zone was similar to that of the light zone. In M1, however, it was slightly different due to the presence of goethite. The darker-shaded area of both mortars was composed of the same mineral phases, although larger amounts of goethite and dolomite were detected in M1.

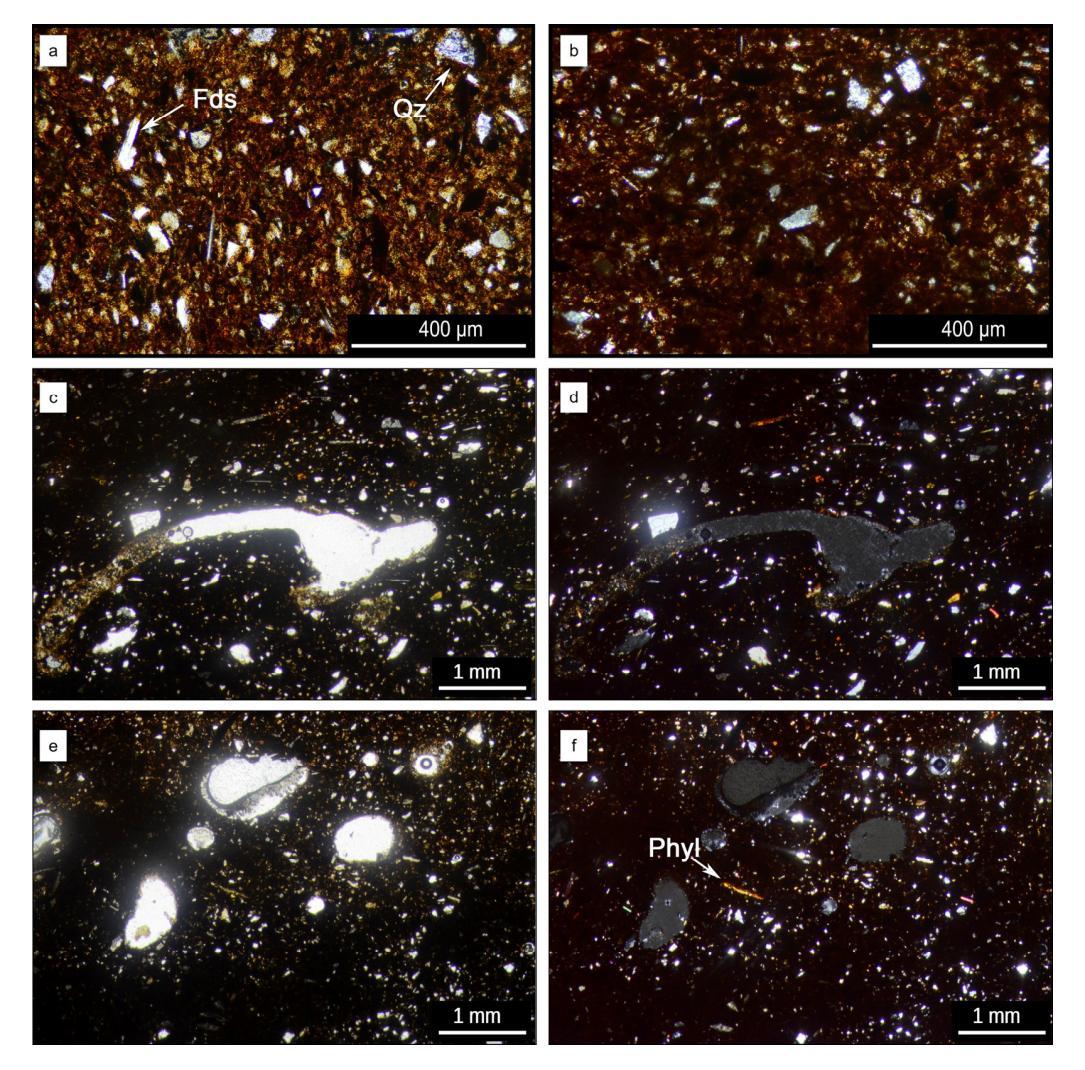
The matrix of the brick layer in samples M1 and M2 is predominantly red (Figure 7a,b), although darker in M2, suggesting that these bricks were fired under oxidising conditions that promoted the formation of hematite (Fe_2O_3) [9], as confirmed by XRD (Table 3). M1 shows slightly higher birefringence of the matrix compared to M2, indicating lower

vitrification in M1, perhaps because it was fired at a lower temperature [9,10]. Both samples have a coarse matrix with quartz, feldspars, and phyllosilicates. In terms of porosity, the pores in M1 are angular and irregular in shape, and contain recrystallizations (Figure 7c,d), while in M2, they are less abundant, and more rounded (Figure 7e,f). The different pore morphologies observed in the two samples are in line with different firing temperatures (possibly higher in M2 than in M1). In both samples, the degreasing agents consist mainly of quartz or added rock fragments, while the fluxes are mostly made up of feldspars and calcite.

Figure 7. Photomicrographs of the samples taken with a transmitted light polarisation optical microscope. Brick fragments from samples M1 (**a**) and M2 (**b**), both with plane polars. Brick fragments from sample M1 with plane polars (**c**) and crossed polars (**d**). Brick fragments from sample M2 with plane polars (**e**) and crossed polars (**f**). The white arrows indicate Fds: feldspars; Qz: quartz; and Phyl: phyllosilicates.

In regards to the brick part of the samples, their similar composition suggests that the raw materials were extracted from the same source. They also seem to have been made using the same technique and for a similar function. Our results indicate that the bricks were fired under oxidising conditions, but with different firing temperatures (lower in M1 than in M2).

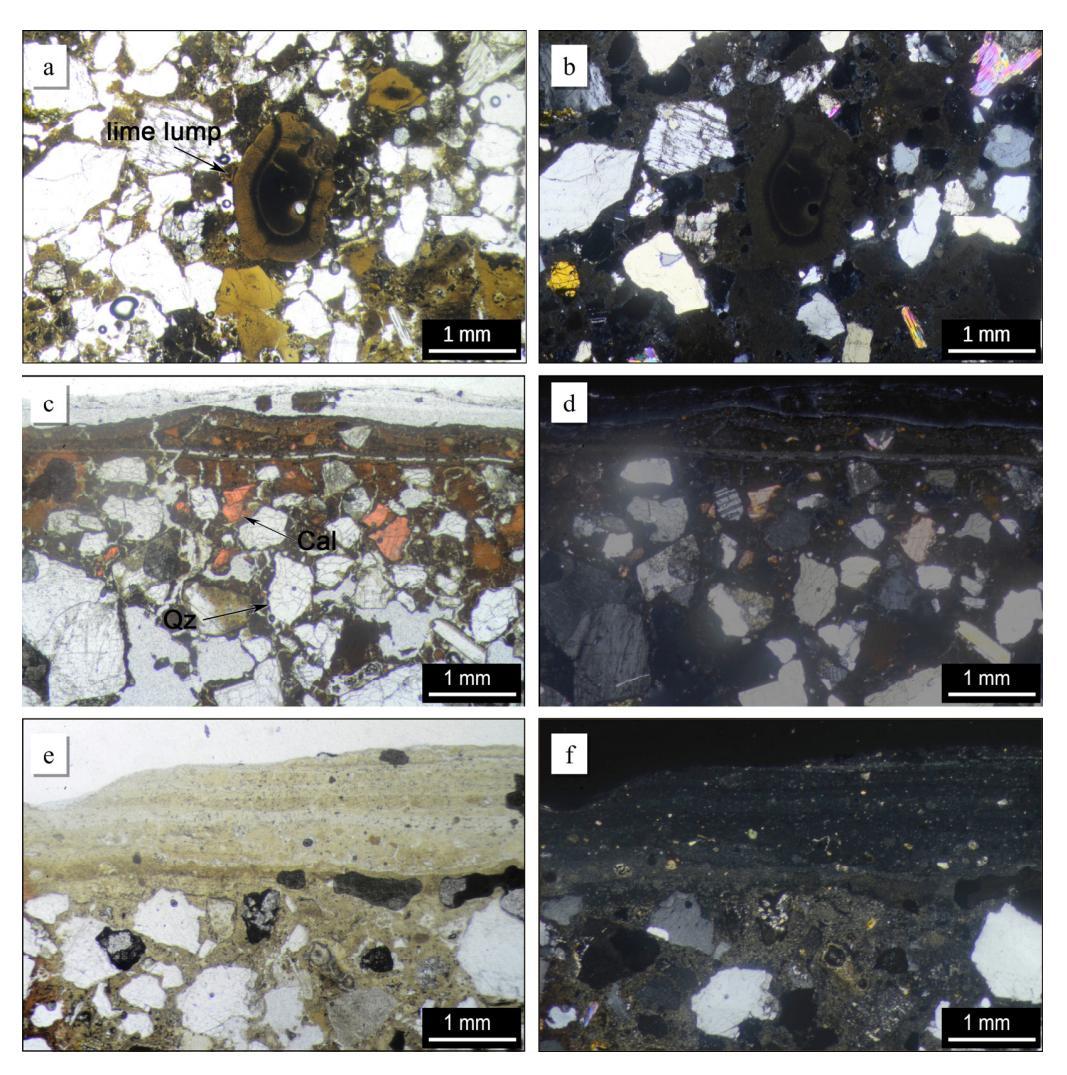
The mortar samples have a high proportion of aggregates. These are mostly natural, crushed quarzitic aggregates, and altered phyllosilicates and feldspars are present in some samples (Figure 8a–f). The larger aggregates tend to have an angular, irregular shape, while the smaller ones are mostly rounded. However, in the area closest to the surface and the paint layer, the aggregates have a more uniform size, especially in M1. Some of these aggregates have a calcitic composition, as revealed by the fact that they turn red when treated with alizarin red (Figure 8c). The mortar matrix is also predominantly calcitic (Figure 8c) and some lime lumps have been observed (Figure 8a,b). All mortar samples

magnesian (or dolomitic) composition (Figure 8c).

Figure 8. Microphotographs of the samples taken with a transmitted light microscope. (Left): With plane polars. (Right): With crossed polars. In descending order: (a,b), sample M1; (c,d), sample M2; (**e**,**f**), sample M5.

The mortars show similar porosity, with large angular, irregular pores, together with smaller, regular, rounded pores. Shrinkage cracks were also observed, especially in M2 (Figure 8c,d).

Our results suggest that the mortars could have been prepared according to artisanal methods. These methods were not entirely efficient and were probably based on the artisan's empirical knowledge. The presence of shrinkage cracks and lime nodules in the samples indicate faulty mixing or poor slaking of the binder.

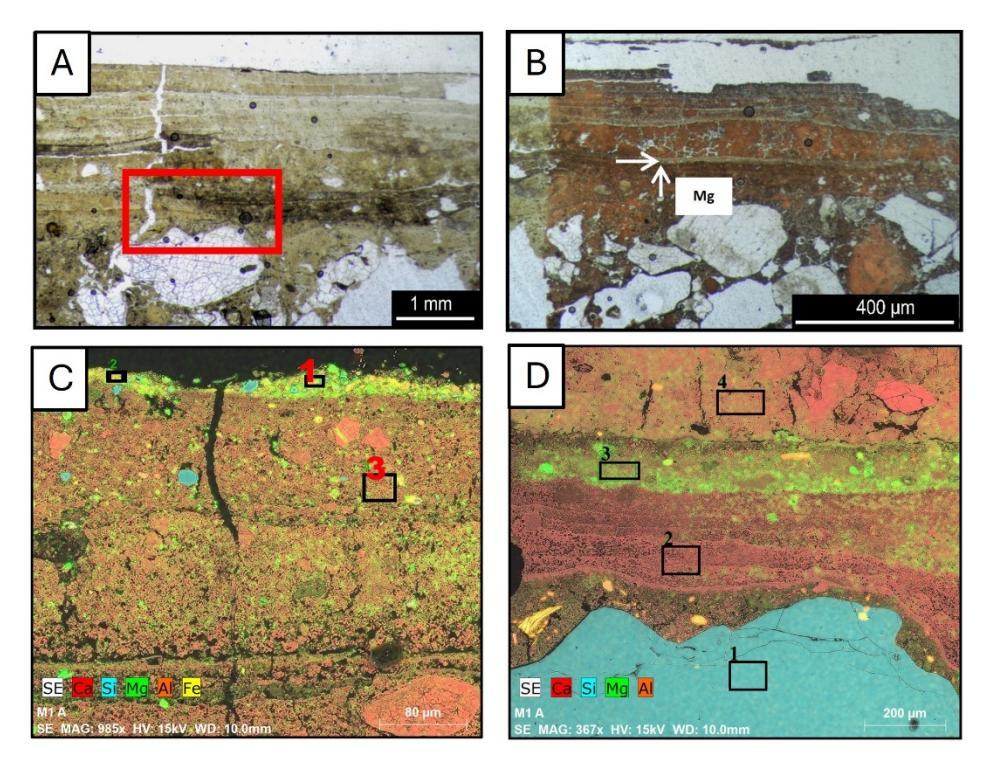
As observed by POM, multiple layers without aggregates were identified in the mortar layer of sample M1 (Figure 9A,B), suggesting successive applications of lime. The main chemical elements analysed by EDS (Figure 9C,D) were silica (Si), calcium (Ca), and aluminium (Al), whilst magnesium (Mg) was only present in some of the layers, thus confirming the mineralogical composition identified by XRD and POM. In the upper layer of sample M1, iron (Fe) mixed with silica (Si), calcium (Ca), aluminium (Al), and magnesium (Mg) was detected. This is probably due to the presence of phyllosilicates and hematite. The latter would explain the red colour of the paint layer observed under optical microscopy.

Figure 9. Polarised optical microscopy (**A**,**B**) and scanning electron microscopy (**C**,**D**) microphotographs of sample M1. The red box in (**A**) indicates the area observed under SEM and analysed by EDS. The black boxes in (**C**,**D**) are the areas analysed by EDS.

The three mortars also show similarities in terms of structure, as they all present superimposed surface layers with no aggregate, which suggests that lime was applied repeatedly over time. It is important to remember here that the samples were taken from a refectory, a place where the Jesuits spent most of their time (eating, praying, etc.). In those days, lime paint was one of the most commonly used disinfection techniques, and it therefore seems likely that the Jesuits whitewashed the building every so often, for maintenance purposes. Lime-based paint (whitewashing and lime glazes) first became popular in Europe in the Middle Ages because in addition to its disinfectant properties, it was also breathable and fireproof [11]. Practical knowledge of this kind would also have been applied as the Jesuit Order expanded across America, in this case in the refectory in Córdoba.

In this regard, lime layers of different composition were found in samples M1 and M5, suggesting that calcitic and magnesian limes were applied alternately on these mortars, something that was not detected in sample M2. According to our hypotheses regarding possible locations for each sample, samples M1 and M2 came from sites that were very close together. In this case, it is difficult to understand why M2 does not have layers of dolomitic lime like M1. This could be because the samples came from different walls, or perhaps because at some point in time the lime was applied in one small area, as a "patch", something that seems unlikely given that when lime was applied as a disinfectant, they normally painted the entire room.
