# **Erosion and vegetation cover in road slopes hydroseeded with sewage sludge**

Juan de Oña, Andrés Ferrer and Francisco Osorio (2011) *Erosion and vegetation cover in road slopes hydroseeded with sewage sludge*. **Transportation Research Part D**, **16**, 465–468.

## STUDY OF EROSION AND VEGETATION COVER IN ROAD SLOPES HYDROSEEDED WITH SEWAGE SLUDGE

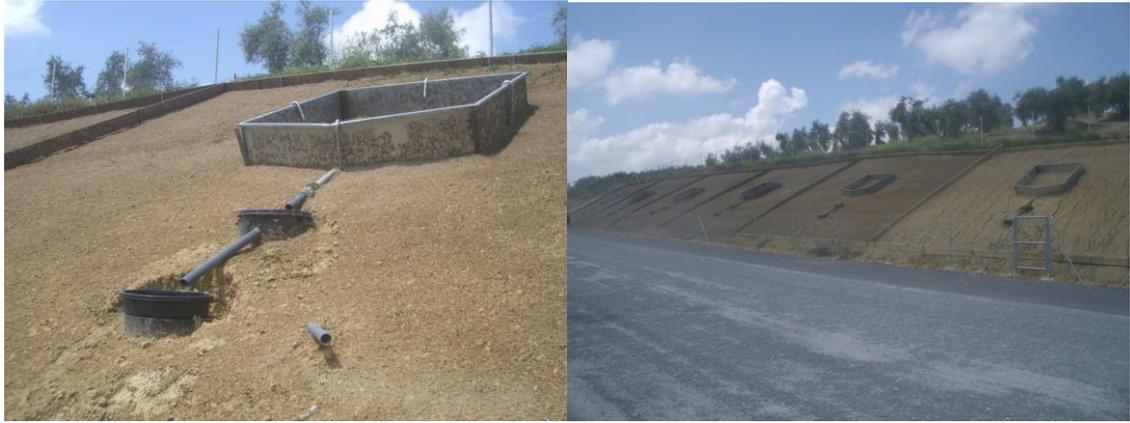
(FIGURE 1)

Figure 1.- Detail of the sediment trap and general view of the cut slope plots

The surface area of each plot was 100 m<sup>2</sup>. A metallic Gerlach trough (Gerlach, 1967) (see Figure 1), measuring 2 x 2 m, was placed at the center of each plot to collect runoff and sediment. Each trap consisted of a broad funnel that channeled water through a tube into a sealed receptacle where the eroded material was stored.

Each receptacle had a volume of 50 liters. Since the traps had an area of 4 m<sup>2</sup>, a rainfall event of 15 liters per m<sup>2</sup> was enough to fill them. Consequently, the lid of this receptacle had six equidistant perforations located at the same level. In this way, the water fell equally through each of the six perforations. One of these perforations was

connected to another receptacle that was able to collect a sixth of what would have been lost in the event that the first container was filled. With this information, it was possible to mathematically calculate the total eroded material.
