The Pavilions at the Alhambra's Court of the Lions: Graphic Analysis of Muqarnas

Abstract: This research documents and graphically analyzes the pavilions muqarnas at the Court of the Lions in the Alhambra in Granada, a World Heritage Site. In order to cast some light on the understanding and preservation of these 14th century architectural elements, after a brief report of historical data on catastrophes and restorations, a novel methodology for the case study based on three complementary graphic analyses is presented here: First, there is a review of outstanding images ranging from the 17th to the 20th centuries; subsequently, new CAD (computer-aided design) drawings from pavilions muqarnas testing the theoretic principles from their geometric grouping are accomplished for the first time; and finally, a 3D laser scanner is used to understand the precise present-day state from the point cloud obtained. Comparing drawings allows us to assess the muqarnas relevance while proving, for the first time, that the muqarnas of both pavilions have distinct configurations and different amounts of pieces. Besides, this process reveals geometric deformations existing in the original Nasrid muq

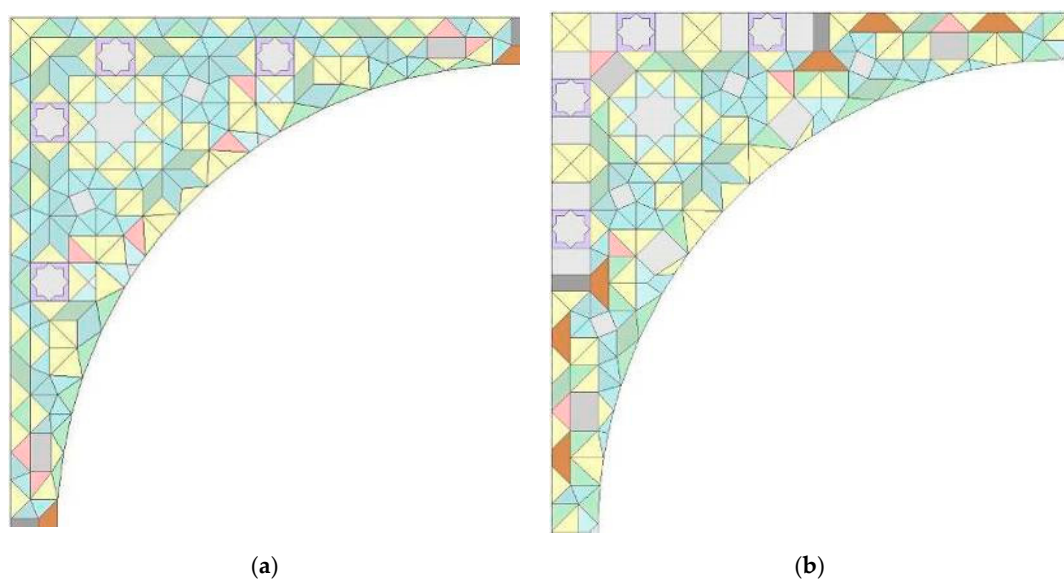
Figure 12. Pendentives composed of muqarnas [authors' own drawing]: (a) Western pavilion; (b) eastern pavilion.

For example, the naked eye may detect the different locations a trapezoidal muqarnas (marked in brown color) occupies on each pavilion (Figure 12). This muqarnas was identified in Jones and Goury's drawings and frequently occur in other Alhambra rooms.
